Η αρχιτεκτονική της Σωτείας Λυκοδήμου
Αθηνών

The Soteira Lykodemou at Athens. Architecture

THE SOTEIRA LYKODEMOU AT ATHENS. ARCHITECTURE*

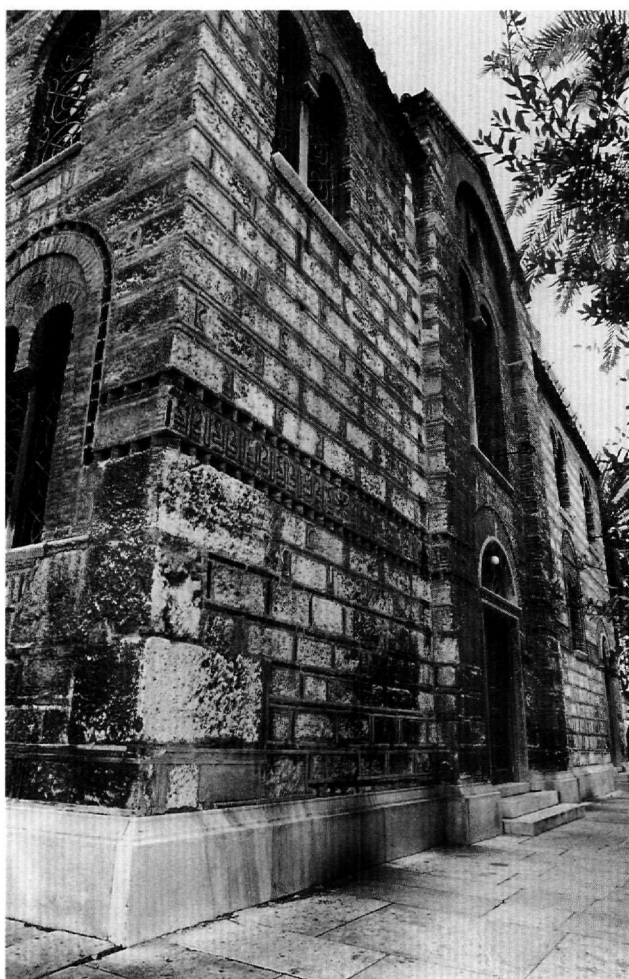
Fig. 1. The north façade looking west.

high chamfered marble crepis added by Vlasopoulos (Fig. 1) detracted from the monument's authenticity, and the old marble templon, the form of which is preserved by Lenoir³³, appears to have been carried off before the work began³⁴. The almost total destruction of the wall-paintings in the church (which will be discussed below) confirms the great scale of the removal of walls and vaults during Vlasopoulos's intervention.

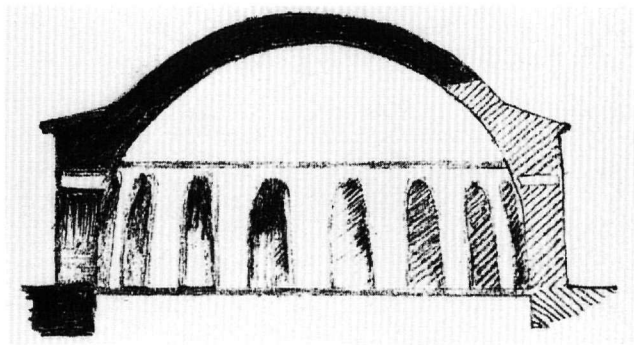
Fig. 2. Section of the original dome by T. Vlasopoulos, after Lambakis.

ing is confirmed by the reports submitted by a committee of technical experts (Smolens, Riedl, Kaftantzoglou and Schiodel (?) on 12th April 1847) and also by Kaftantzoglou himself, to the effect that “...the church, being in a very ruined state, must be razed to the foundations and erected anew...”. This information is recorded for us forty years later by G. Lambakis²¹, who appears to have derived it from the military architect responsible for the work, Telemachos Vlasopoulos²², who was still alive in 1894 at least²³. In the end, the church was fortunately not demolished but radically repaired, with parts of it being reconstructed. Lambakis, who was not even born at this time²⁴, knew the plans that had been drawn up by Vlasopoulos, one of which – the section of the dome – he published (Fig. 2)²⁵. The work was carried out between 1850 and 1855.

earthquake is based on the assumptions that the measured drawing of the original dome by T. Vlasopoulos⁵² was accurate and that the reconstruction followed it faithfully. It is only by making these assumptions that it is possible to use as a base the much later drawings of the plan and section of the present form of the Soteira by R. Schultz and S. Barnsley⁵³, which, when checked, proved to have a satisfactory degree of accuracy⁵⁴.

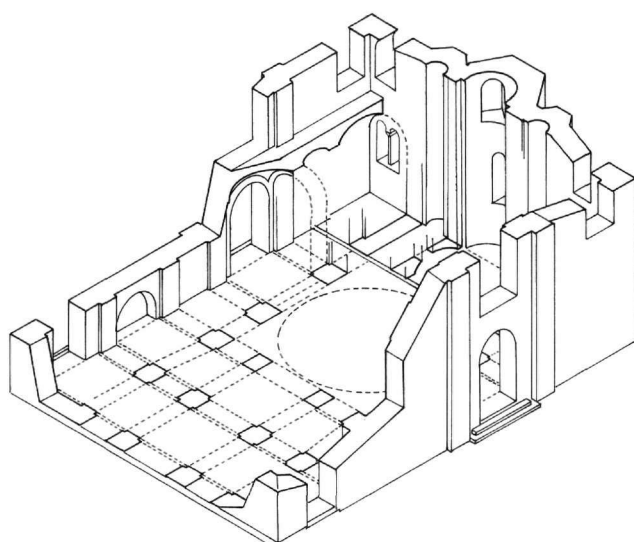
Fig. 3. Isometric section of the church, showing the existing original parts of the building, by C. Koliopoulos.

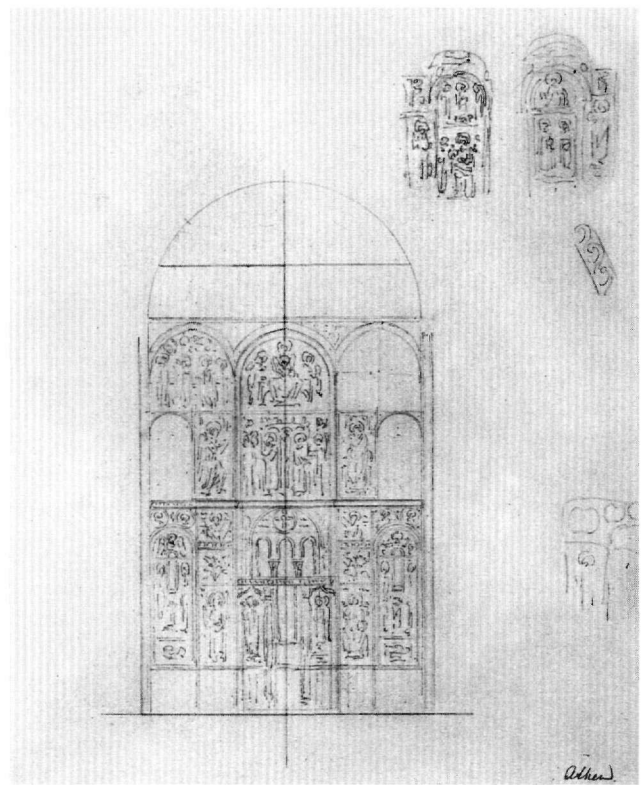
Fig. 4. M.G. Bindesbøl. Athens, Byzantine Church, 1835. Library of the Copenhagen Academy of Fine Arts, G.B. 074.

The Danish architect M.G. Bindesbøl⁴¹ has bequeathed us a drawing of a transverse section and two rough sketches (Fig. 4), which bear the title “Byzantine church in Athens”. The church is clearly the Soteira, since the drawing shows the two squinches either side of the east arm, the wide, low dome, and the templon with its two columns in front of the sanctuary. The two sketches depict the apses of the prothesis and

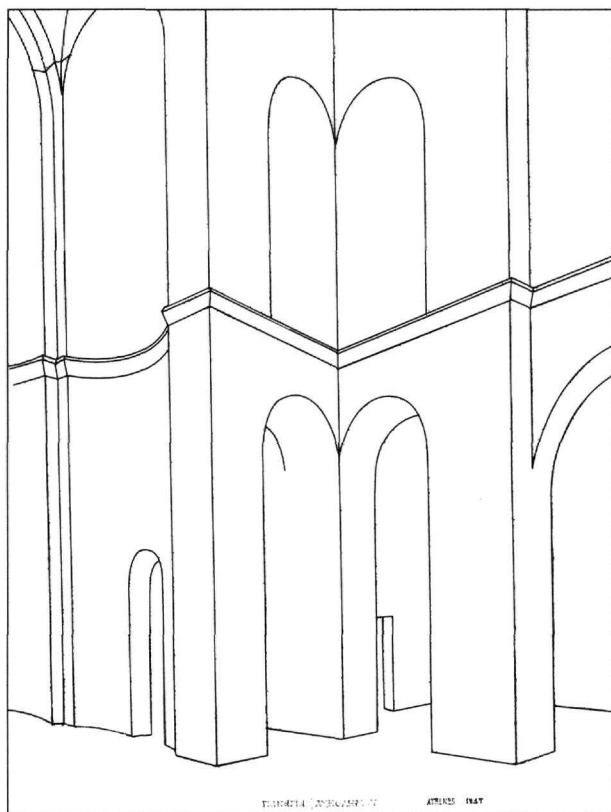
Fig. 6. Interior of naos facing south-east. P. Durand, no. 32.2, Hellenic Literary and Historic Archive (EΛIA).

from the level of an observer at the lower level, looking to the south-east (Fig. 6). It depicts the south part of the sanctuary with its shallow apse and the corner of the nave. The second (32/16) was taken from the level of the galleries (Fig. 7) and depicts the south-west corner and parts of the ruined west arm and narthex, as well as the dome, which has partly collapsed. Both these drawings, and indirectly the 22 others depicting wall-paintings⁵¹, provide a great deal of information on the form of the Soteira after the Greek Uprising, which I shall try to exploit in what follows.

The major problem in the reconstruction is the precise form taken by the rest of the vaulting of the church. From Durand's drawing 32/2 it emerges that the east arm was covered by a cross-vault and from 32/16 that the west probably also had an elevated cross-vault or low domes carried on pendentives. All the other vaults in the drawings (8 and 9 are unaccompanied by any substantial information regarding the original form.

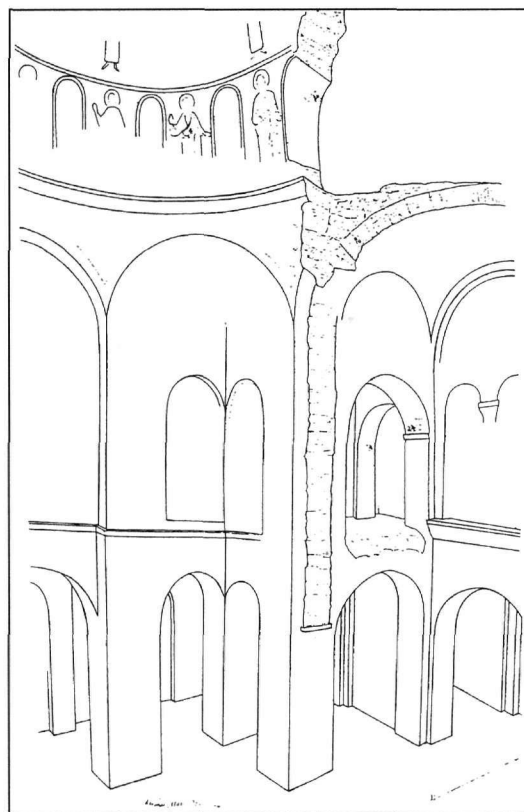
Fig. 7. Interior of naos facing north-west. P. Durand, no. 32.16, Hellenic Literary and Historic Archive (EΛIA).

The dome, then, did not have an internal tympanum, and the sixteen windows created around the edge of it penetrated its hemisphere. There was a low tympanum only on the exterior. From Durand's drawing 32/16 it can be calculated

that the two main axes of the nave coincided at the dome not with windows but with a section of wall between two windows. This feature further reveals the similarity of the dome of the Soteira with that of the katholikon of the monastery of Hosios Loukas. The breach created by the bomb must have been above the south-west pillar and, according to Couchaud, it destroyed two thirds of the dome. There was a painted strip above the window arches. In Durand's drawings, the thickness of the face of the arches bearing the dome can be made out, as well as that of the unified surface of the circumscribed sphere above them. Both were probably equal to the length of a brick.

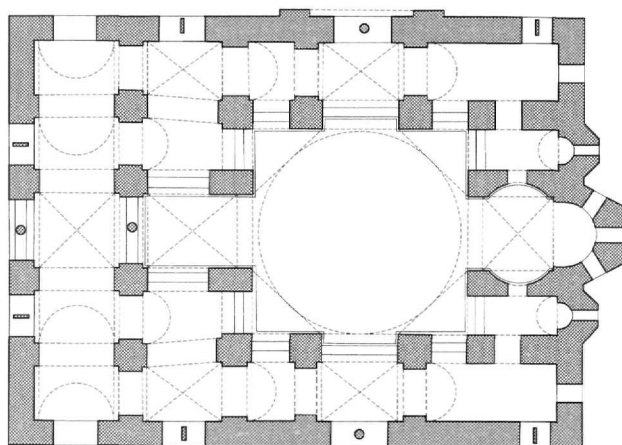
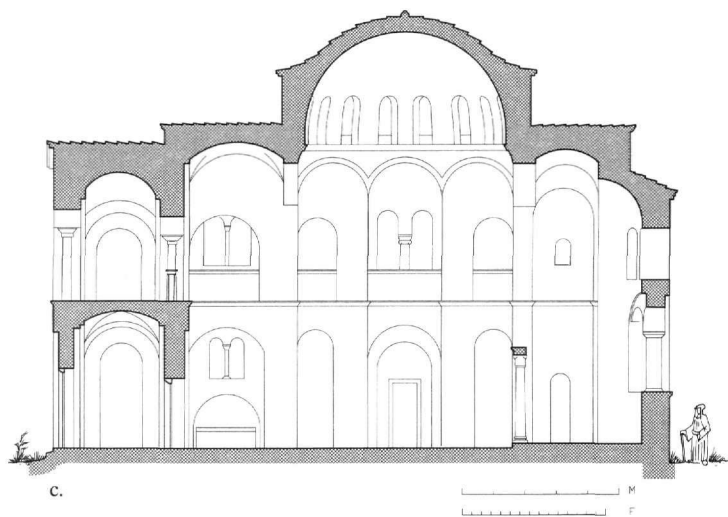
Fig. 8. Reconstruction of the church in its original form. a. Plan at ground level. b. Plan at gallery level. c. Longitudinal section.

The attempted restoration of the Soteira in the form it originally had (Fig. 8) and in the form it received after the 1705

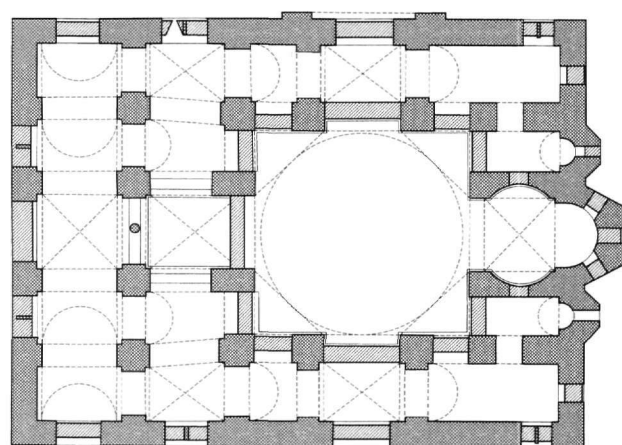
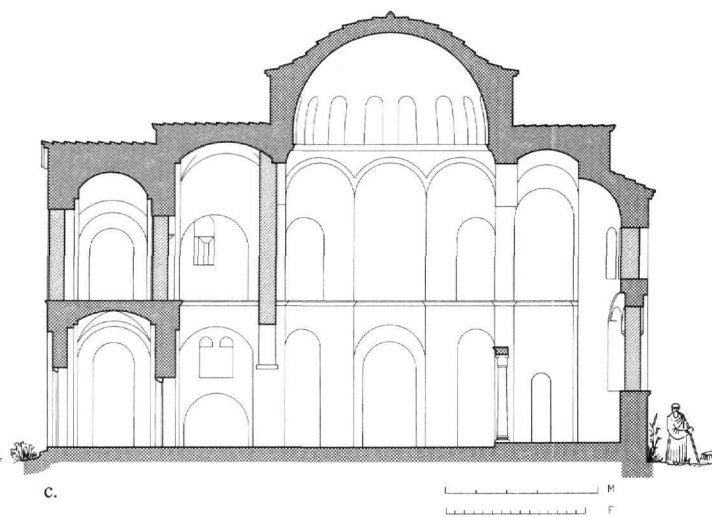
Fig. 9. Reconstruction of the church as in 1820. a. Plan at ground level. b. Plan at gallery level. c. Longitudinal section.

The reconstruction of the Soteira in the form it took after the repairs necessitated by the 1705 earthquake and before the Greek Uprising of 1821 (Fig. 9) is based on the same documentation, mainly on P. Durand's drawings.
