Η αρχιτεκτονική της Σωτείρας Λυκοδήμου
Αθηνών

The Soteira Lykodemou at Athens. Architecture

THE SOTEIRA LYKODEMOU AT ATHENS. ARCHITECTURE*

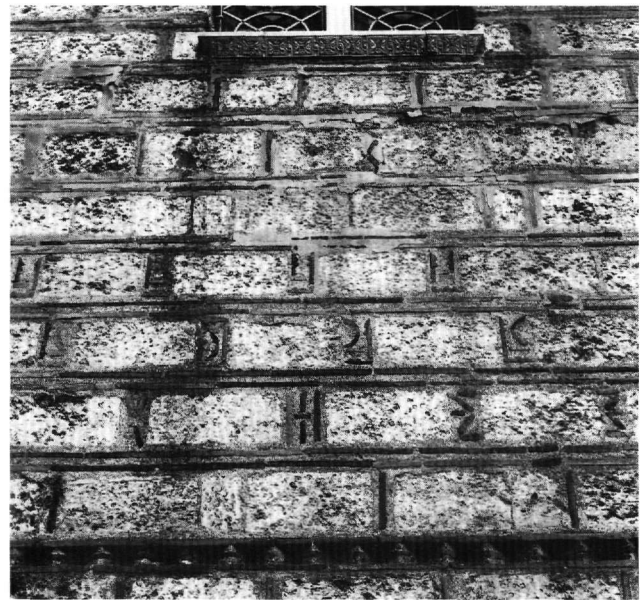
Fig. 15. Detail of the masonry on the south façade.
