Η αρχιτεκτονική της Σωτείρας Λυκοδήμου
Αθηνών

The Soteira Lykodemou at Athens. Architecture

THE SOTEIRA LYKODEMOU AT ATHENS. ARCHITECTURE*

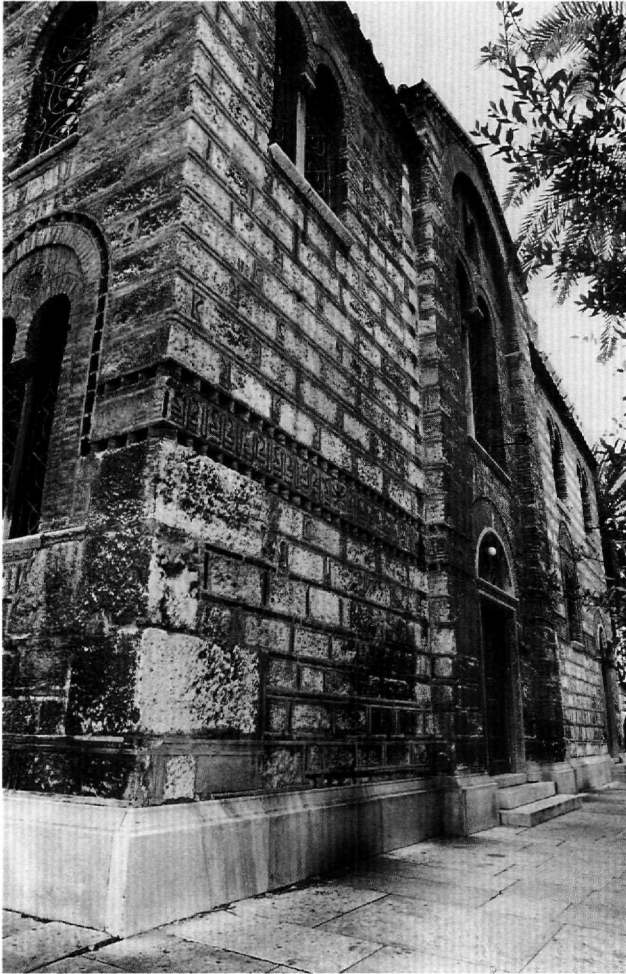
Fig. 1. The north façade looking west.

The architecture of the church of the Soteira Lykodemou at Athens, now known also as the Russian church (Fig. 1), has never been the subject of systematic scholarly investigation. The reason for this is clear: the damage it suffered during the Greek War of Independence and the drastic repair it underwent just after 1850 gave rise to serious doubts as to whether it was an authentic Byzantine monument and deterred scholars from turning their attention to the question. It was in any case regarded as a published monument, since five drawings of the church, made, moreover, before 1840, appeared in A. Couchaud's now inaccessible book on the Byzantine monuments of Greece¹. Nothing published since that time is based on primary research², with only a few exceptions: the two drawings of the modern condition of the church made by Schultz and Barnsley³ and a few observations by A.H.S. Megaw seventy years ago⁴.

high chamfered marble crepis added by Vlasopoulos (Fig. 1) detracted from the monument's authenticity, and the old marble templon, the form of which is preserved by Lenoir³³, appears to have been carried off before the work began³⁴. The almost total destruction of the wall-paintings in the church (which will be discussed below) confirms the great scale of the removal of walls and vaults during Vlasopoulos's intervention.

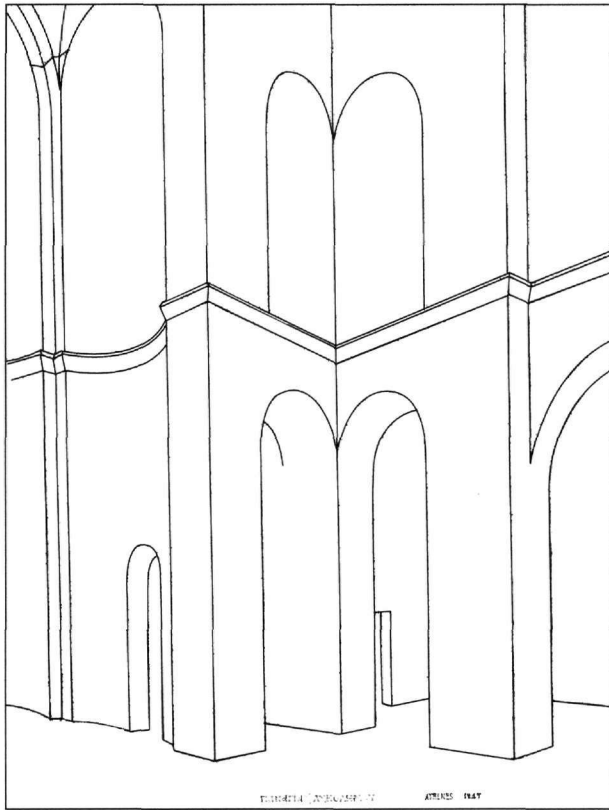
Fig. 6. Interior of naos facing south-east. P. Durand, no. 32.2, Hellenic Literary and Historic Archive (EΛIA).

from the level of an observer at the lower level, looking to the south-east (Fig. 6). It depicts the south part of the sanctuary with its shallow apse and the corner of the nave. The second (32/16) was taken from the level of the galleries (Fig. 7) and depicts the south-west corner and parts of the ruined west arm and narthex, as well as the dome, which has partly collapsed. Both these drawings, and indirectly the 22 others depicting wall-paintings⁵¹, provide a great deal of information on the form of the Soteira after the Greek Uprising, which I shall try to exploit in what follows.

The major problem in the reconstruction is the precise form taken by the rest of the vaulting of the church. From Durand's drawing 32/2 it emerges that the east arm was covered by a cross-vault and from 32/16 that the west probably also had an elevated cross-vault or low domes carried on pendentives. All the other vaults in the drawings (8 and 9 are unaccompanied by any substantial information regarding the original form.

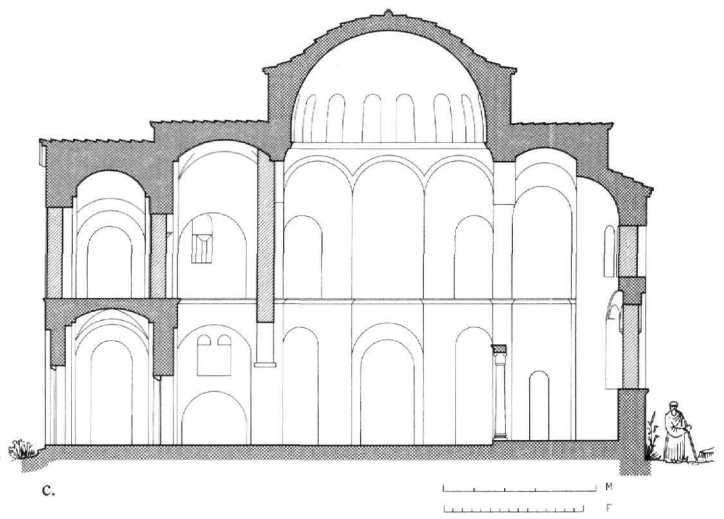
Fig. 9. Reconstruction of the church as in 1820. a. Plan at ground level. b. Plan at gallery level. c. Longitudinal section.

The reconstruction of the Soteira in the form it took after the repairs necessitated by the 1705 earthquake and before the Greek Uprising of 1821 (Fig. 9) is based on the same documentation, mainly on P. Durand's drawings.

Both drawings testify to the fact that all the arches opening

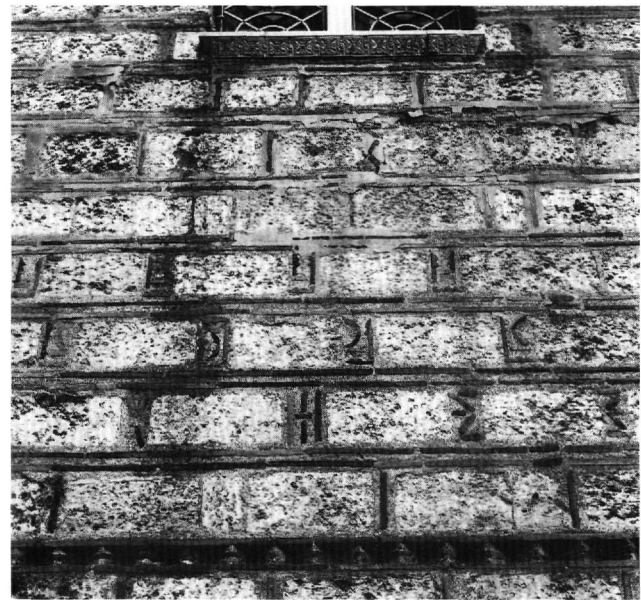
Fig. 15. Detail of the masonry on the south façade.
