Η αρχιτεκτονική της Σωτείρας Λυκοδήμου
Αθηνών

Charalambos BOURAS

THE SOTEIRA LYKODEMOU AT ATHENS. ARCHITECTURE*

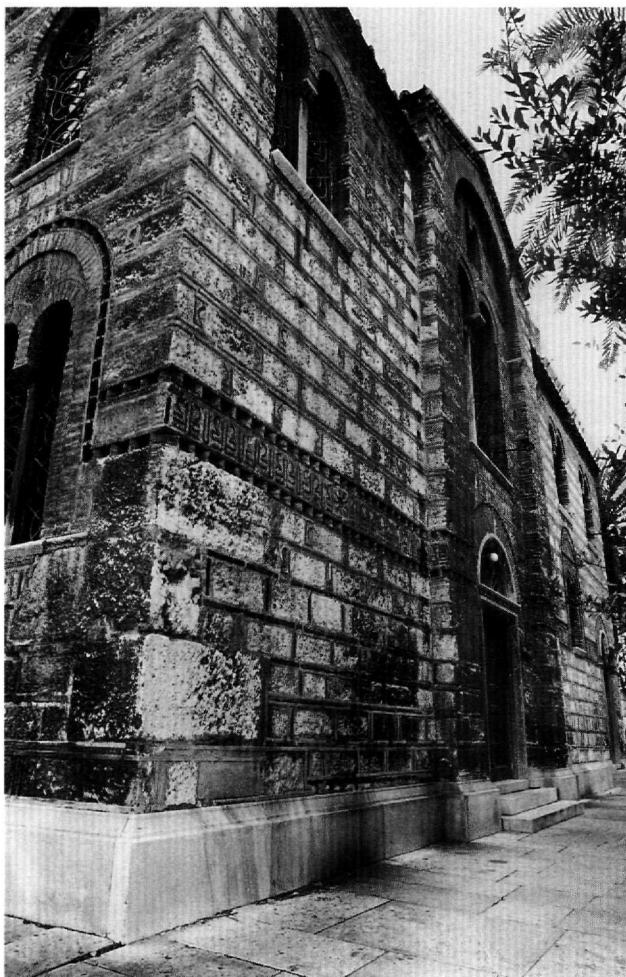
Fig. 1. The north façade looking west.

high chamfered marble crepis added by Vlasopoulos (Fig. 1) detracted from the monument's authenticity, and the old marble templon, the form of which is preserved by Lenoir³³, appears to have been carried off before the work began³⁴. The almost total destruction of the wall-paintings in the church (which will be discussed below) confirms the great scale of the removal of walls and vaults during Vlasopoulos's intervention.

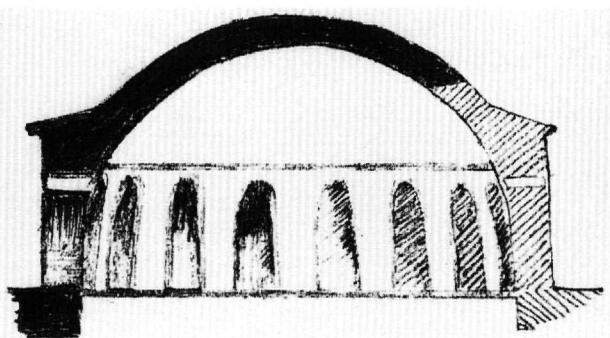
Fig. 2. Section of the original dome by T. Vlasopoulos, after Lambakis.

earthquake is based on the assumptions that the measured drawing of the original dome by T. Vlasopoulos⁵² was accurate and that the reconstruction followed it faithfully. It is only by making these assumptions that it is possible to use as a base the much later drawings of the plan and section of the present form of the Soteira by R. Schultz and S. Barnsley⁵³, which, when checked, proved to have a satisfactory degree of accuracy⁵⁴.

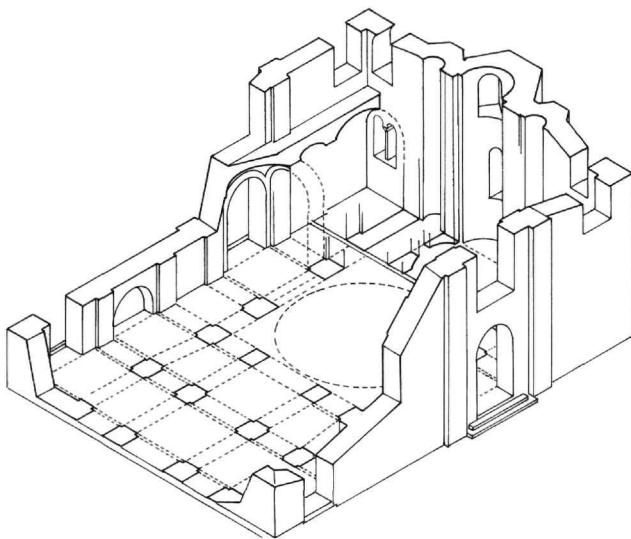
Fig. 3. Isometric section of the church, showing the existing original parts of the building, by C. Koliopoulos.

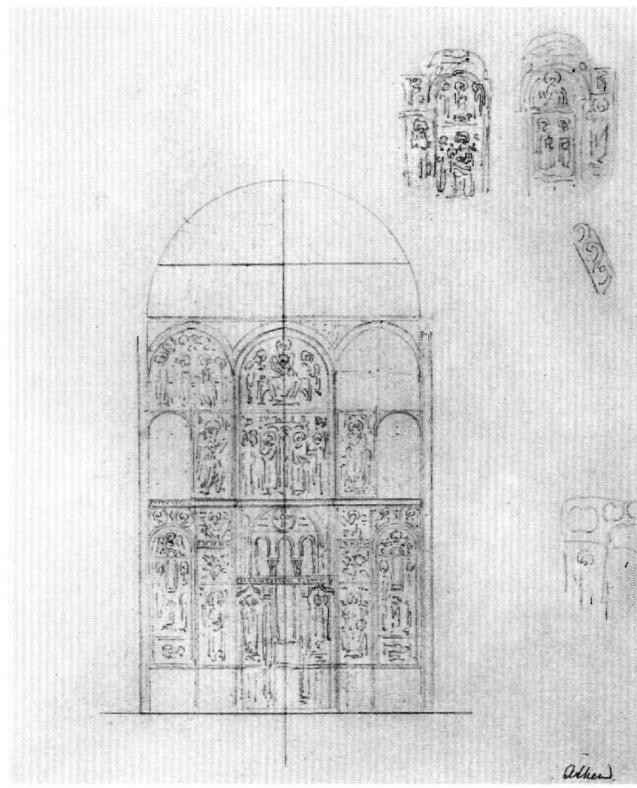
Fig. 4. M.G. Bindesbel. Athens, Byzantine Church, 1835. Library of the Copenhagen Academy of Fine Arts, G.B. 074.

The Danish architect M.G. Bindesbøl⁴¹ has bequeathed us a drawing of a transverse section and two rough sketches (Fig. 4), which bear the title "Byzantine church in Athens". The church is clearly the Soteira, since the drawing shows the two squinches either side of the east arm, the wide, low dome, and the templon with its two columns in front of the sanctuary. The two sketches depict the apses of the prothesis and

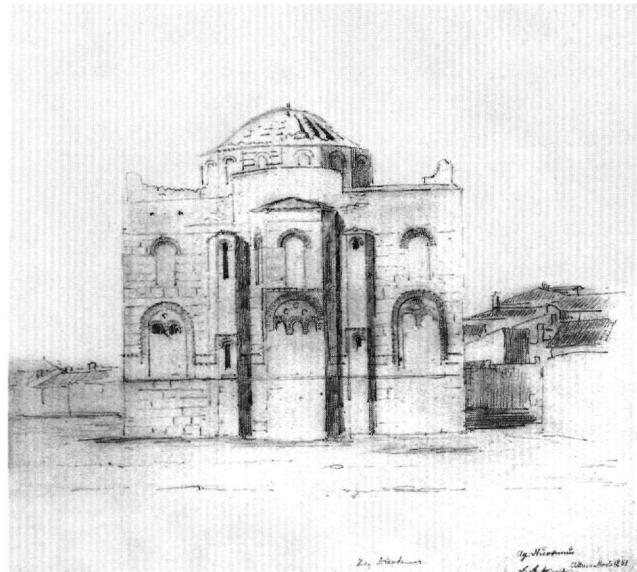
Fig. 5. L.A. Winstrup. The Byzantine Church of Sotira Likodhimou. Library of the Copenhagen Academy of Fine Arts, LAW 094.

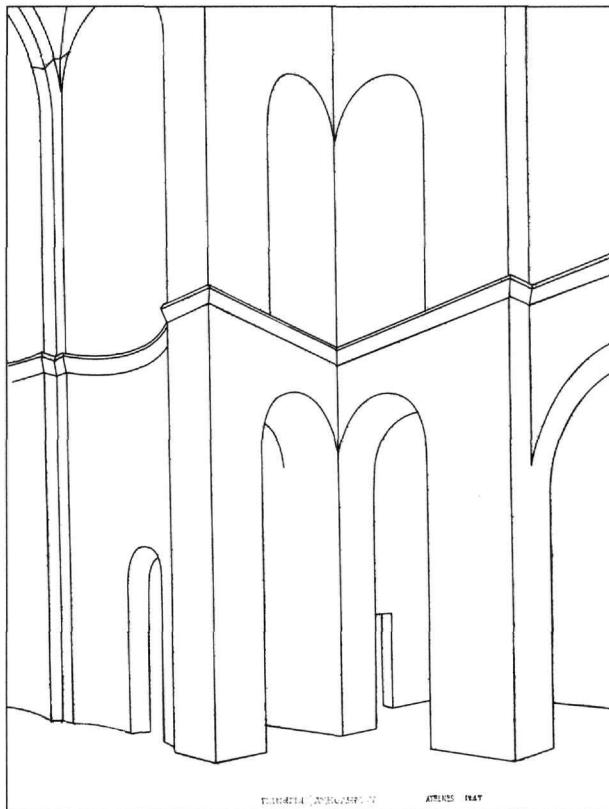
Fig. 6. Interior of naos facing south-east. P. Durand, no. 32.2, Hellenic Literary and Historic Archive (EIAA).

from the level of an observer at the lower level, looking to the south-east (Fig. 6). It depicts the south part of the sanctuary with its shallow apse and the corner of the nave. The second (32/16) was taken from the level of the galleries (Fig. 7) and depicts the south-west corner and parts of the ruined west arm and narthex, as well as the dome, which has partly collapsed. Both these drawings, and indirectly the 22 others depicting wall-paintings⁵¹, provide a great deal of information on the form of the Soteira after the Greek Uprising, which I shall try to exploit in what follows.

The major problem in the reconstruction is the precise form taken by the rest of the vaulting of the church. From Durand's drawing 32/2 it emerges that the east arm was covered by a cross-vault and from 32/16 that the west probably also had an elevated cross-vault or low domes carried on pendentives. All the other vaults in the drawings (8 and 9 are unaccompanied by any substantial information regarding the original form.

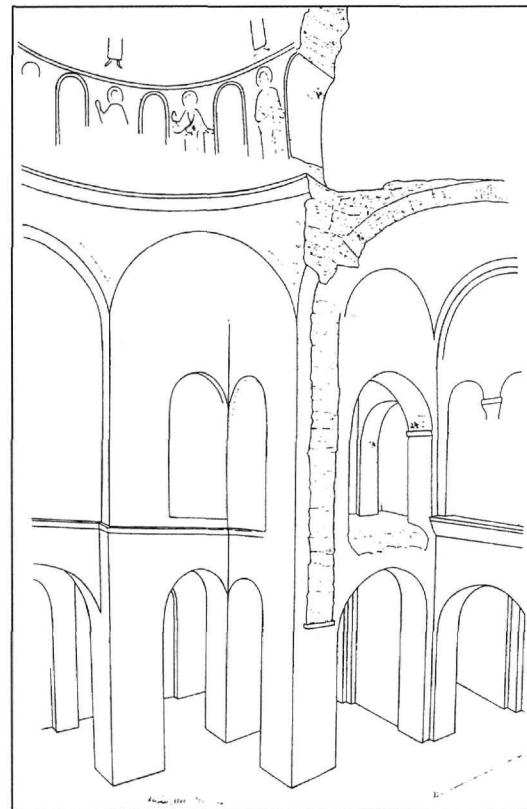
Fig. 7. Interior of naos facing north-west. P. Durand, no. 32.16, Hellenic Literary and Historic Archive (EIAA).

The dome, then, did not have an internal tympanum, and the sixteen windows created around the edge of it penetrated its hemisphere. There was a low tympanum only on the exterior. From Durand's drawing 32/16 it can be calculated

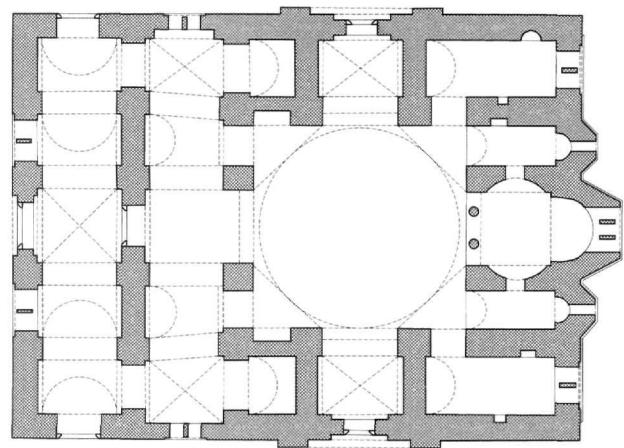
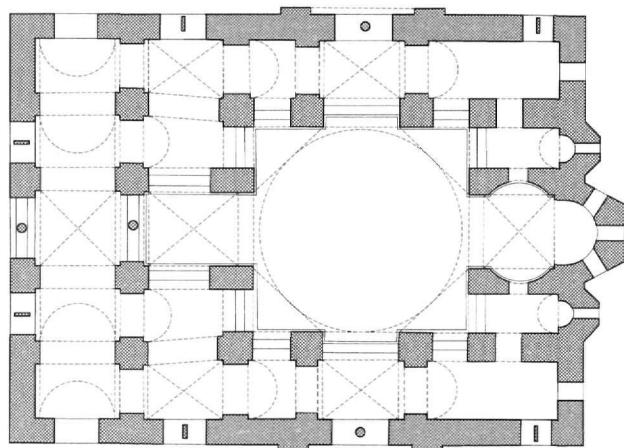
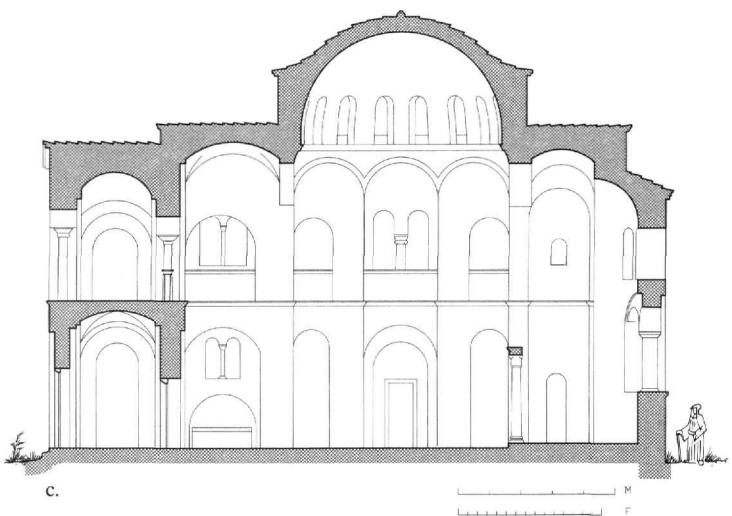
Fig. 8. Reconstruction of the church in its original form. a. Plan at ground level. b. Plan at gallery level. c. Longitudinal section.

The attempted restoration of the Soteira in the form it originally had (Fig. 8) and in the form it received after the 1705

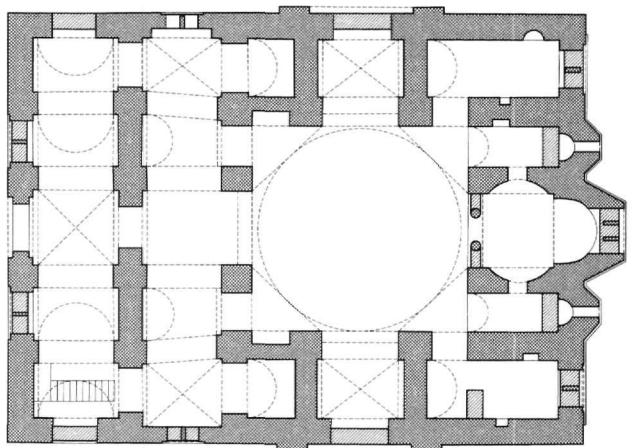
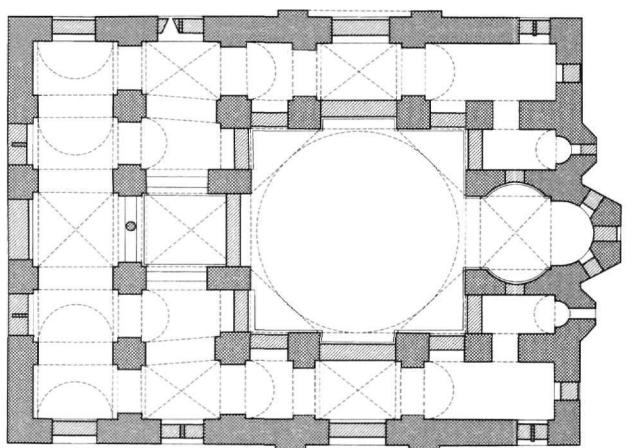
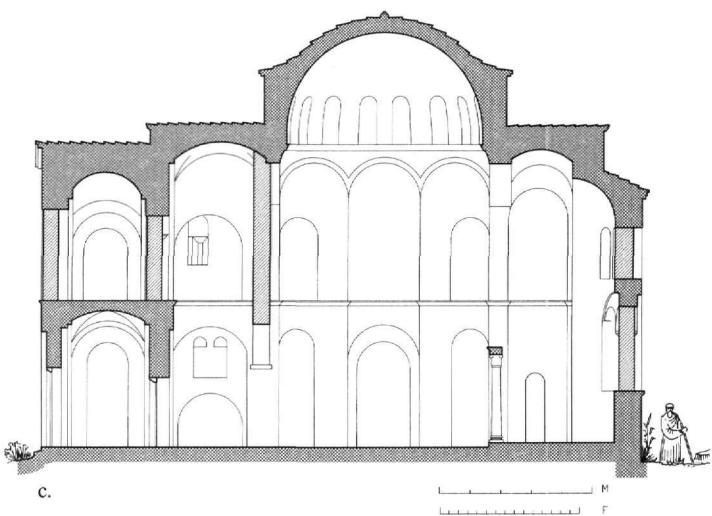
Fig. 9. Reconstruction of the church as in 1820. a. Plan at ground level. b. Plan at gallery level. c. Longitudinal section.

The reconstruction of the Soteira in the form it took after the repairs necessitated by the 1705 earthquake and before the Greek Uprising of 1821 (Fig. 9) is based on the same documentation, mainly on P. Durand's drawings.

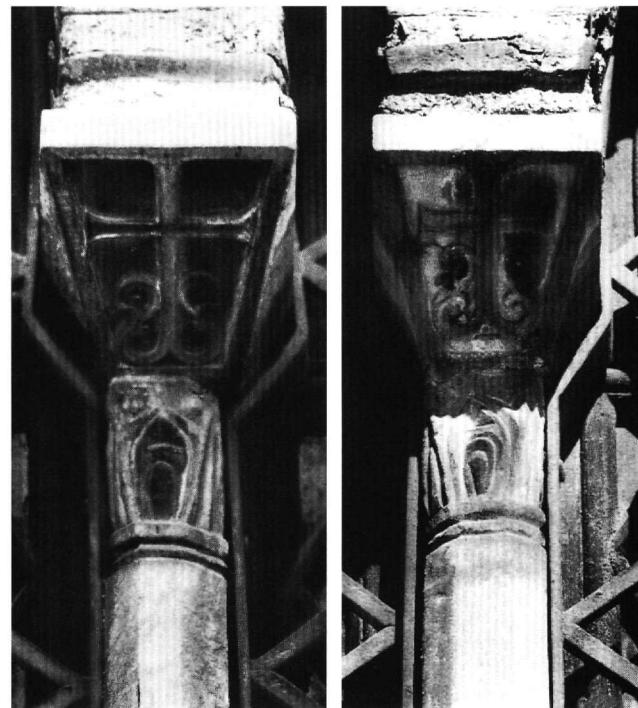
Fig. 10. The mullion capitals of the east façade windows. The imposts are modern (1850).

Very little survives of the sculptural decoration of the Soteira. Mullions are all that remain *in situ* of all the windows on the east side and of the two-light windows at the east end of the galleries (Figs. 10-11). As noted above, Vlasisopoulos's restoration respected the axial column with its Ionic capital integral with the impost block (Fig. 12), a form common in the Early Christian period⁶⁵ though not unknown in the katholikon of the monastery of Hosios Loukas⁶⁶. The decorative motifs of the capitals and impost blocks above the mullions are very simple and commonly found in the eleventh century (six-point rosettes and

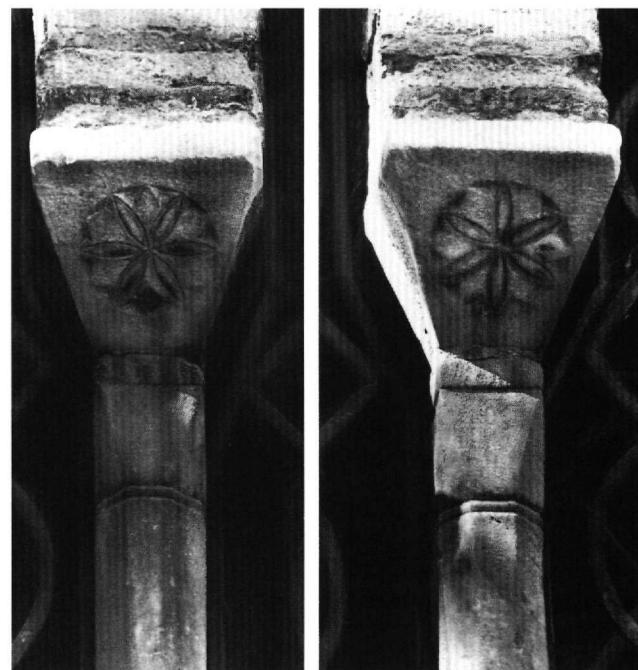
Fig. 11. The mullion capitals and imposts of the triple window of the bema apse.

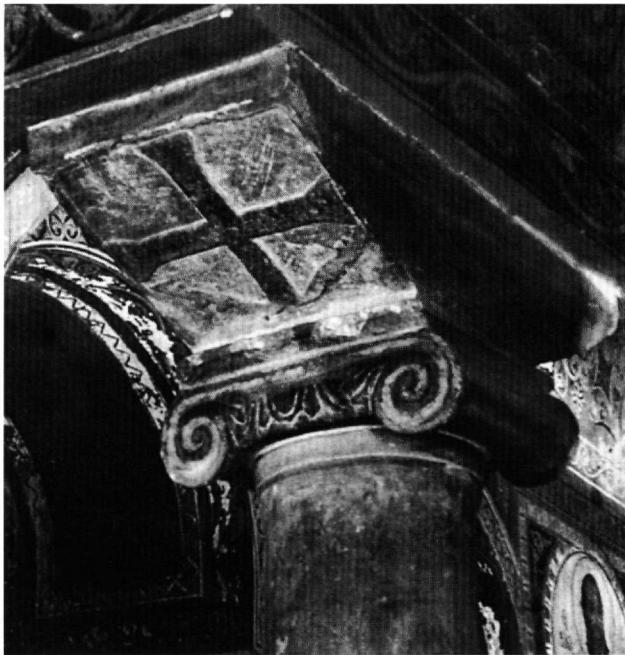
Fig. 12. Capital and impost of the colonette at the axis of the gallery.

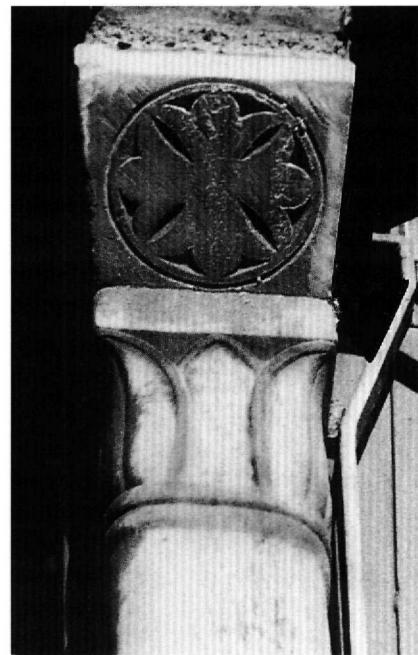
Fig. 13. Impost over a modern mullion on the south façade.

crosses) (Fig. 13). Unfortunately, none of the marble door-frames of the church survives. They were probably removed during the long period of its abandonment. The bowls in the tympana of the three-light window of the bema apse have been replaced by later small decorative disks.

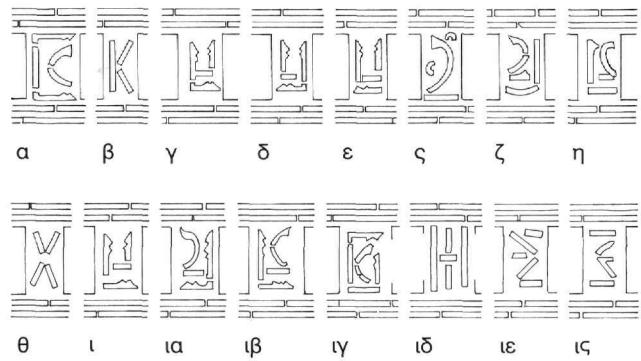
Fig. 14. Cut brick pseudo-cufic patterns.

The cufic and pseudo-cufic motifs on the walls of the Soteira have been treated directly or indirectly by G. Sotiriou⁷⁵, A.H.S. Megaw⁷⁶, G. Miles⁷⁷, P. Vocopoulos⁷⁸, A. Frantz⁷⁹ and N. Nikonanos⁸⁰. Depictions of them have already been published by Chr. Hansen⁸¹, A. Lenoir⁸² and G. Lambakis⁸³. Despite the destruction of a large part of the ceramic decoration, it is immediately apparent that the motifs of the individual cufic patterns and the system by which they were ap-

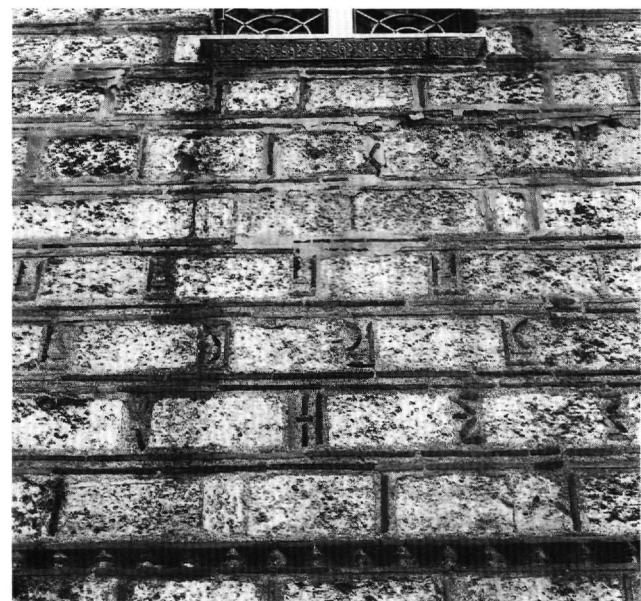
Fig. 15. Detail of the masonry on the south façade.

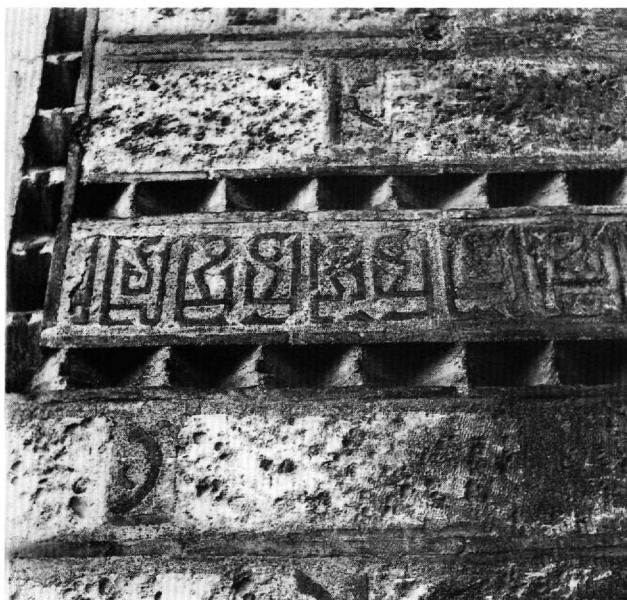
Fig. 16. North façade. Detail of the frieze.
