Η αρχιτεκτονική της Σωτείρας Λυκοδήμου
Αθηνών

The Soteira Lykodemou at Athens. Architecture

THE SOTEIRA LYKODEMOU AT ATHENS. ARCHITECTURE*

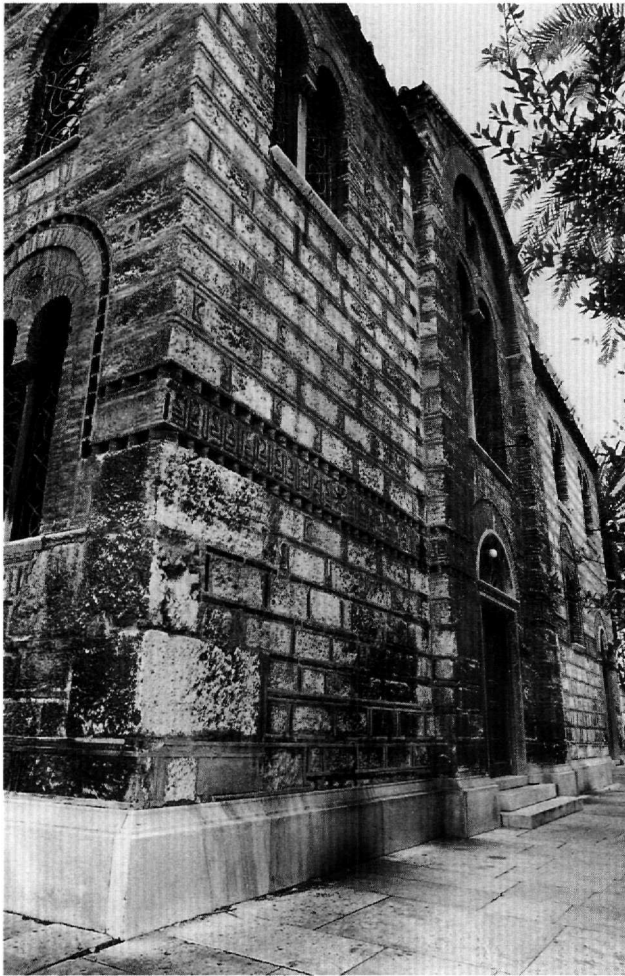
Fig. 1. The north façade looking west.

high chamfered marble crepis added by Vlasopoulos (Fig. 1) detracted from the monument's authenticity, and the old marble templon, the form of which is preserved by Lenoir³³, appears to have been carried off before the work began³⁴. The almost total destruction of the wall-paintings in the church (which will be discussed below) confirms the great scale of the removal of walls and vaults during Vlasopoulos's intervention.
