Η αρχιτεκτονική της Σωτείας Λυκοδήμου
Αθηνών

The Soteira Lykodemou at Athens. Architecture

THE SOTEIRA LYKODEMOU AT ATHENS. ARCHITECTURE*

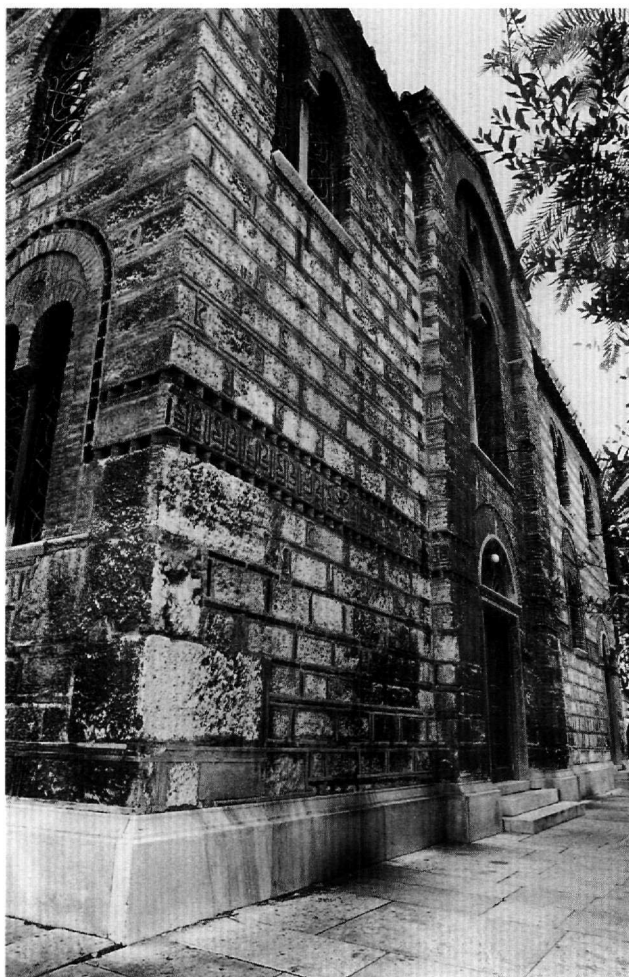
Fig. 1. The north façade looking west.

high chamfered marble crepis added by Vlasopoulos (Fig. 1) detracted from the monument's authenticity, and the old marble templon, the form of which is preserved by Lenoir³³, appears to have been carried off before the work began³⁴. The almost total destruction of the wall-paintings in the church (which will be discussed below) confirms the great scale of the removal of walls and vaults during Vlasopoulos's intervention.

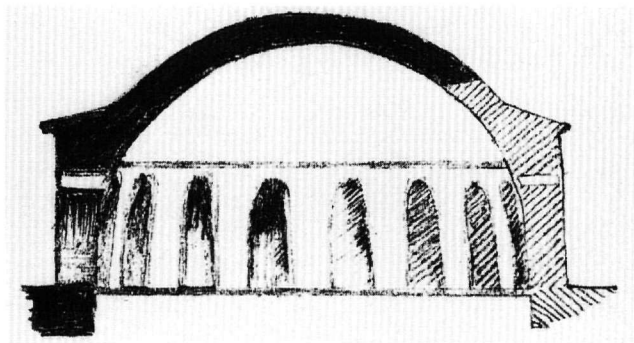
Fig. 2. Section of the original dome by T. Vlasopoulos, after Lambakis.

ing is confirmed by the reports submitted by a committee of technical experts (Smolens, Riedl, Kaftantzoglou and Schiodel (?) on 12th April 1847) and also by Kaftantzoglou himself, to the effect that “...the church, being in a very ruined state, must be razed to the foundations and erected anew...”. This information is recorded for us forty years later by G. Lambakis²¹, who appears to have derived it from the military architect responsible for the work, Telemachos Vlasopoulos²², who was still alive in 1894 at least²³. In the end, the church was fortunately not demolished but radically repaired, with parts of it being reconstructed. Lambakis, who was not even born at this time²⁴, knew the plans that had been drawn up by Vlasopoulos, one of which – the section of the dome – he published (Fig. 2)²⁵. The work was carried out between 1850 and 1855.

earthquake is based on the assumptions that the measured drawing of the original dome by T. Vlasopoulos⁵² was accurate and that the reconstruction followed it faithfully. It is only by making these assumptions that it is possible to use as a base the much later drawings of the plan and section of the present form of the Soteira by R. Schultz and S. Barnsley⁵³, which, when checked, proved to have a satisfactory degree of accuracy⁵⁴.

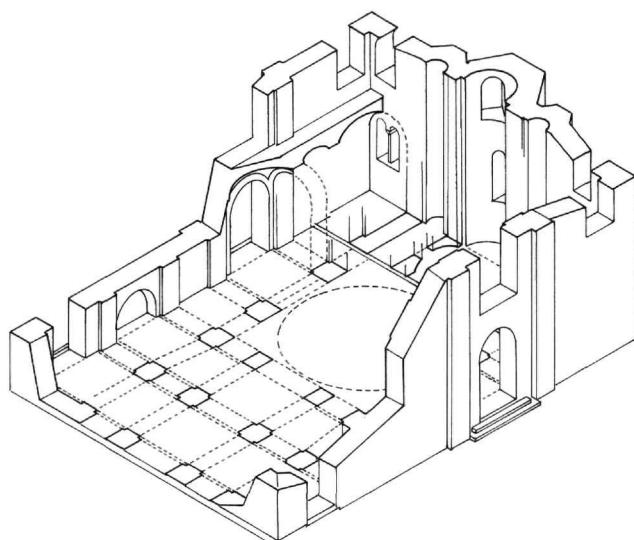
Fig. 3. Isometric section of the church, showing the existing original parts of the building, by C. Koliopoulos.

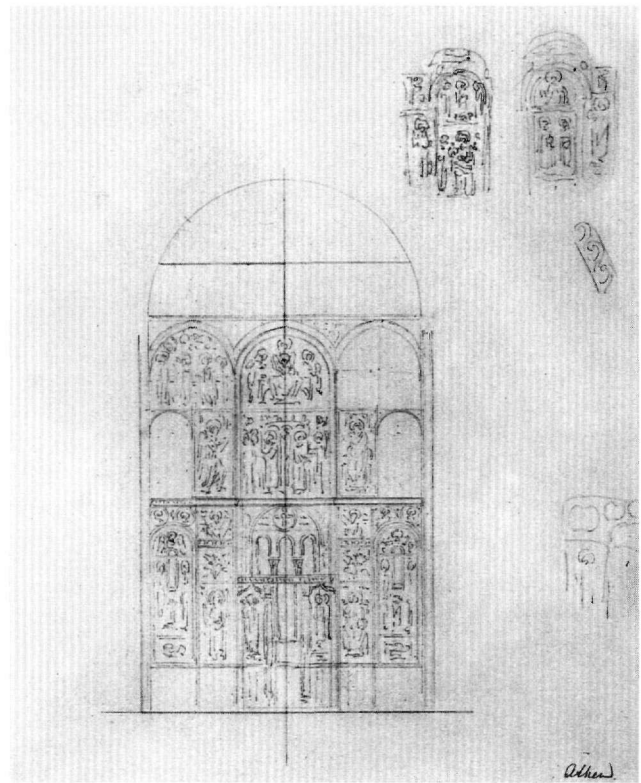
Fig. 4. M.G. Bindesbøl. Athens, Byzantine Church, 1835. Library of the Copenhagen Academy of Fine Arts, G.B. 074.

The Danish architect M.G. Bindesbøl⁴¹ has bequeathed us a drawing of a transverse section and two rough sketches (Fig. 4), which bear the title “Byzantine church in Athens”. The church is clearly the Soteira, since the drawing shows the two squinches either side of the east arm, the wide, low dome, and the templon with its two columns in front of the sanctuary. The two sketches depict the apses of the prothesis and

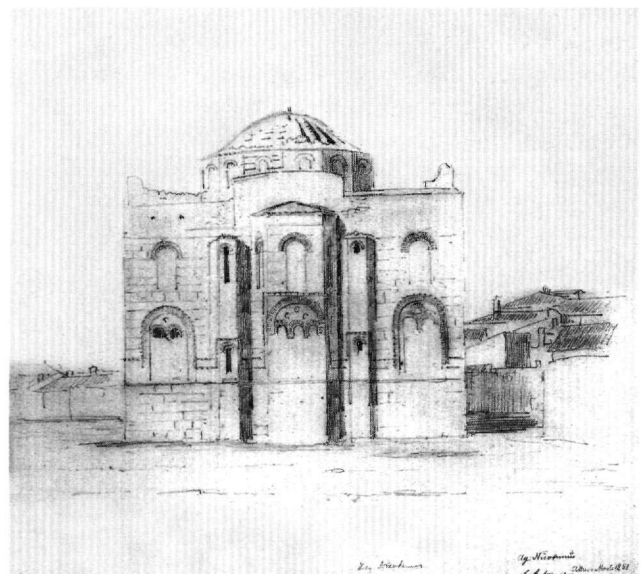
Fig. 5. L.A. Winstrup. The Byzantine Church of Sotira Likodhimou. Library of the Copenhagen Academy of Fine Arts, LAW 094.

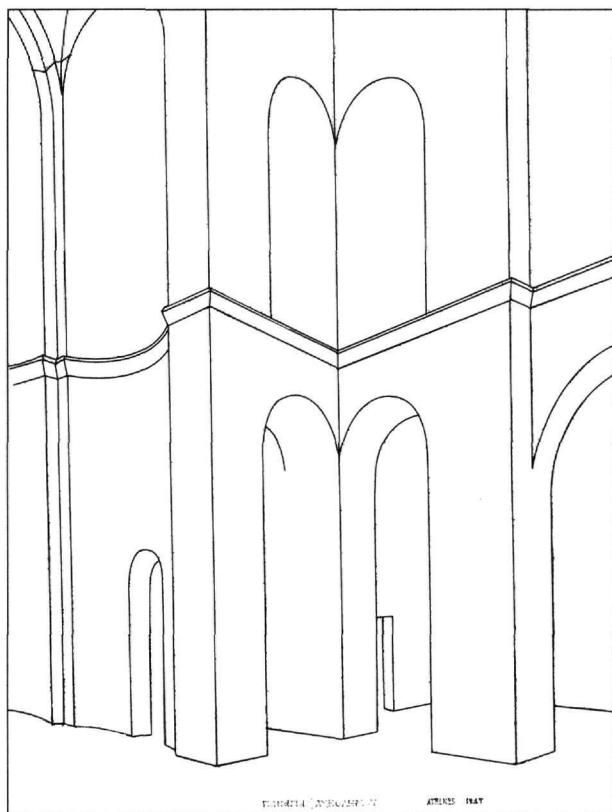
Fig. 6. Interior of naos facing south-east. P. Durand, no. 32.2, Hellenic Literary and Historic Archive (EΛIA).

from the level of an observer at the lower level, looking to the south-east (Fig. 6). It depicts the south part of the sanctuary with its shallow apse and the corner of the nave. The second (32/16) was taken from the level of the galleries (Fig. 7) and depicts the south-west corner and parts of the ruined west arm and narthex, as well as the dome, which has partly collapsed. Both these drawings, and indirectly the 22 others depicting wall-paintings⁵¹, provide a great deal of information on the form of the Soteira after the Greek Uprising, which I shall try to exploit in what follows.

The major problem in the reconstruction is the precise form taken by the rest of the vaulting of the church. From Durand's drawing 32/2 it emerges that the east arm was covered by a cross-vault and from 32/16 that the west probably also had an elevated cross-vault or low domes carried on pendentives. All the other vaults in the drawings (8 and 9 are unaccompanied by any substantial information regarding the original form.

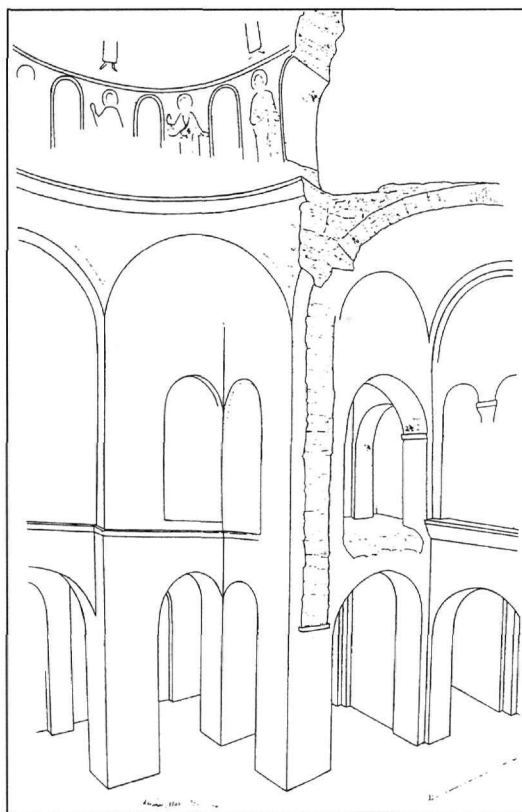
Fig. 7. Interior of naos facing north-west. P. Durand, no. 32.16, Hellenic Literary and Historic Archive (EΛIA).

The dome, then, did not have an internal tympanum, and the sixteen windows created around the edge of it penetrated its hemisphere. There was a low tympanum only on the exterior. From Durand's drawing 32/16 it can be calculated

that the two main axes of the nave coincided at the dome not with windows but with a section of wall between two windows. This feature further reveals the similarity of the dome of the Soteira with that of the katholikon of the monastery of Hosios Loukas. The breach created by the bomb must have been above the south-west pillar and, according to Couchaud, it destroyed two thirds of the dome. There was a painted strip above the window arches. In Durand's drawings, the thickness of the face of the arches bearing the dome can be made out, as well as that of the unified surface of the circumscribed sphere above them. Both were probably equal to the length of a brick.

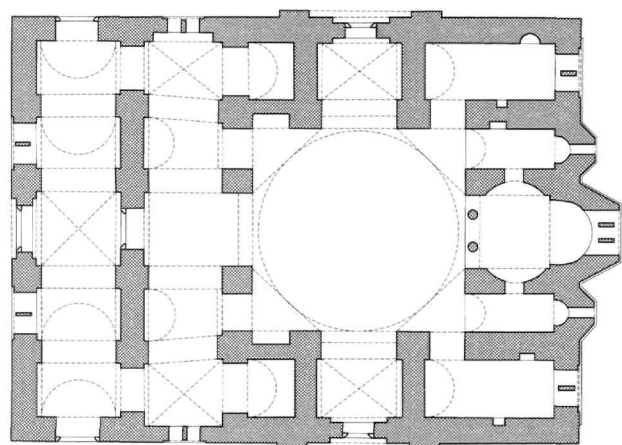
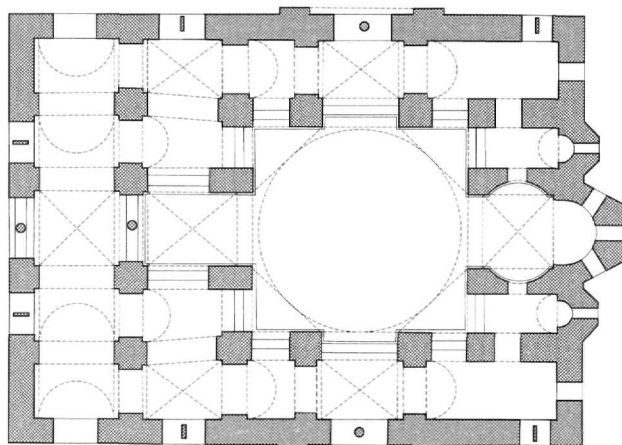
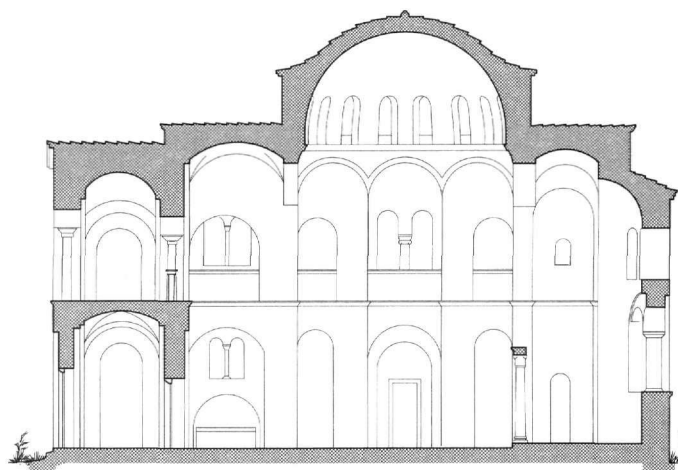
Fig. 8. Reconstruction of the church in its original form. a. Plan at ground level. b. Plan at gallery level. c. Longitudinal section.

The attempted restoration of the Soteira in the form it originally had (Fig. 8) and in the form it received after the 1705

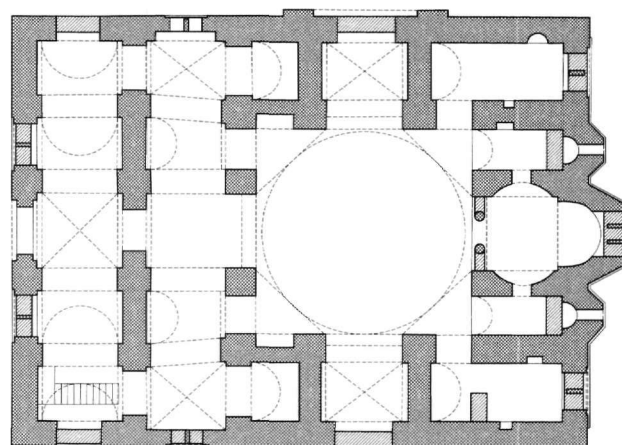
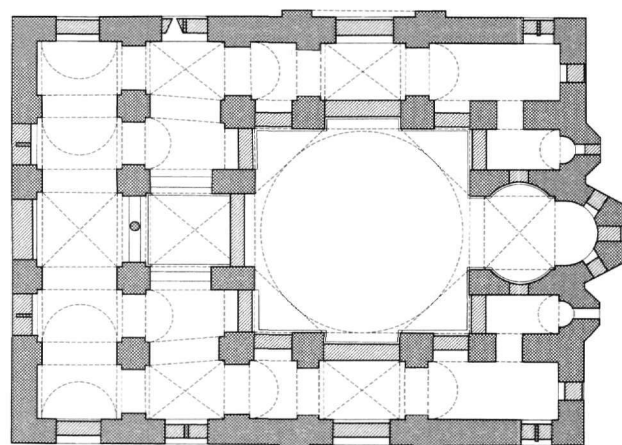
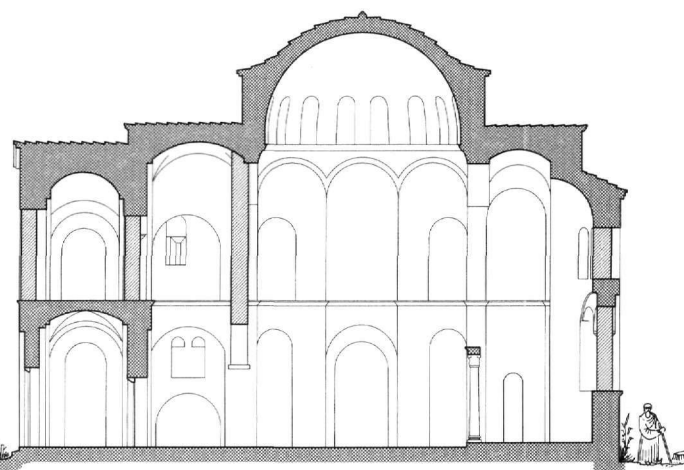
Fig. 9. Reconstruction of the church as in 1820. a. Plan at ground level. b. Plan at gallery level. c. Longitudinal section.

The reconstruction of the Soteira in the form it took after the repairs necessitated by the 1705 earthquake and before the Greek Uprising of 1821 (Fig. 9) is based on the same documentation, mainly on P. Durand's drawings.

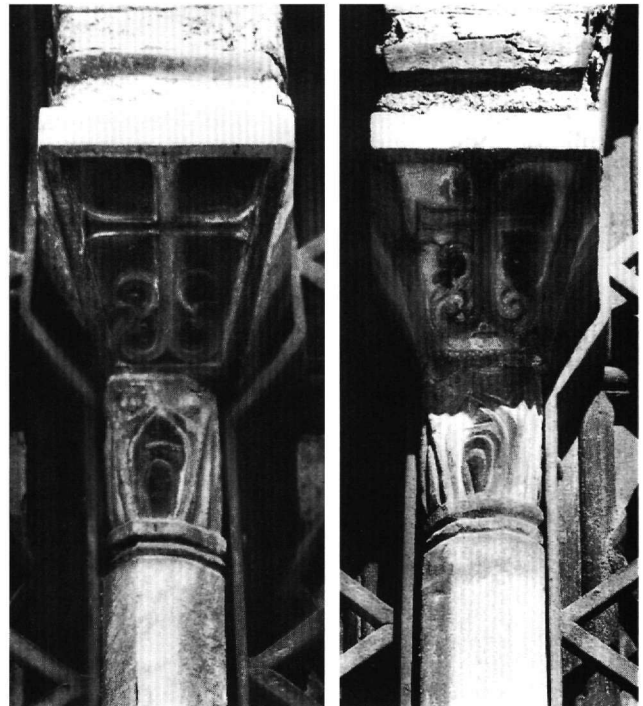
Fig. 10. The mullion capitals of the east façade windows. The imposts are modern (1850).

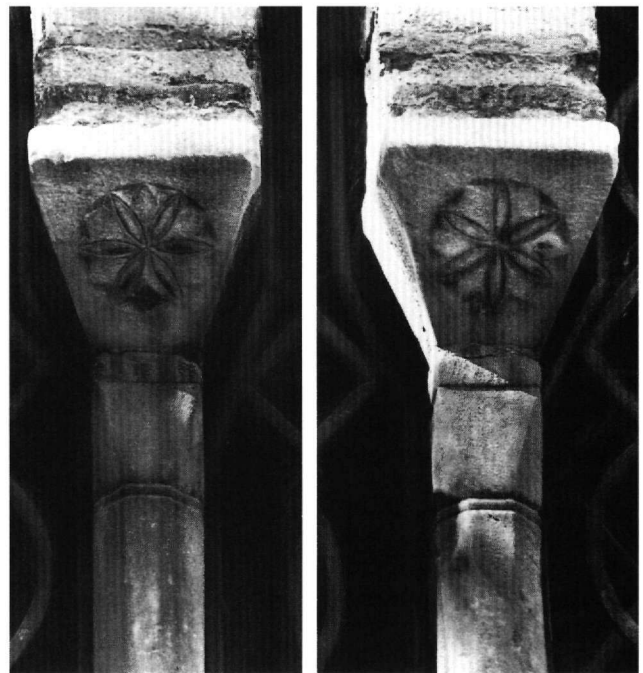
Fig. 11. The mullion capitals and imposts of the triple window of the bema apse.

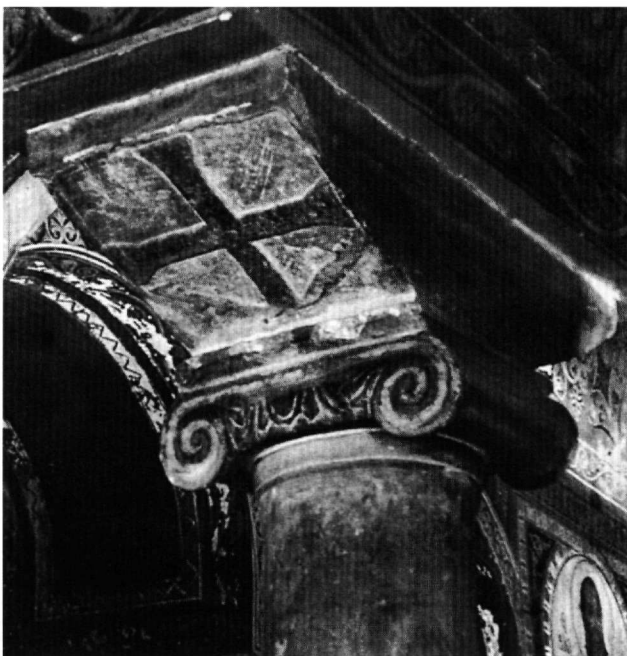
Fig. 12. Capital and impost of the colonette at the axis of the gallery.

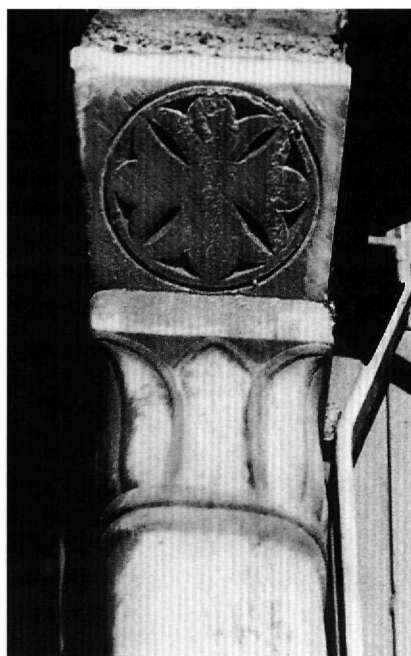
Fig. 13. Impost over a modern mullion on the south façade.

crosses) (Fig. 13). Unfortunately, none of the marble door-frames of the church survives. They were probably removed during the long period of its abandonment. The bowls in the tympana of the three-light window of the bema apse have been replaced by later small decorative disks.

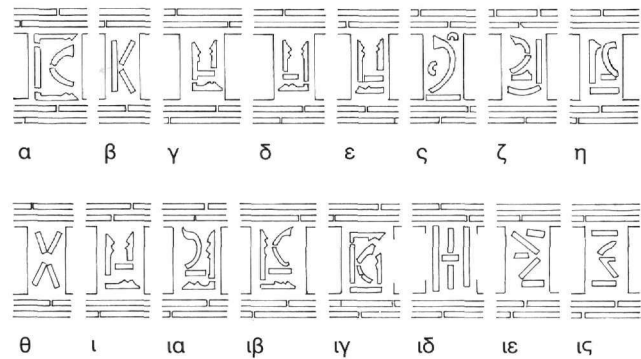
Fig. 14. Cut brick pseudo-cufic patterns.

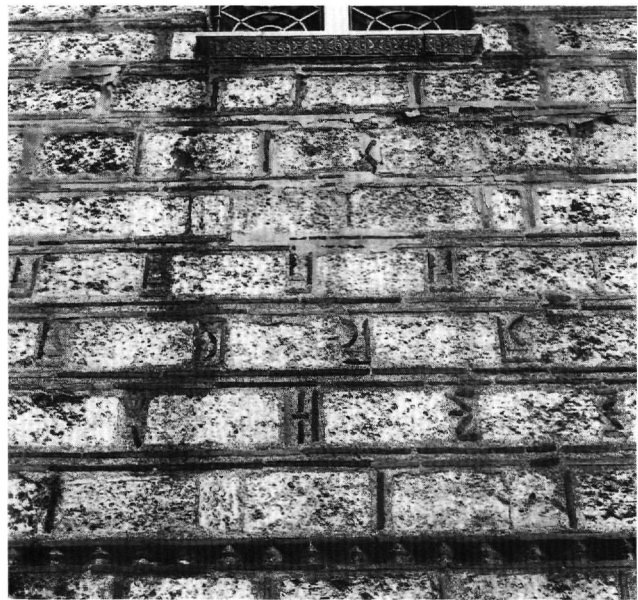
Fig. 15. Detail of the masonry on the south façade.

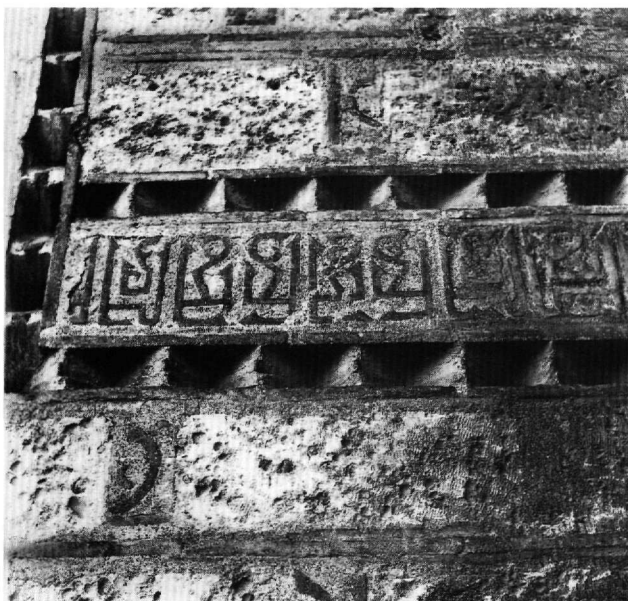
Fig. 16. North façade. Detail of the frieze.
