Δελτίον ΧΑΕ 25 (2004), Περίοδος Δ'

Charalambos Bouras

THE SOTEIRA LYKODEMOU AT ATHENS. ARCHITECTURE*

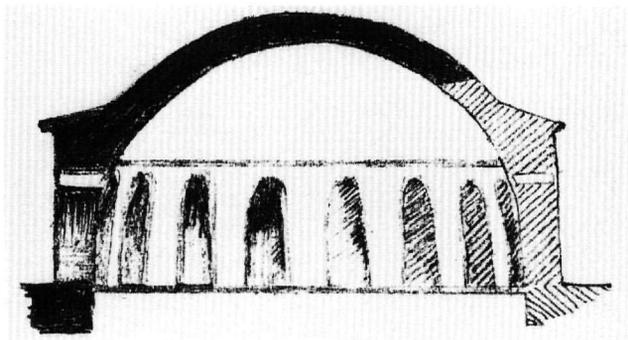
Fig. 2. Section of the original dome by T. Vlasopoulos, after Lambakis.

earthquake is based on the assumptions that the measured drawing of the original dome by T. Vlasopoulos⁵² was accurate and that the reconstruction followed it faithfully. It is only by making these assumptions that it is possible to use as a base the much later drawings of the plan and section of the present form of the Soteira by R. Schultz and S. Barnsley⁵³, which, when checked, proved to have a satisfactory degree of accuracy⁵⁴.

The dome, then, did not have an internal tympanum, and the sixteen windows created around the edge of it penetrated its hemisphere. There was a low tympanum only on the exterior. From Durand's drawing 32/16 it can be calculated

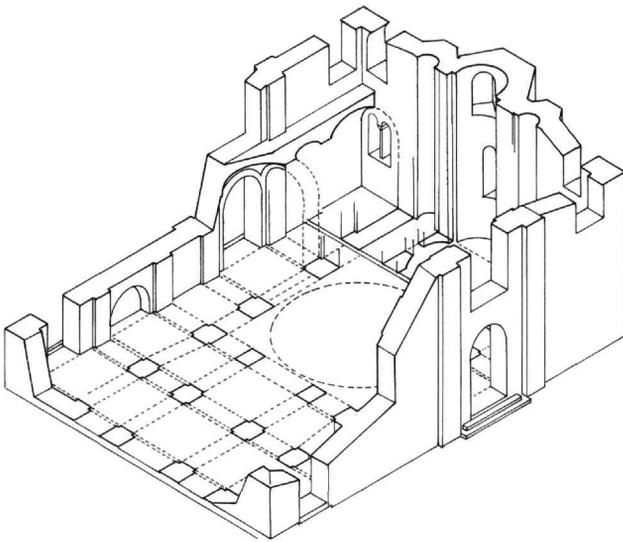
Fig. 3. Isometric section of the church, showing the existing original parts of the building, by C. Koliopoulos.

moved, including the dome. The entire east side and parts of the north and south were preserved, all the bearing elements retained their original position, as did the lower parts of all the walls³⁰, while the arches and vaults were restored, using as a guide their springings, which were preserved in the side walls and in the area of the sanctuary and the east wall (Fig. 3). Unfortunately, Vlasopoulos removed all the internal non-bearing walls, both original and later (which will be discussed in brief below), following the arbitrary interventions in the drawing by A. Couchaud³¹, and this resulted in the deterioration of the interior space and the loss of the link between function and spatial units inside the church. The new vaults, though retaining the springing of the original ones, had a different form³².

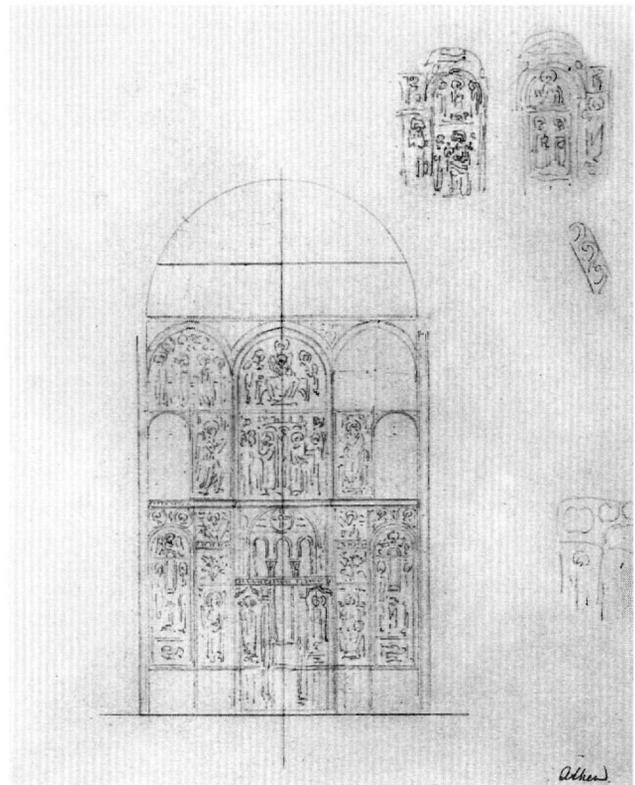
Fig. 4. M.G. Bindsbel. Athens, Byzantine Church, 1835. Library of the Copenhagen Academy of Fine Arts, G.B. 074.

The Danish architect M.G. Bindsbeil⁴¹ has bequeathed us a drawing of a transverse section and two rough sketches (Fig. 4), which bear the title "Byzantine church in Athens". The church is clearly the Soteira, since the drawing shows the two squinches either side of the east arm, the wide, low dome, and the templon with its two columns in front of the sanctuary. The two sketches depict the apses of the prothesis and

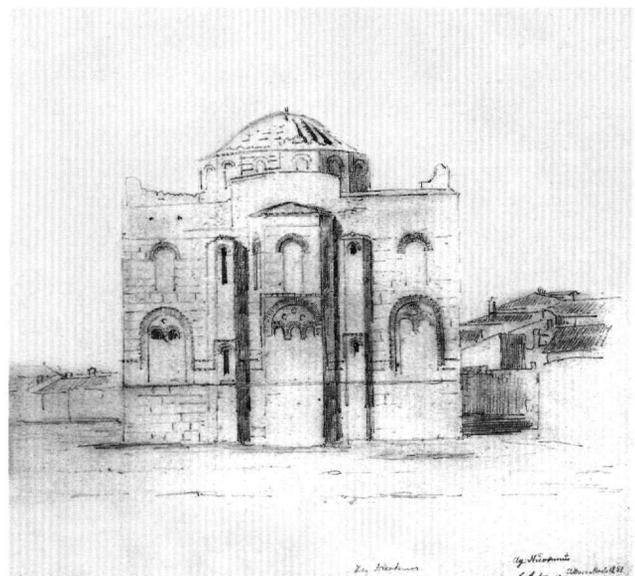
Fig. 5. L.A. Winstrup. The Byzantine Church of Sotira Likodhimou. Library of the Copenhagen Academy of Fine Arts, LAW 094.

The drawings in the collection of the University of Karlsruhe, which were made between 1842 and 1845⁴⁵, include a plan, longitudinal section and west elevation of the Soteira and are still unpublished⁴⁶. Their anonymous compiler probably copied Couchaud's drawings and made some minor corrections⁴⁷ to them, after seeing the church for himself. The sketch made by L.A. Winstrup (Fig. 5)⁴⁸, also of Denmark, depicts the east façade of the church, which is in a very good state of preservation, and is useful for the walled-up windows in this façade.

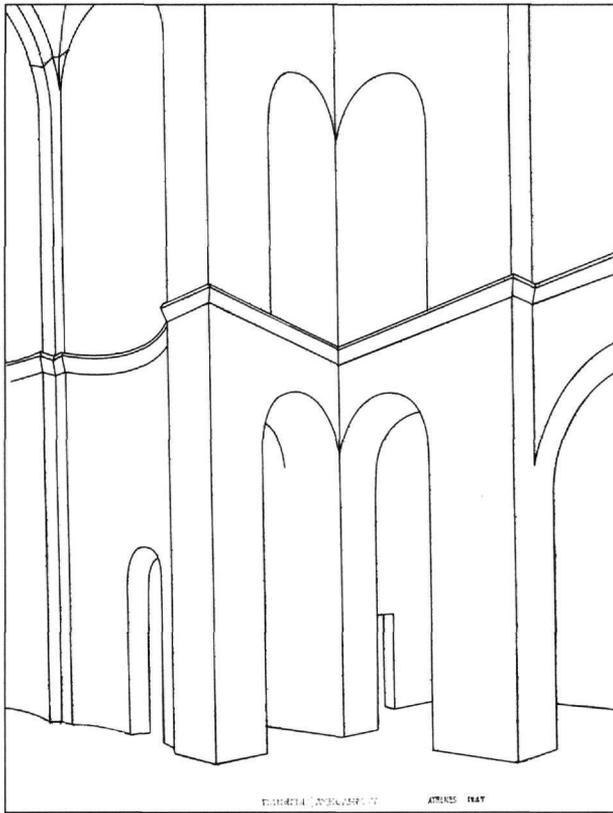
Fig. 6. Interior of naos facing south-east. P. Durand, no. 32.2, Hellenic Literary and Historic Archive (EΛIA).

from the level of an observer at the lower level, looking to the south-east (Fig. 6). It depicts the south part of the sanctuary with its shallow apse and the corner of the nave. The second (32/16) was taken from the level of the galleries (Fig. 7) and depicts the south-west corner and parts of the ruined west arm and narthex, as well as the dome, which has partly collapsed. Both these drawings, and indirectly the 22 others depicting wall-paintings⁵¹, provide a great deal of information on the form of the Soteira after the Greek Uprising, which I shall try to exploit in what follows.

The major problem in the reconstruction is the precise form taken by the rest of the vaulting of the church. From Durand's drawing 32/2 it emerges that the east arm was covered by a cross-vault and from 32/16 that the west probably also had an elevated cross-vault or low domes carried on pendentives. All the other vaults in the drawings (8 and 9 are unaccompanied by any substantial information regarding the original form.

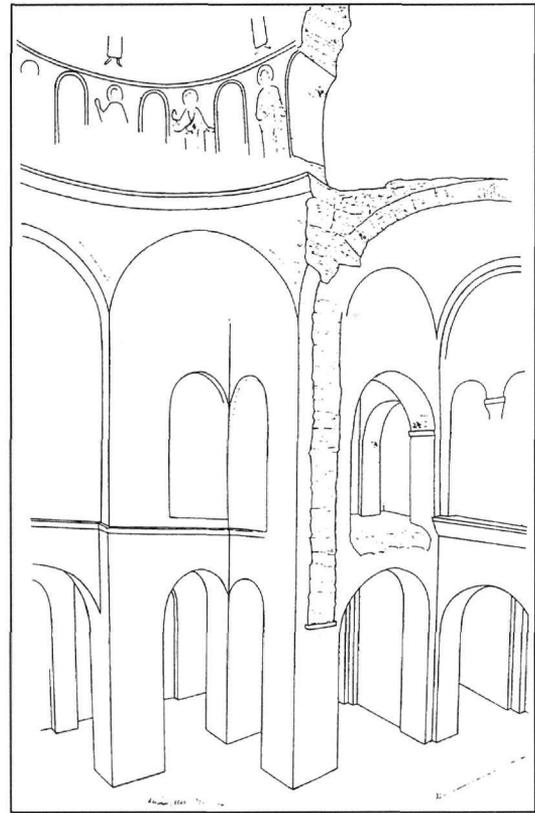
Fig. 7. Interior of naos facing north-west. P. Durand, no. 32.16, Hellenic Literary and Historic Archive (EΛIA).

that the two main axes of the nave coincided at the dome not with windows but with a section of wall between two windows. This feature further reveals the similarity of the dome of the Soteira with that of the katholikon of the monastery of Hosios Loukas. The breach created by the bomb must have been above the south-west pillar and, according to Couchaud, it destroyed two thirds of the dome. There was a painted strip above the window arches. In Durand's drawings, the thickness of the face of the arches bearing the dome can be made out, as well as that of the unified surface of the circumscribed sphere above them. Both were probably equal to the length of a brick.

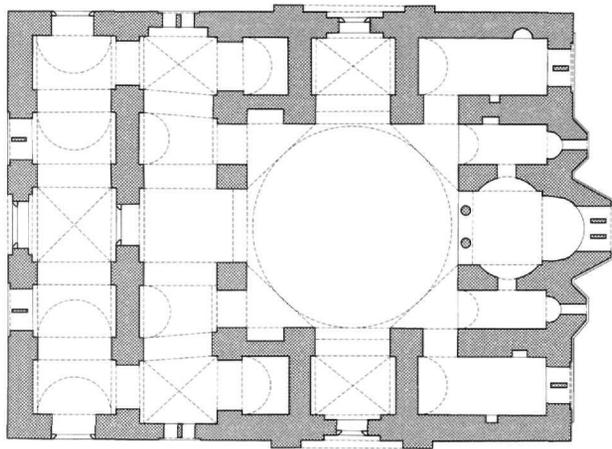
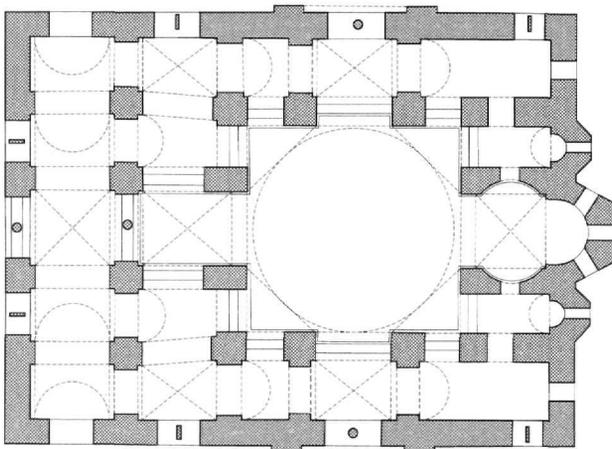
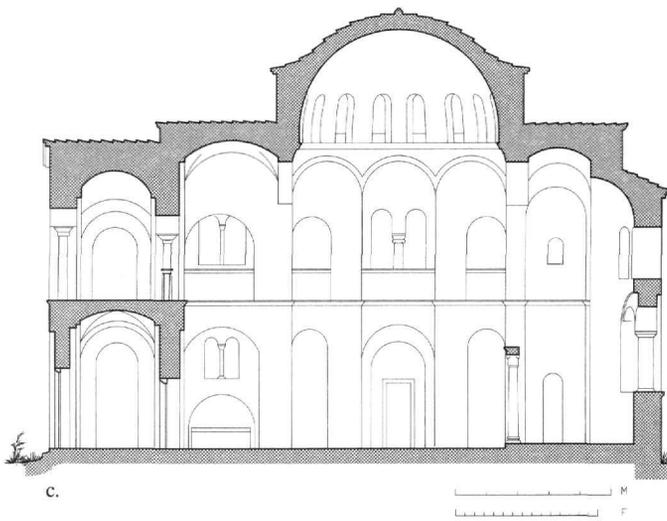
Fig. 8. Reconstruction of the church in its original form. a. Plan at ground level. b. Plan at gallery level. c. Longitudinal section.

The attempted restoration of the Soteira in the form it originally had (Fig. 8) and in the form it received after the 1705

The galleries did not extend above the west arm of the cross, as erroneously indicated in a section drawing by Couchaud⁵⁵. As in Hosios Loukas, they were confined to the area above the narthex and the side aisles. This is clearly attested by the chamfered cornice-cum-stylobate in Durand's drawing 32/16. Here there was a colonnette on the axis which had been replaced in this position by Vlasopoulos (Fig. 12). Neither of the side openings of the galleries facing on to the west arm were two-light windows with mullions, but plain arches, presumably with parapets at the bottom for safety reasons. A characteristic feature is that, as at Hosios Loukas, the galleries and the chamfered cornice were recessed by about 30 m. to the right and left above the two transverse arms, so as clearly to suggest the cruciform plan⁵⁶. The reconstruction of the original form of the west façade of the church presents a more difficult problem. Couchaud drew and explicitly referred to three doors, which have no function, given that another two opened on to the narthex from the sides. Windows can be seen in Fauvel's sketch, made before the destruction, though higher than the arch of

the main door. It is equally probable, therefore, that there were two windows, one either side of the door, as in the katholikon of the monastery of Hosios Loukas. The upper line of all the façades is also unknown. Both Couchaud and Winstrup and Bindesbel drew a raised part with a flat roof in the position of the arms, but it is virtually certain that the roofs were originally pitched⁵⁷ and covered the barrel vaults or the cross vaults over the arms.

The large openings on the lateral axis of the church⁵⁸ are 1.83 m. wide on the ground floor. They presumably still have the original width, though this is disproportionately large for ordinary windows⁵⁹. The corresponding openings on the upper storey are narrower. These, too, have presumably not been altered perceptibly, since the poros impostes of the pilasters at either side are still *in situ*. The openings did not have sills, like ordinary windows, but extended down to the floor of the galleries. The marble columns on the axis of the upper storey at present appear to be reconstructed.

It thus seems to be a reasonable hypothesis that the architectural solution was similar to the one applied in the case of the katholikon of Hosios Loukas, with two vertically articulated windows on the sides. In this case they were two-light windows, instead of the three-light windows of Hosios Loukas. That is, the same principle was followed in the interior of the church as in the opening on the axis of the gallery inside the church. The reconstruction above the two-light windows of the galleries is uncertain; here Couchaud drew a small window, also with two lights, while in Fauvel's sketch the tympanum is solid.

Similar questions arise in the case of the side openings of the narthex, both on the ground floor and in the galleries. They have the same width: 1.41 m. The upper opening was converted by Vlasopoulos into a two-light window, while the lower one remains a disproportionately large door.

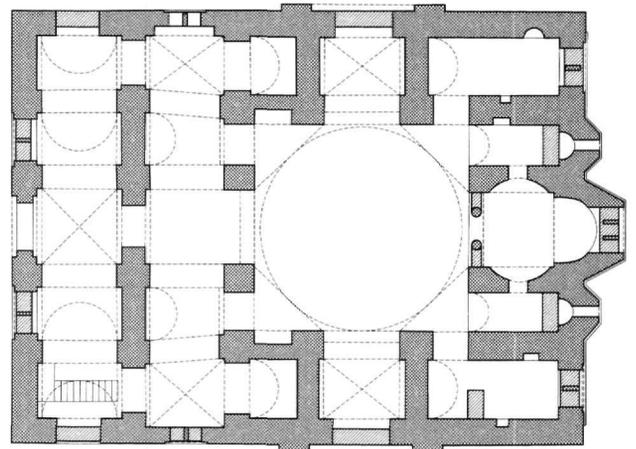
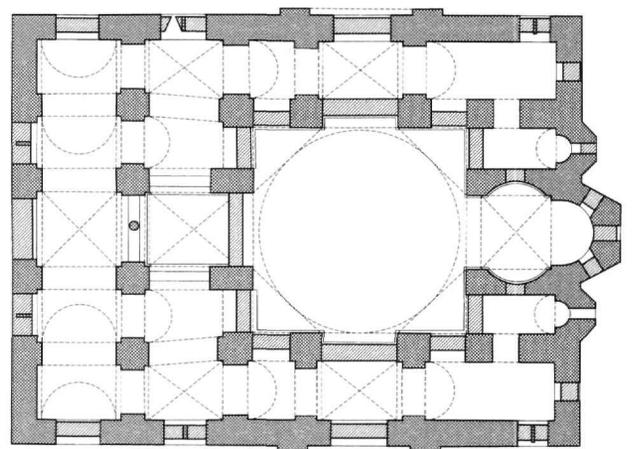
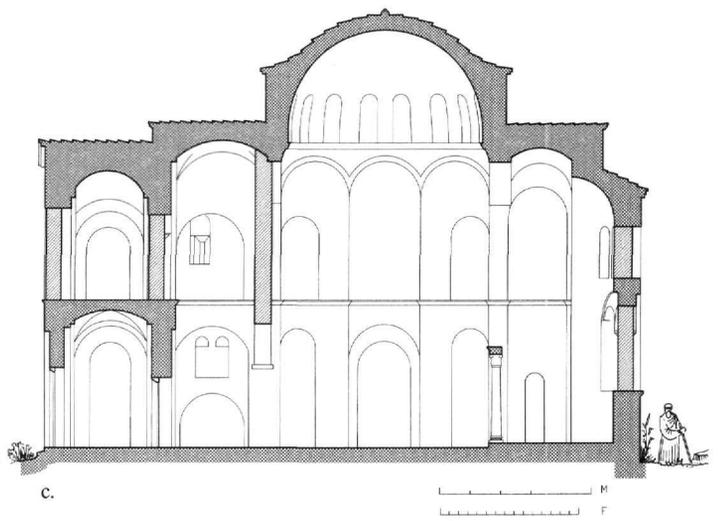
Fig. 9. Reconstruction of the church as in 1820. a. Plan at ground level. b. Plan at gallery level. c. Longitudinal section.

The reconstruction of the Soteira in the form it took after the repairs necessitated by the 1705 earthquake and before the Greek Uprising of 1821 (Fig. 9) is based on the same documentation, mainly on P. Durand's drawings.

Both drawings testify to the fact that all the arches opening

The preserved archways either side of the sanctuary on the upper floor (*paraklyptika*?) have also been walled up. Couchaud's plan shows reinforcing walls in front of the apses of the prothesis and diakonikon, though Durand's and Bindesbel's drawings of the wall-paintings indicate that these walls did not exist. The south-east side-chapel was isolated at the west by a transverse wall, in which a small door was created. Finally, the staircase at the south-west extreme of the church in Couchaud's plan, which pierced the corner vault, certainly did not belong to the original form of the building⁶⁴.

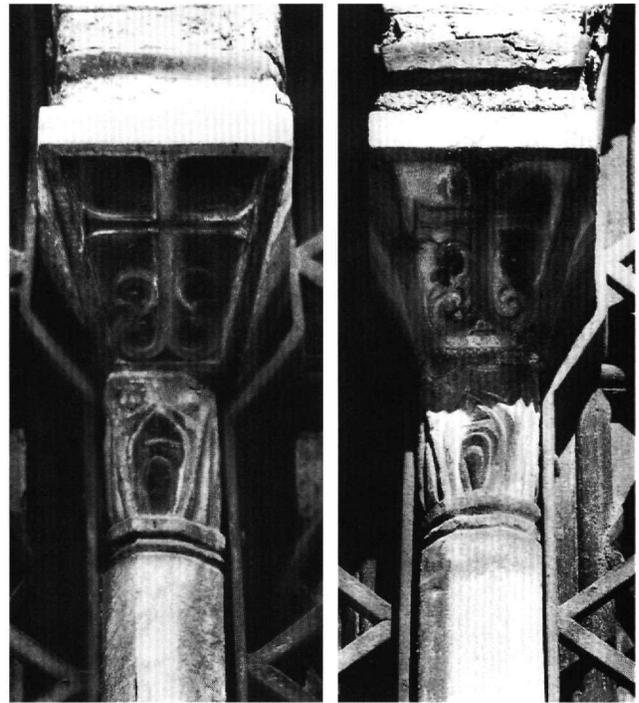
Fig. 10. The mullion capitals of the east façade windows. The imposts are modern (1850).

Very little survives of the sculptural decoration of the Soteira. Mullions are all that remain *in situ* of all the windows on the east side and of the two-light windows at the east end of the galleries (Figs. 10-11). As noted above, Vlasopoulos's restoration respected the axial column with its Ionic capital integral with the impost block (Fig. 12), a form common in the Early Christian period⁶⁵ though not unknown in the katholikon of the monastery of Hosios Loukas⁶⁶. The decorative motifs of the capitals and impost blocks above the mullions are very simple and commonly found in the eleventh century (six-point rosettes and

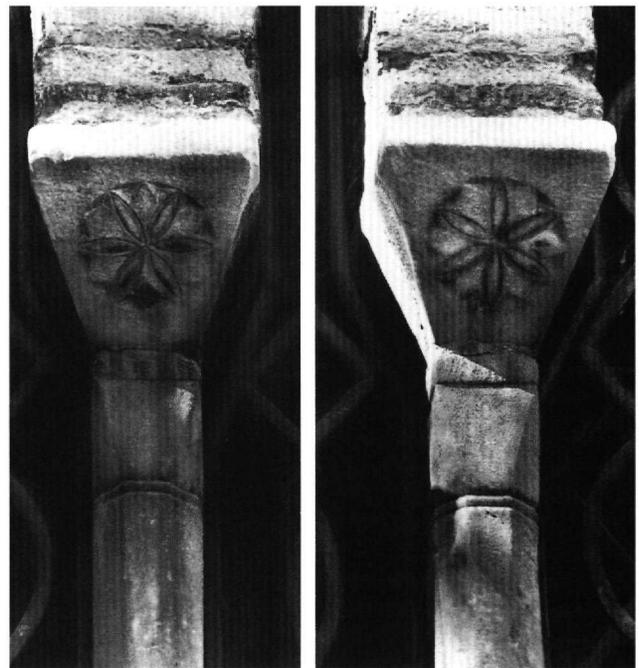
Fig. 11. The mullion capitals and imposts of the triple window of the bema apse.

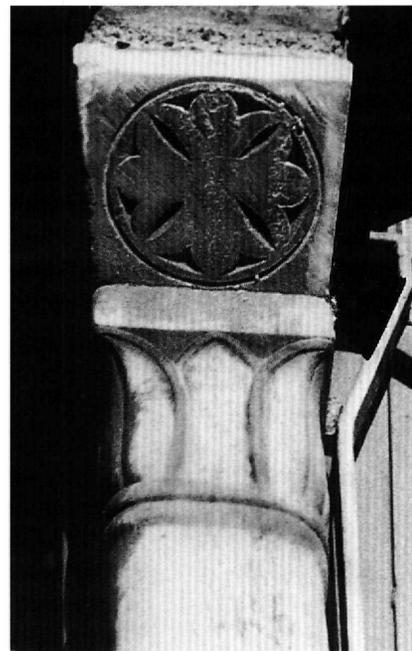
Fig. 13. Impost over a modern mullion on the south façade.

crosses) (Fig. 13). Unfortunately, none of the marble door-frames of the church survives. They were probably removed during the long period of its abandonment. The bowls in the tympana of the three-light window of the bema apse have been replaced by later small decorative disks.

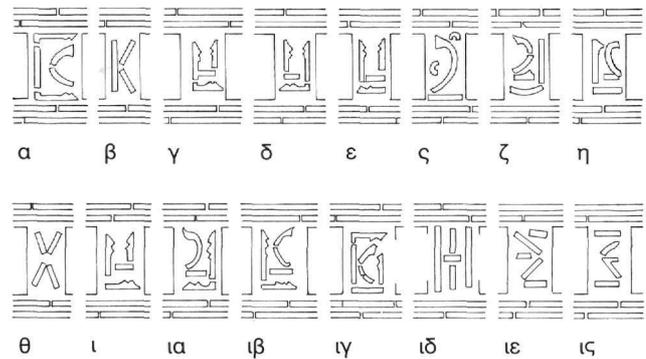
Fig. 14. Cut brick pseudo-cufic patterns.

The cufic and pseudo-cufic motifs on the walls of the Soteira have been treated directly or indirectly by G. Sotiriou⁷⁵, A.H.S. Megaw⁷⁶, G. Miles⁷⁷, P. Vocotopoulos⁷⁸, A. Frantz⁷⁹ and N. Nikonanos⁸⁰. Depictions of them have already been published by Chr. Hansen⁸¹, A. Lenoir⁸² and G. Lambakis⁸³. Despite the destruction of a large part of the ceramic decoration, it is immediately apparent that the motifs of the individual cufic patterns and the system by which they were ap-

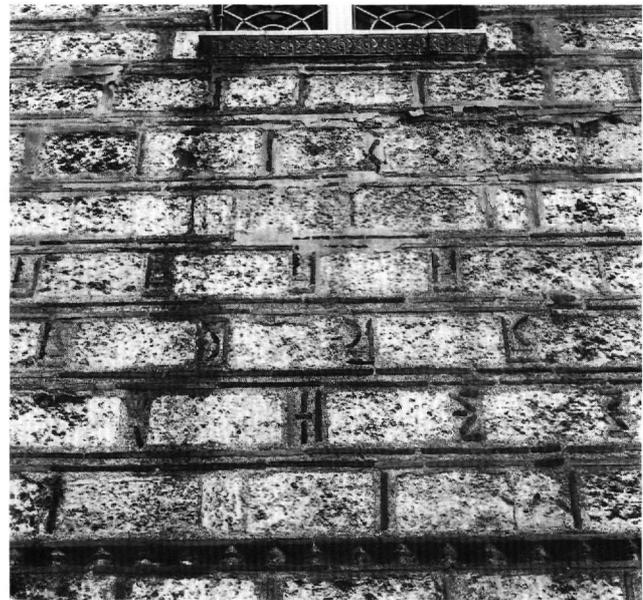
Fig. 15. Detail of the masonry on the south façade.

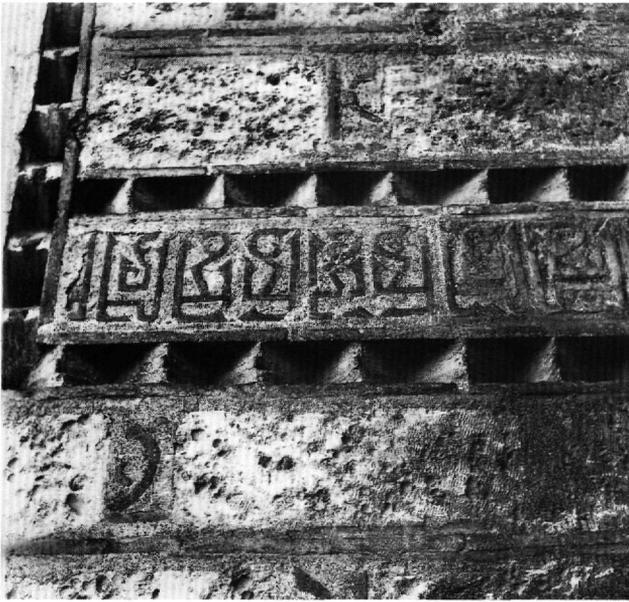
Fig. 16. North façade. Detail of the frieze.
