The Soteira Lykodemou at Athens. Architecture

Charalambos BOURAS

Τόμος ΚΕ' (2004) • Σελ. 11-24

THE SOTEIRA LYKODEMOU AT ATHENS. ARCHITECTURE*

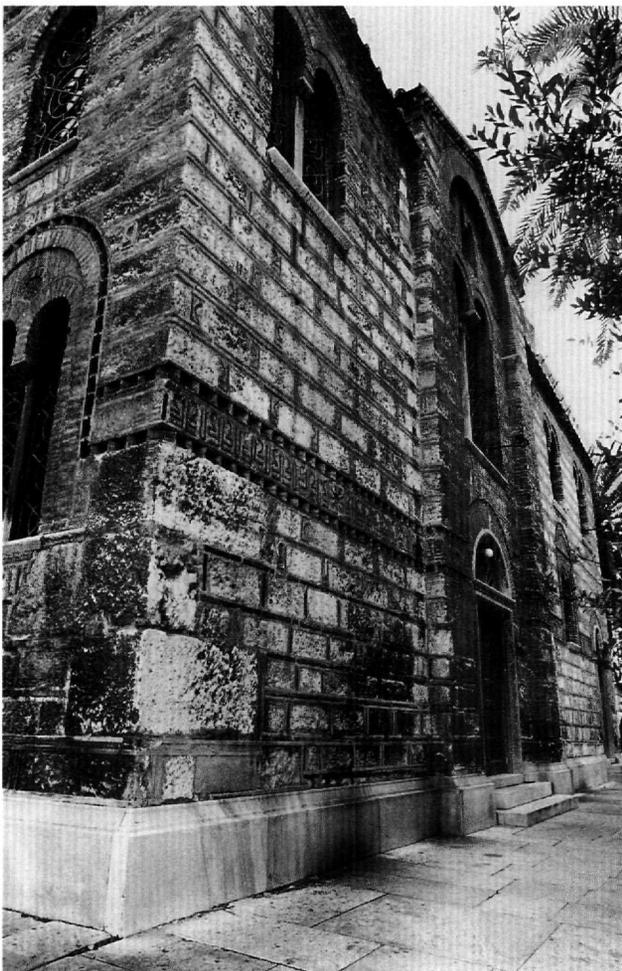
Fig. 1. The north façade looking west.

high chamfered marble crepis added by Vlasopoulos (Fig. 1) detracted from the monument's authenticity, and the old marble templon, the form of which is preserved by Lenoir³³, appears to have been carried off before the work began³⁴. The almost total destruction of the wall-paintings in the church (which will be discussed below) confirms the great scale of the removal of walls and vaults during Vlasopoulos's intervention.

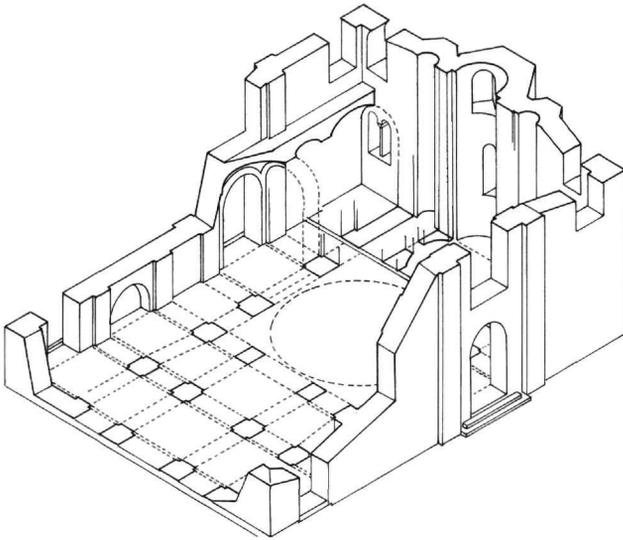
Fig. 3. Isometric section of the church, showing the existing original parts of the building, by C. Koliopoulos.

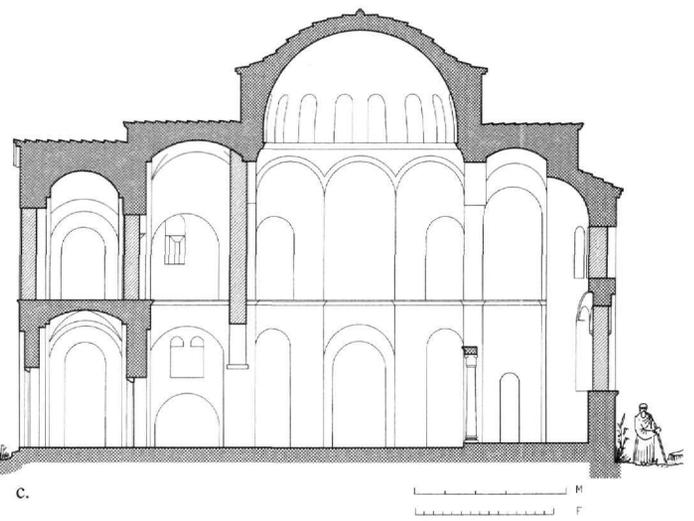
Fig. 9. Reconstruction of the church as in 1820. a. Plan at ground level. b. Plan at gallery level. c. Longitudinal section.

The reconstruction of the Soteira in the form it took after the repairs necessitated by the 1705 earthquake and before the Greek Uprising of 1821 (Fig. 9) is based on the same documentation, mainly on P. Durand's drawings.

Both drawings testify to the fact that all the arches opening

The preserved archways either side of the sanctuary on the upper floor (*paraklyptika?*) have also been walled up. Couchaud's plan shows reinforcing walls in front of the apses of the prothesis and diakonikon, though Durand's and Bindesbel's drawings of the wall-paintings indicate that these walls did not exist. The south-east side-chapel was isolated at the west by a transverse wall, in which a small door was created. Finally, the staircase at the south-west extreme of the church in Couchaud's plan, which pierced the corner vault, certainly did not belong to the original form of the building⁶⁴.

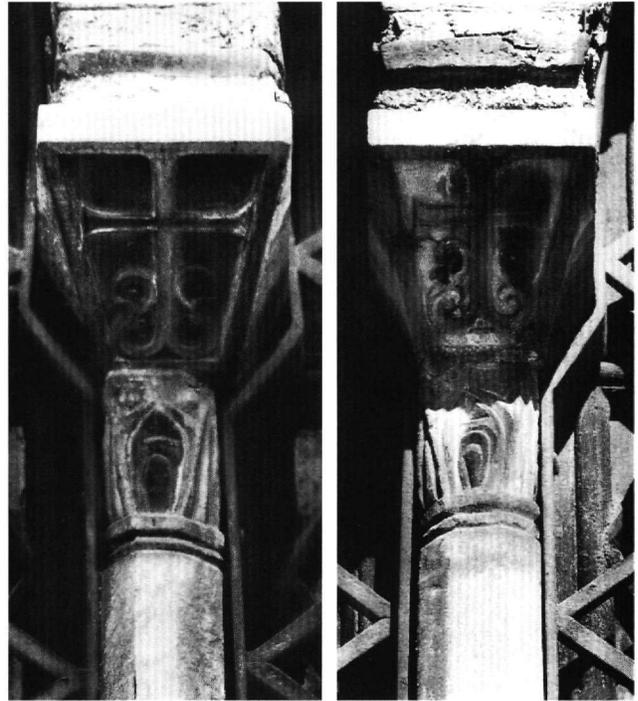
Fig. 10. The mullion capitals of the east façade windows. The imposts are modern (1850).

Very little survives of the sculptural decoration of the Soteira. Mullions are all that remain *in situ* of all the windows on the east side and of the two-light windows at the east end of the galleries (Figs. 10-11). As noted above, Vlasopoulos's restoration respected the axial column with its Ionic capital integral with the impost block (Fig. 12), a form common in the Early Christian period⁶⁵ though not unknown in the katholikon of the monastery of Hosios Loukas⁶⁶. The decorative motifs of the capitals and impost blocks above the mullions are very simple and commonly found in the eleventh century (six-point rosettes and

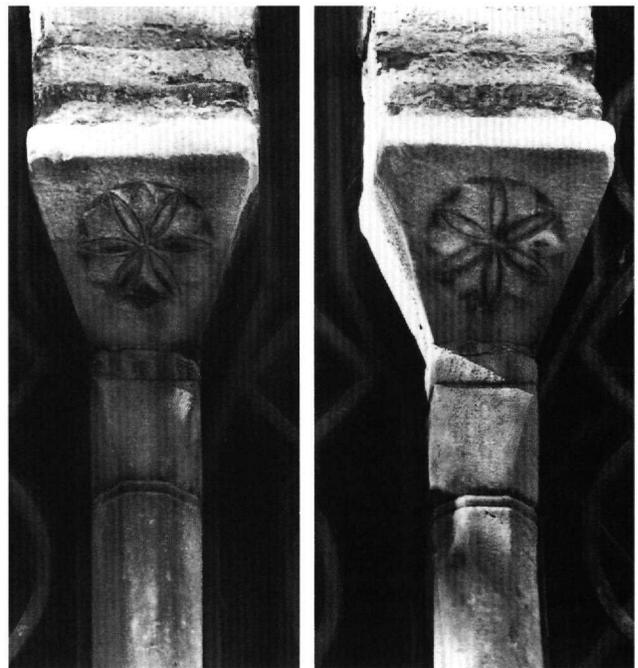
Fig. 11. The mullion capitals and imposts of the triple window of the bema apse.

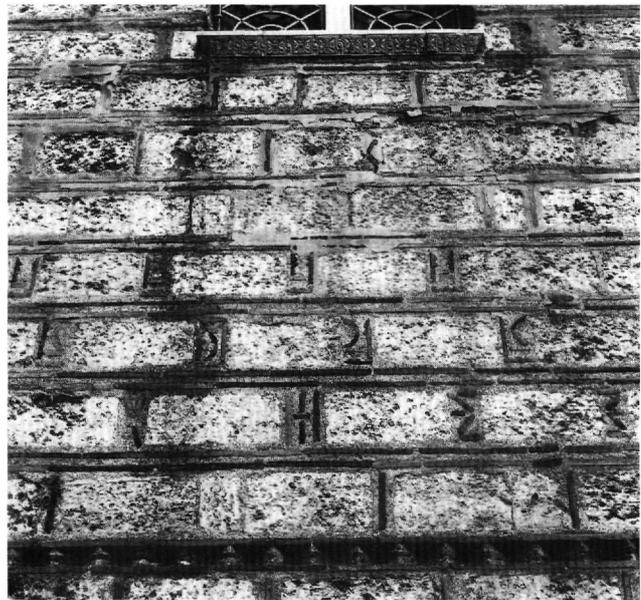
Fig. 15. Detail of the masonry on the south façade.
