Η αρχιτεκτονική της Σωτείρας Λυκοδήμου  
Αθηνών

*Charalambos BOURAS*

## THE SOTEIRA LYKODEMOU AT ATHENS. ARCHITECTURE\*

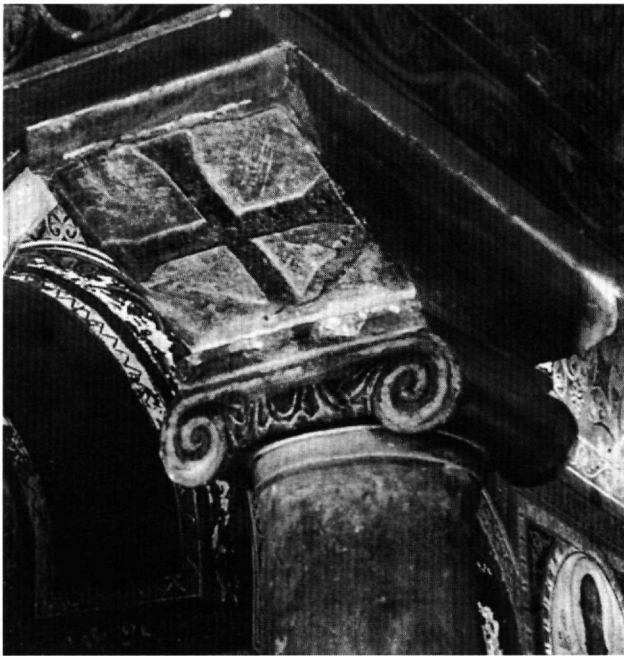
Fig. 12. Capital and impost of the colonette at the axis of the gallery.

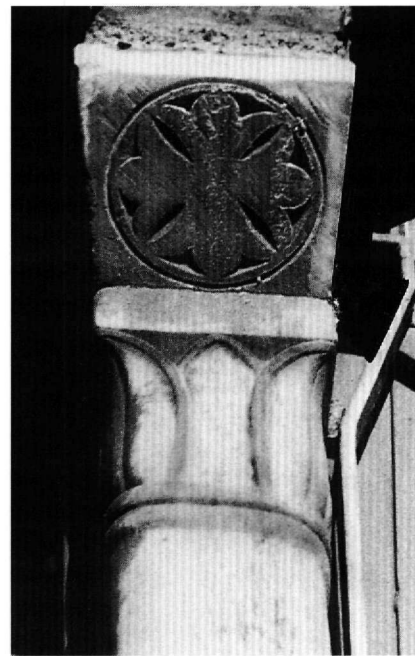
Fig. 13. Impost over a modern mullion on the south façade.

crosses) (Fig. 13). Unfortunately, none of the marble door-frames of the church survives. They were probably removed during the long period of its abandonment. The bowls in the tympana of the three-light window of the bema apse have been replaced by later small decorative disks.

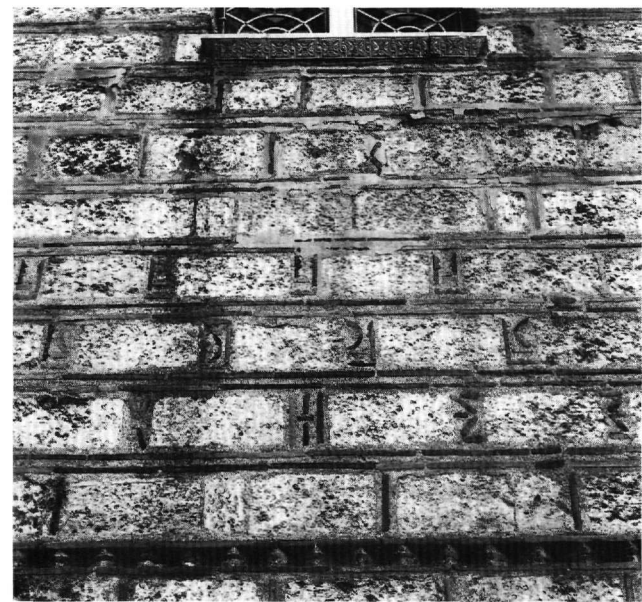
Fig. 15. Detail of the masonry on the south façade.
