Some Notes on the Construction of Christos Ho Pantepoptes (Eski Imaret Camii) in Istanbul

Robert OUSTERHOUT

Δελτίον ΧΑΕ 16 (1991-1992), Περίοδος Δ'. Στη μνήμη του
André Grabar (1896-1990) • Σελ. 47-56

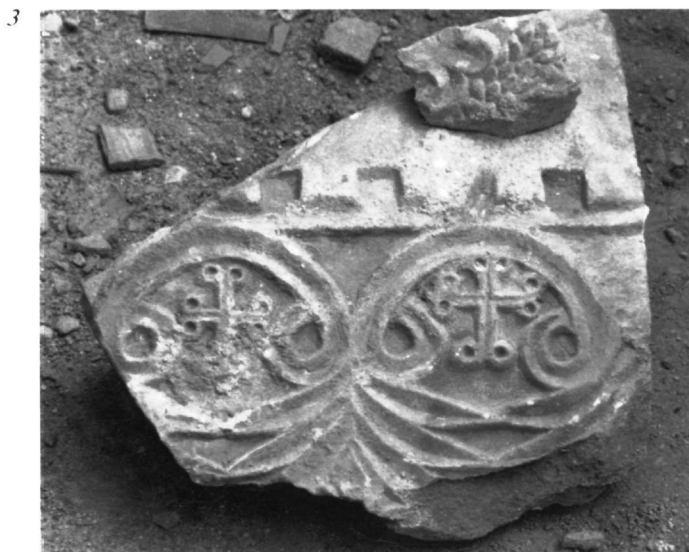
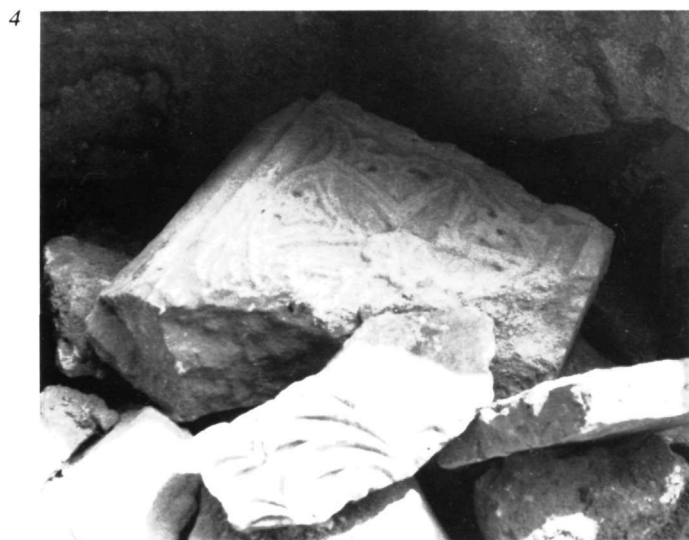
Figs. 3-4. Istanbul, Christos ho Pantepoptes. Sculpture fragments, found in 1990.

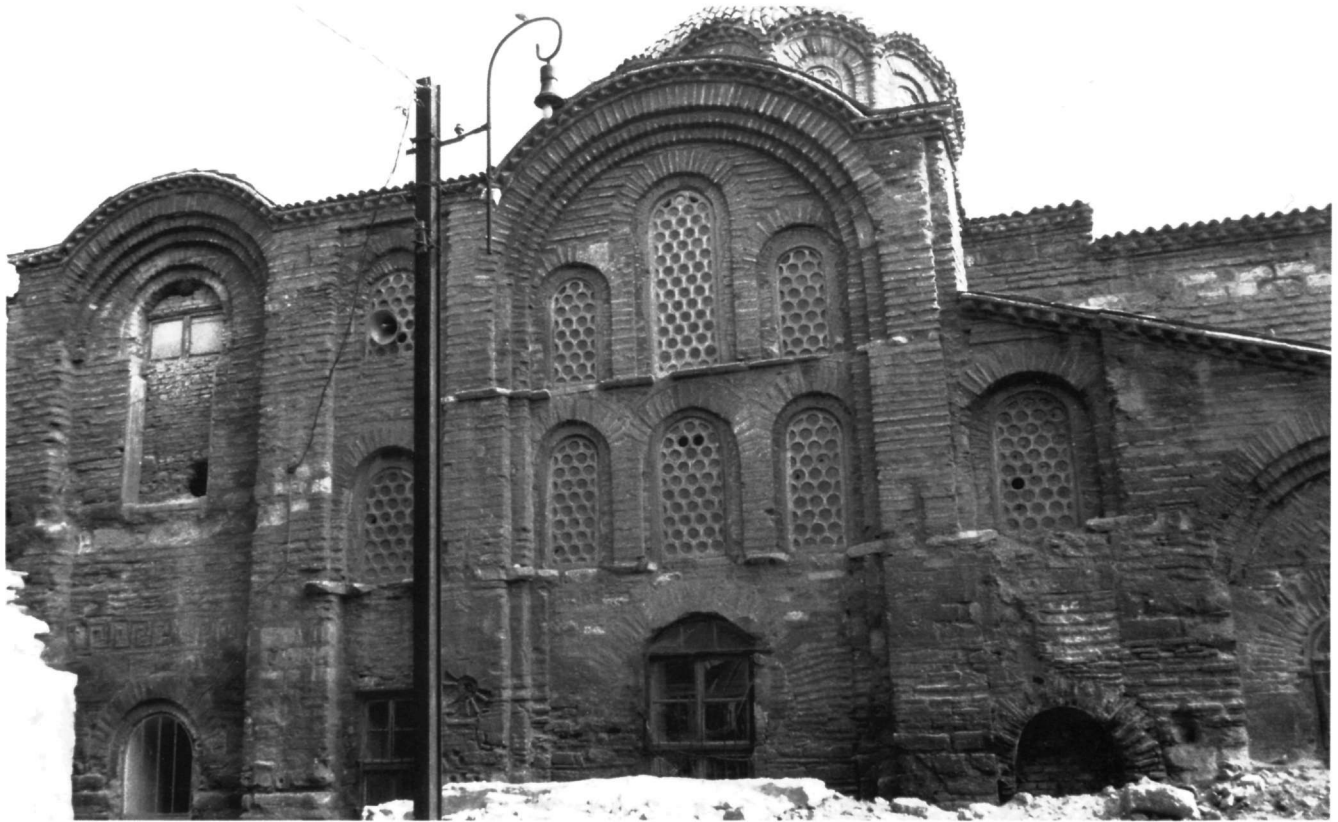
Fig. 5. Istanbul, *Christos ho Pantepoptes*. South façade.

the horizontal row of bricks above the gallery chamber appears a bit odd as well (Figs. 5-7). The exterior cornices were originally finely sculpted, and vestiges of the decoration survive. Those on the south façade project outward, well beyond the masonry surface, and this led Van Millingen to suggest that some of the external surfaces may have been revetted¹². This seems unlikely: there is no evidence for setting pins or cramps, but the possibility of a painted plaster surface like that at the church of the Virgin Eleousa at Veljusa, built *ca.* 1080, might be considered¹³. Several areas of fine white plaster can be observed on the remains of a stepped arch on the south façade of the exonarthex (Fig. 11). The context appears to be Byzantine and probably middle Byzantine, as will be discussed below. Unfortunately the surface is weathered, and it is unclear if it was painted.

çade are intriguing. On the south façade, the arches are normally stilted and have triple setbacks (Figs. 5-6). However, the pilasters are simple, single-stepped, and they do not reflect the complexity of the arches. Most pilasters become narrower above the level of the cornice in order to accommodate the setback arches. In addition, on the narthex and on the diakonikon façades, the innermost arch of the triple setback springs from corbelled bricks. The combination of complex arches and simple pilasters may be seen in several twelfth-century buildings in the capital, such as the Pantokrator and the Gül Camii. This contrasts with the emphatically three-dimensional façade articulation of some earlier buildings of the eleventh century, such as the Panagia Chalkeon in Thessaloniki, the narthex of the Koimesis in Nicaea

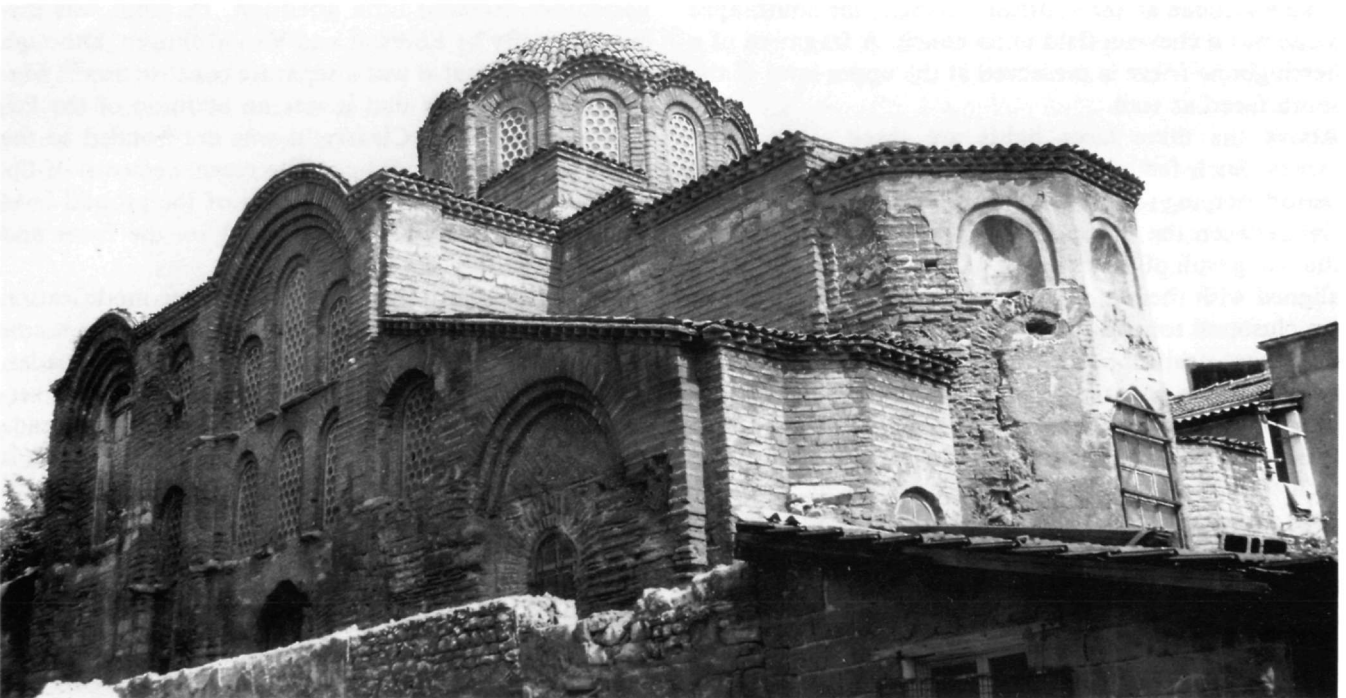
Fig. 7. Istanbul, Christos ho Pantepoptes. View from south-east.

ably along the eastern portions of the south façade and in some arches (Figs. 6-7). In these areas, roofing tiles often are used as filler. The refaced pastophoria apses utilize the recessed brick technique, but here it clearly represents a modern addition that helped to secure the new facing to the existing surface (Fig. 7). In any event, the employment of the technique is certainly not uniform, and reference to the Pantepoptes in this context should be qualified.

A similar feature appears on the main apse as well. The three facets of the apse once opened with extremely tall windows, the outline of which can still be discerned around the stone fill (Figs. 7-8)²⁴. The pier to the south of the window contains a small niche in the original masonry, positioned flanking the lower portion of the window opening (Fig. 8). A symmetrical counterpart appears to the north, although it is covered with plaster. Like the niche at the southeast corner, the south apse niche has a chevron field in its conch. A fragment of a herringbone frieze is preserved at the upper level of the south faced as well.

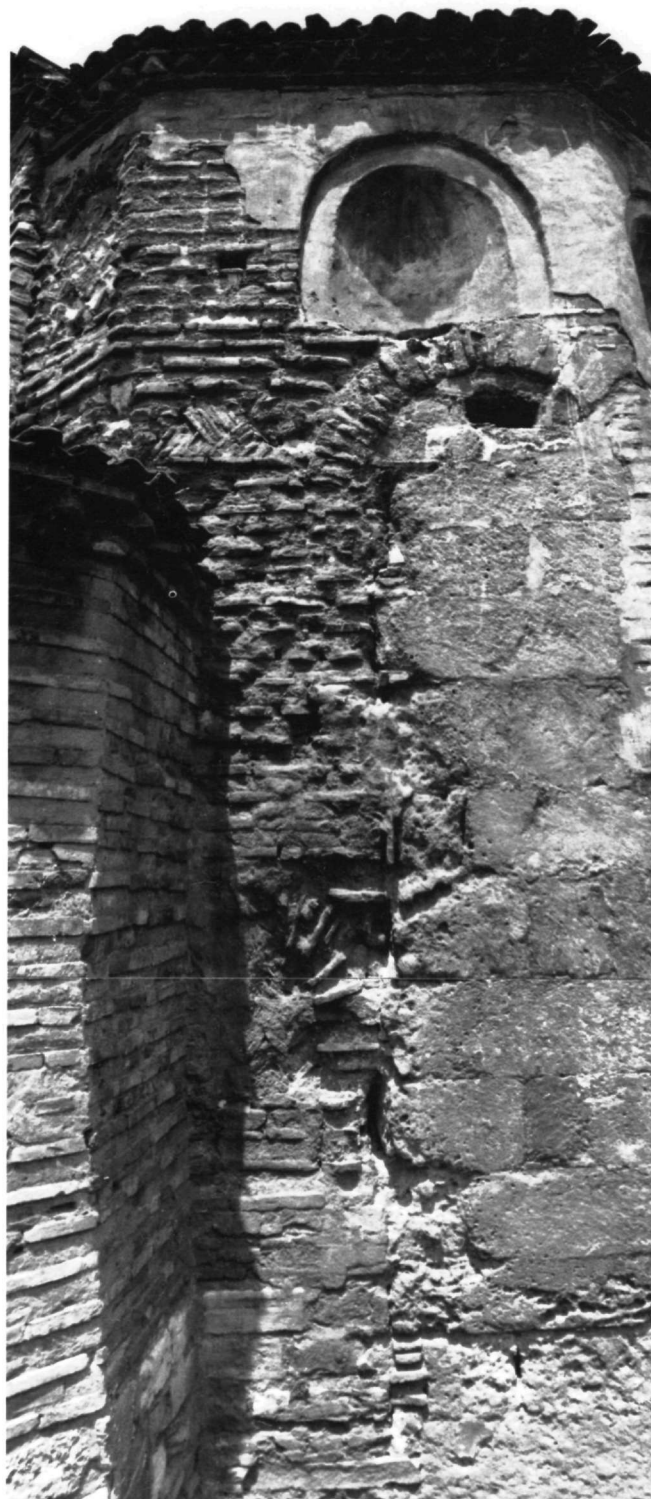
Fig. 8. Istanbul, *Christos ho Pantepoptes*. Main apse, detail of south facet.

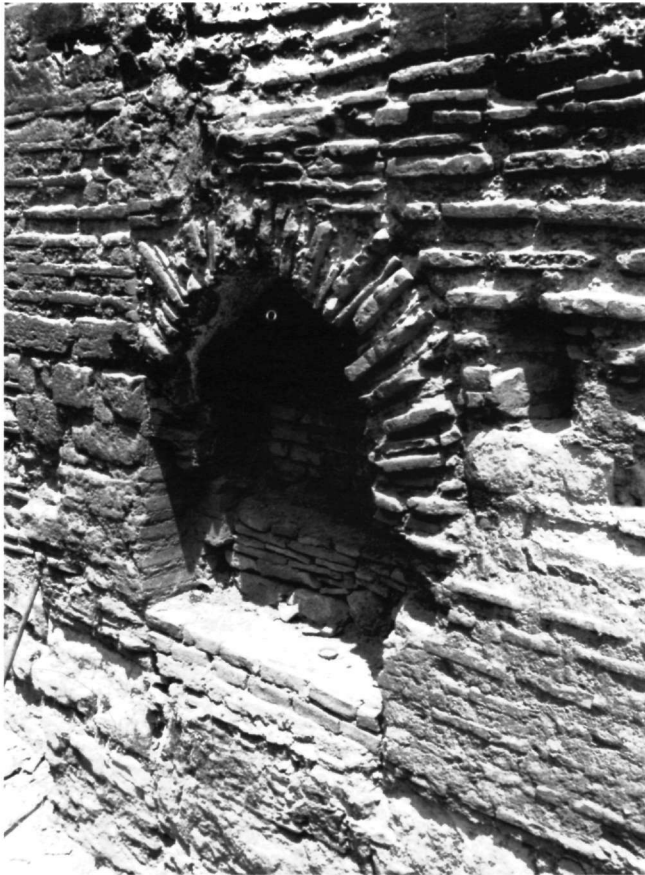
Fig. 9. Istanbul, *Christos ho Pantepoptes*. South façade, detail of niche.

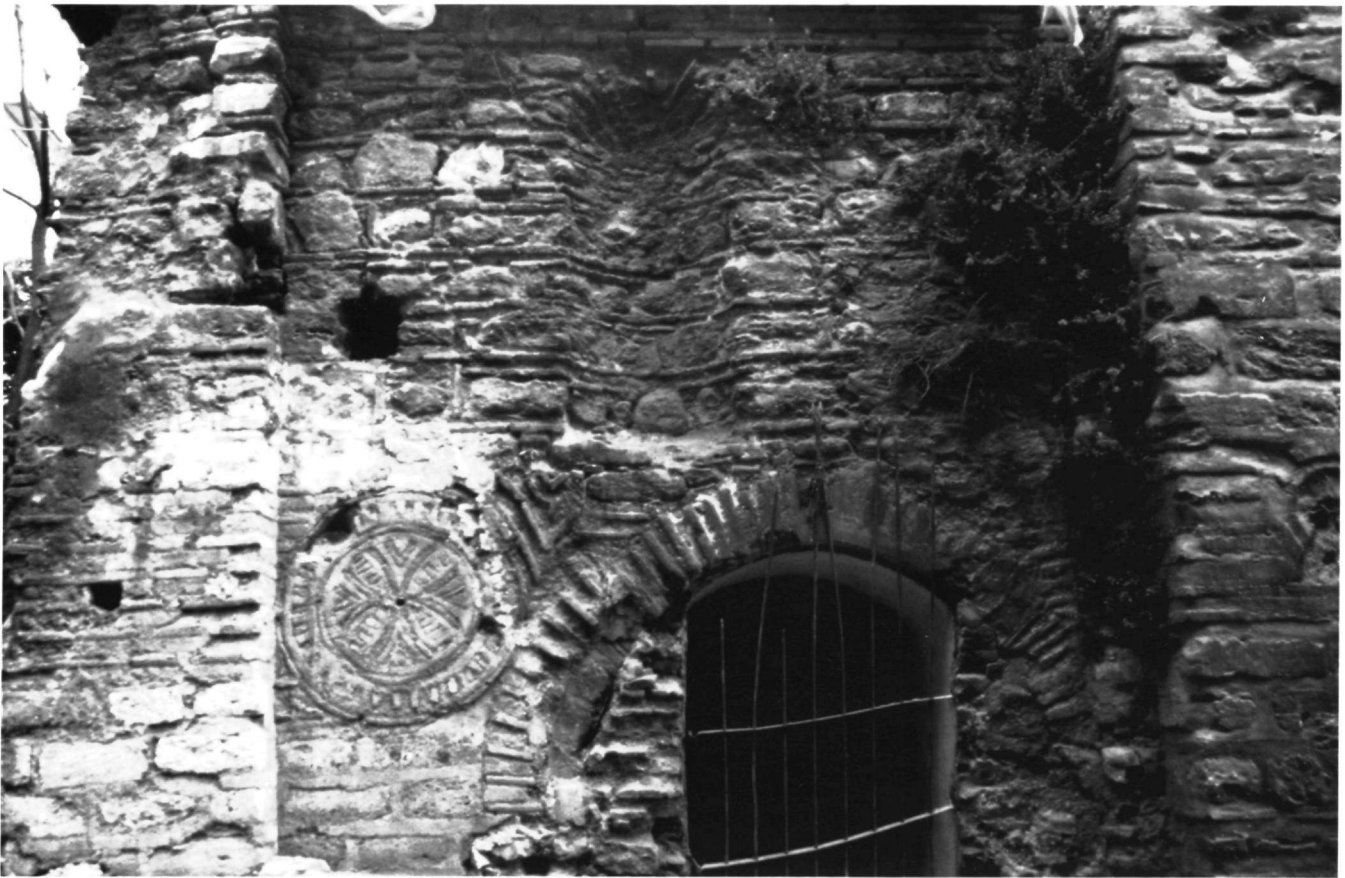
Fig. 11. Istanbul, *Christos ho Pantepoptes*. Exonarthex, south façade.

At the western corner of the south façade, a large roundel enclosing a cross appears, executed in brick and curved tiles (Fig. 11). This had been hidden until recently by the base of the minaret. This area of wall surface had been covered since the late fifteenth century, preserving in pristine condition the colors and the details. Between the roundel and the arch is a curved chevron pattern: its asymmetrical form followed the lines of the roundel and the arch.

The exterior masonry of the rebuilt portion is normally an alternation of two courses of brick to one of rough stone (Figs. 10-11). The arches on the west façade are outlined in brick, and recessed tiles appear sporadically in the arches. Decorative niches appear in the west and south façades, although at different levels. In addition, the pier to the south of the main entrance seems to have included a decorative niche, plastered on its inner sur-
