Δελτίον ΧΑΕ 16 (1991-1992), Περίοδος Δ'. Στη μνήμη του André Grabar (1896-1990)

Ορισμένες παρατηρήσεις για την κατασκευή του Χριστού Παντεπόπτη (Eski Imaret Camii) στην Κωνσταντινούπολη

## SOME NOTES ON THE CONSTRUCTION OF CHRISTOS HO PANTEOPTES (ESKI IMARET CAMII) IN ISTANBUL

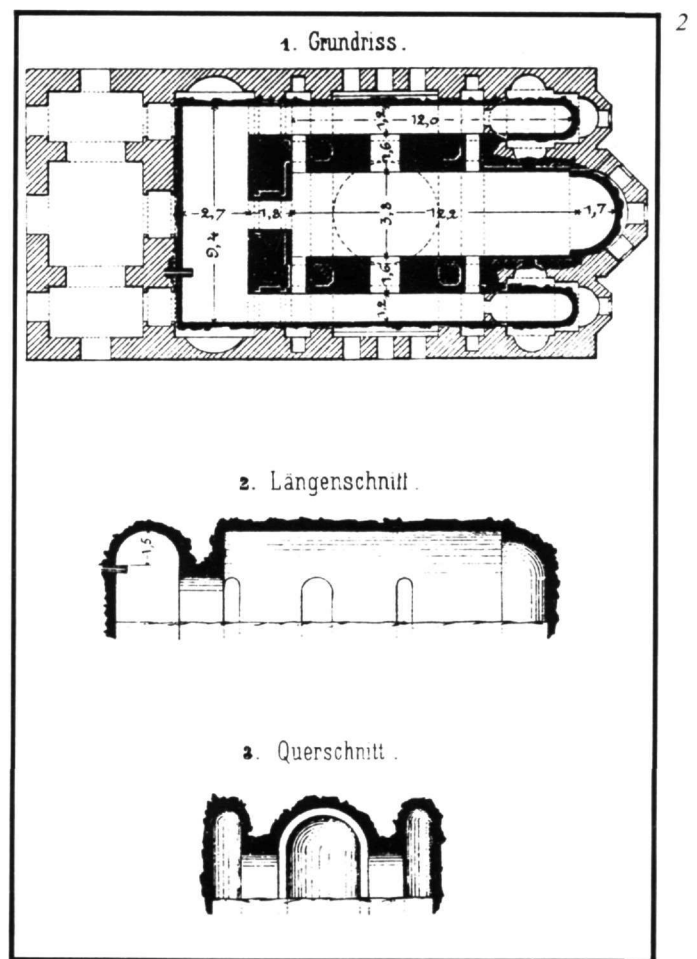
Fig. 2. Istanbul, *Christos ho Pantepoptes*. Plan of substructures (after Forchheimer and Strzygowski).

One of the best preserved examples of the cross-in-square church type in the capital, the Pantepoptes was carefully laid out above barrel vaulted cisterns that form the substructure for the naos, narthex, and sanctuary (Figs. 1-2)<sup>4</sup>. The exonarthex, a later addition, apparently lacked such substructures. The spaces of the interior still reflect the original disposition, although the four columns of the naos have been replaced with octagonal piers, the tribelon of the south façade has been filled, and the forms of several windows have been altered. The building is long overdue from a thorough architectural analysis, and it would benefit from soundings beneath the plastered surfaces of the interior, as well as in the ground around the exterior. The Pantepoptes has never been systematically examined for the remains of its interior decoration. In addition, it is sometimes suggested that the building had lateral porticoes, the existence of which could be demonstrated by soundings<sup>5</sup>. As none of this appears likely to occur in the next decades, I offer the following observations, based on an examination of the masonry undertaken during the summer of 1990<sup>6</sup>.

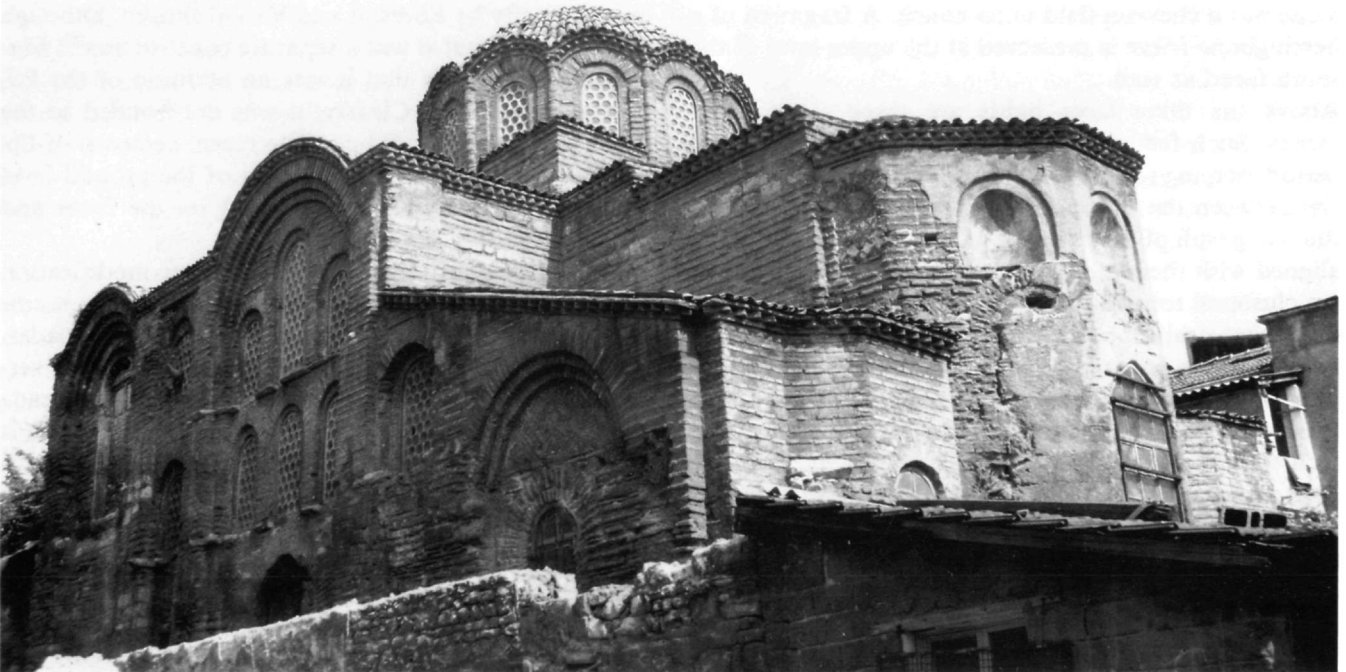
*Fig. 7. Istanbul, Christos ho Pantepotes. View from south-east.*

A similar feature appears on the main apse as well. The three facets of the apse once opened with extremely tall windows, the outline of which can still be discerned around the stone fill (Figs. 7-8)<sup>24</sup>. The pier to the south of the window contains a small niche in the original masonry, positioned flanking the lower portion of the window opening (Fig. 8). A symmetrical counterpart appears to the north, although it is covered with plaster. Like the niche at the southeast corner, the south apse niche has a chevron field in its conch. A fragment of a herringbone frieze is preserved at the upper level of the south faced as well.

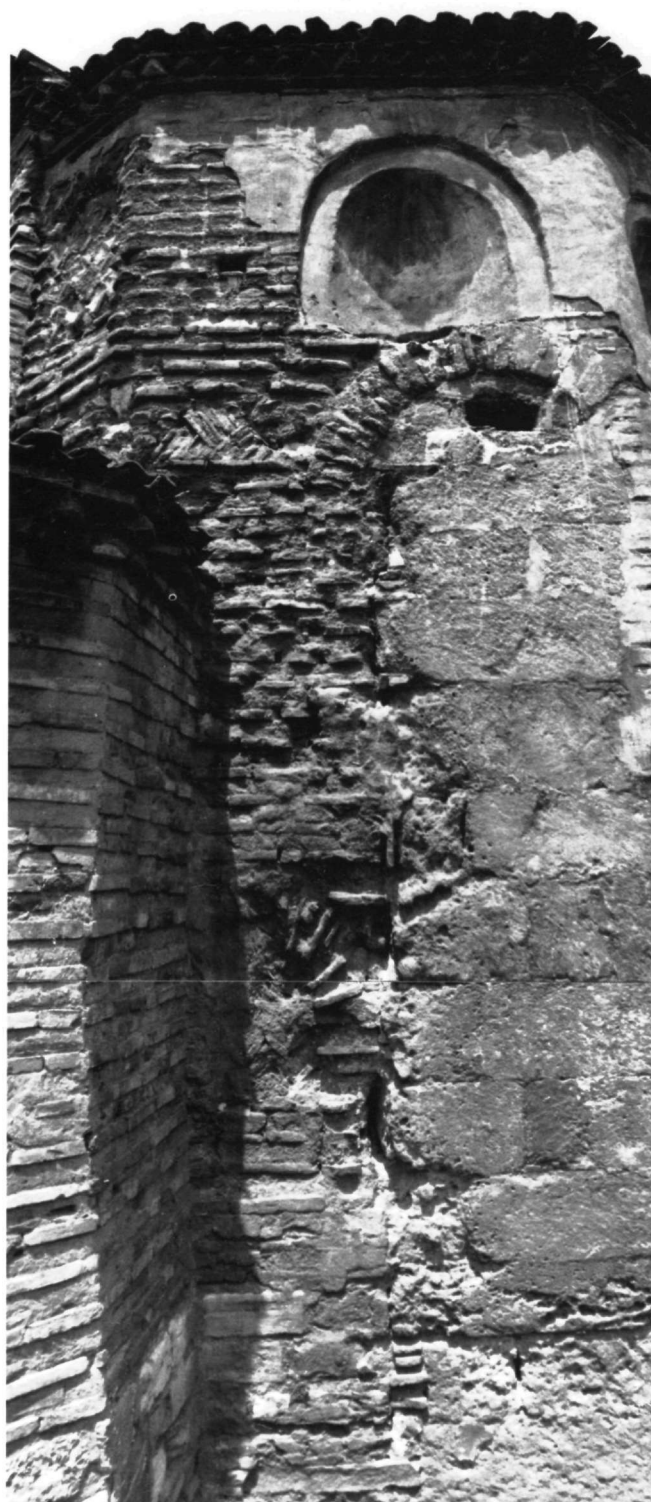
Fig. 8. Istanbul, *Christos ho Pantepoptes*. Main apse, detail of south facet.

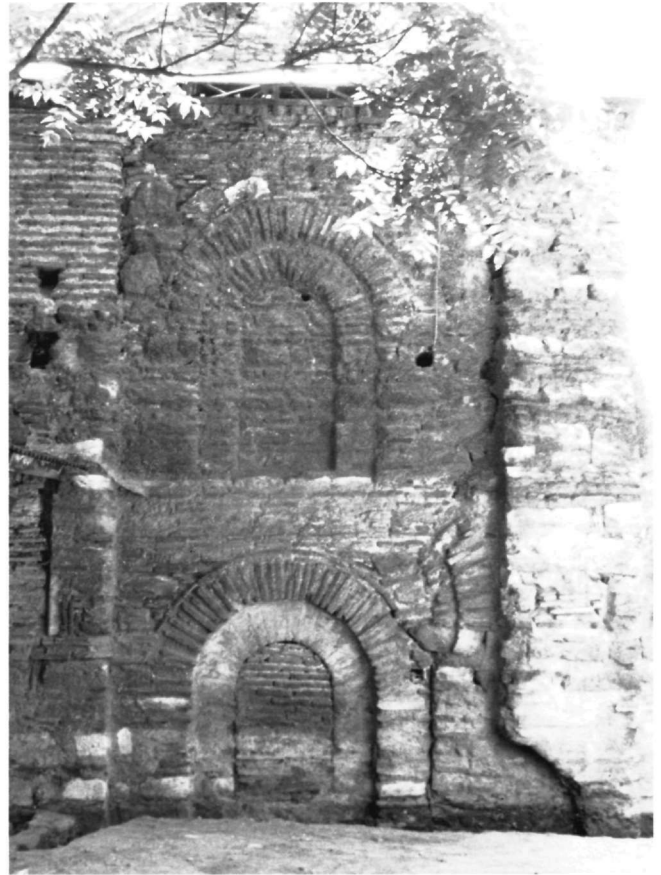
Fig. 10. Istanbul, *Christos ho Pantepoptes*. Exonarthex, west façade.

The exterior masonry of the rebuilt portion is normally an alternation of two courses of brick to one of rough stone (Figs. 10-11). The arches on the west façade are outlined in brick, and recessed tiles appear sporadically in the arches. Decorative niches appear in the west and south façades, although at different levels. In addition, the pier to the south of the main entrance seems to have included a decorative niche, plastered on its inner sur-
