## Some Notes on the Construction of Christos Ho Pantepoptes (Eski Imaret Camii) in Istanbul

Robert OUSTERHOUT

Δελτίον ΧΑΕ 16 (1991-1992), Περίοδος Δ'. Στη μνήμη του  
André Grabar (1896-1990) • Σελ. 47-56

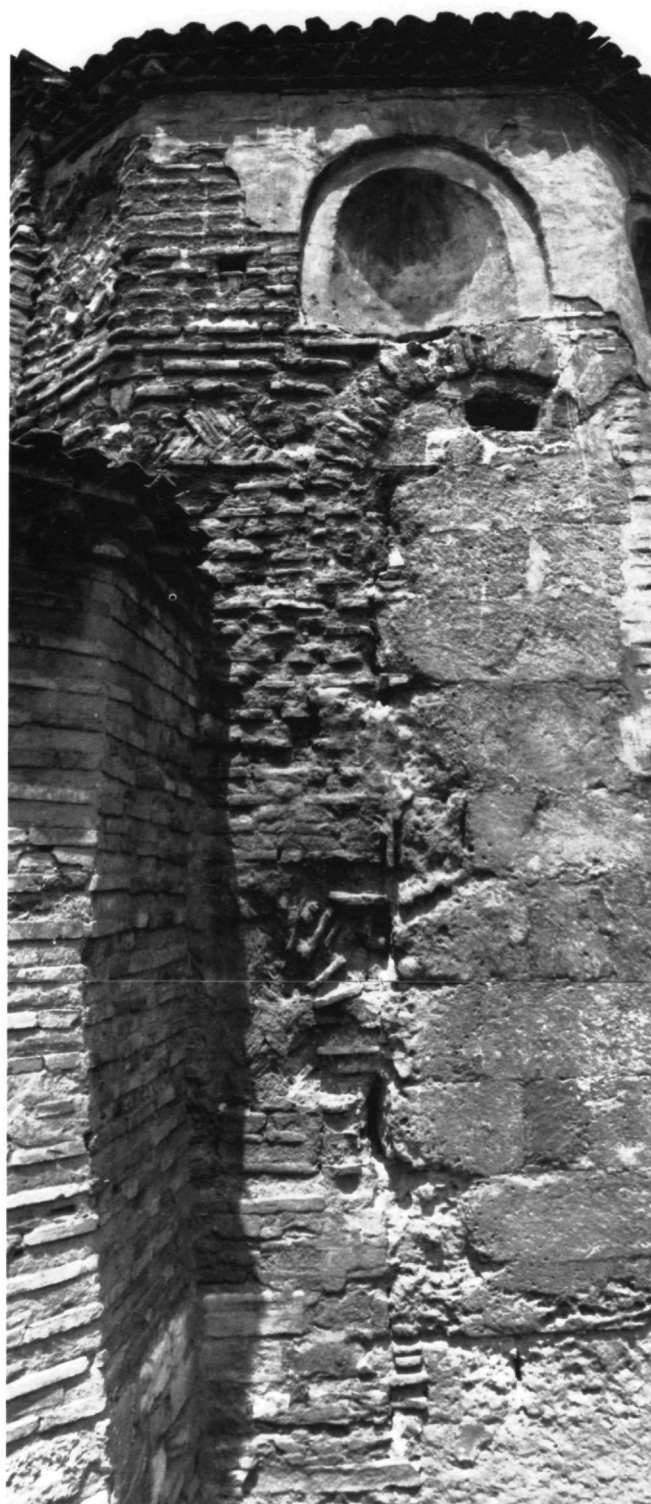
Fig. 8. Istanbul, *Christos ho Pantepoptes*. Main apse, detail of south facet.

A similar feature appears on the main apse as well. The three facets of the apse once opened with extremely tall windows, the outline of which can still be discerned around the stone fill (Figs. 7-8)<sup>24</sup>. The pier to the south of the window contains a small niche in the original masonry, positioned flanking the lower portion of the window opening (Fig. 8). A symmetrical counterpart appears to the north, although it is covered with plaster. Like the niche at the southeast corner, the south apse niche has a chevron field in its conch. A fragment of a herringbone frieze is preserved at the upper level of the south faced as well.
