## Some Notes on the Construction of Christos Ho Pantepoptes (Eski Imaret Camii) in Istanbul

Robert OUSTERHOUT

Δελτίον ΧΑΕ 16 (1991-1992), Περίοδος Δ'. Στη μνήμη του  
André Grabar (1896-1990) • Σελ. 47-56

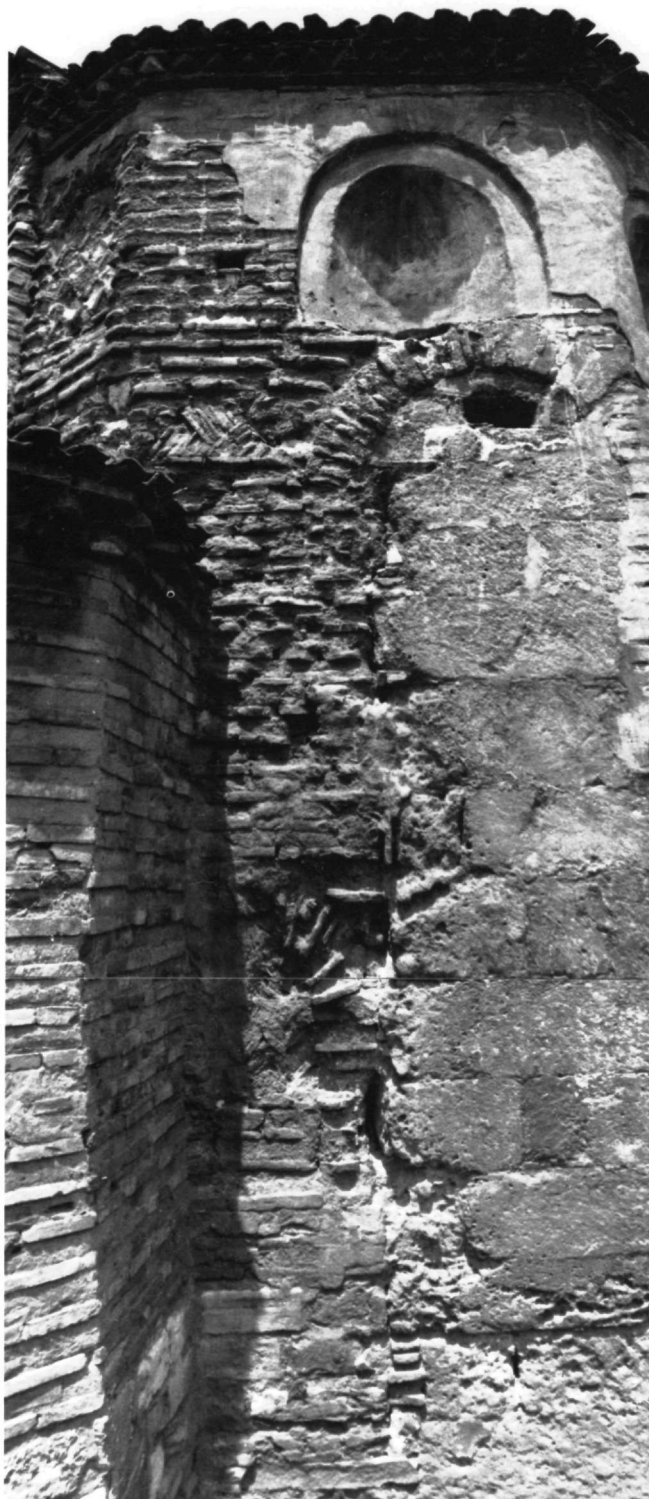
Fig. 8. Istanbul, *Christos ho Pantepoptes*. Main apse, detail of south facet.

A similar feature appears on the main apse as well. The three facets of the apse once opened with extremely tall windows, the outline of which can still be discerned around the stone fill (Figs. 7-8)<sup>24</sup>. The pier to the south of the window contains a small niche in the original masonry, positioned flanking the lower portion of the window opening (Fig. 8). A symmetrical counterpart appears to the north, although it is covered with plaster. Like the niche at the southeast corner, the south apse niche has a chevron field in its conch. A fragment of a herringbone frieze is preserved at the upper level of the south faced as well.

Above the three large lights are three semicircular niches. Such features are common in the apses of the period, helping to relieve the mass of construction material between the conch of the apse on the interior and the rising wall of the exterior<sup>25</sup>. Curiously, these are not aligned with the windows below: the window openings are clustered toward the center of the apse, whereas the niches are positioned centrally within each facet. A decorative niche containing a flat field is in a similar position on the lateral surface of the apse extension, above the level of the diakonikon. The flat surface of the niche is filled with a diaper pattern in brick and mortar. The apse niches are still covered with a layer of plaster, but one wonders whether they also may preserve some elements of brick decoration. The nineteenth-century drawing by Paspates, which was probably based on a photograph, shows a chevron or herringbone pattern in the niches<sup>26</sup>.
