Ορισμένες παρατηρήσεις για την κατασκευή του Χριστού Παντεπόπτη (Eski Imaret Camii) στην Κωνσταντινούπολη

## Some Notes on the Construction of Christos Ho Pantepoptes (Eski Imaret Camii) in Istanbul

Robert OUSTERHOUT

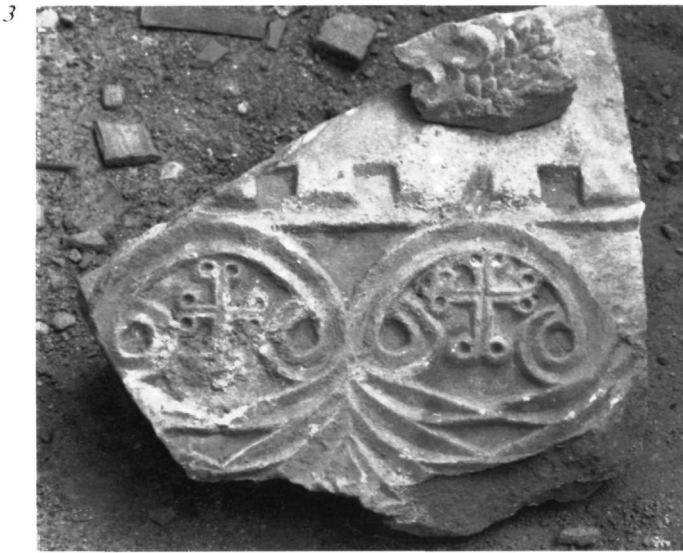
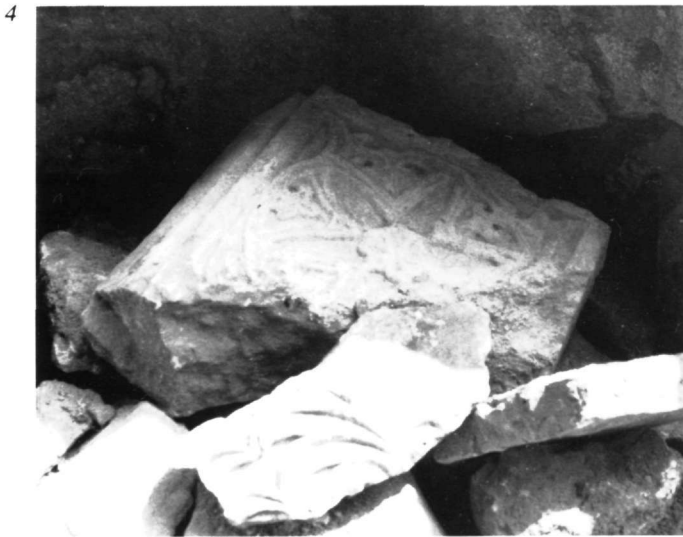
Figs. 3-4. Istanbul, *Christos ho Pantepoptes*. Sculpture fragments, found in 1990.

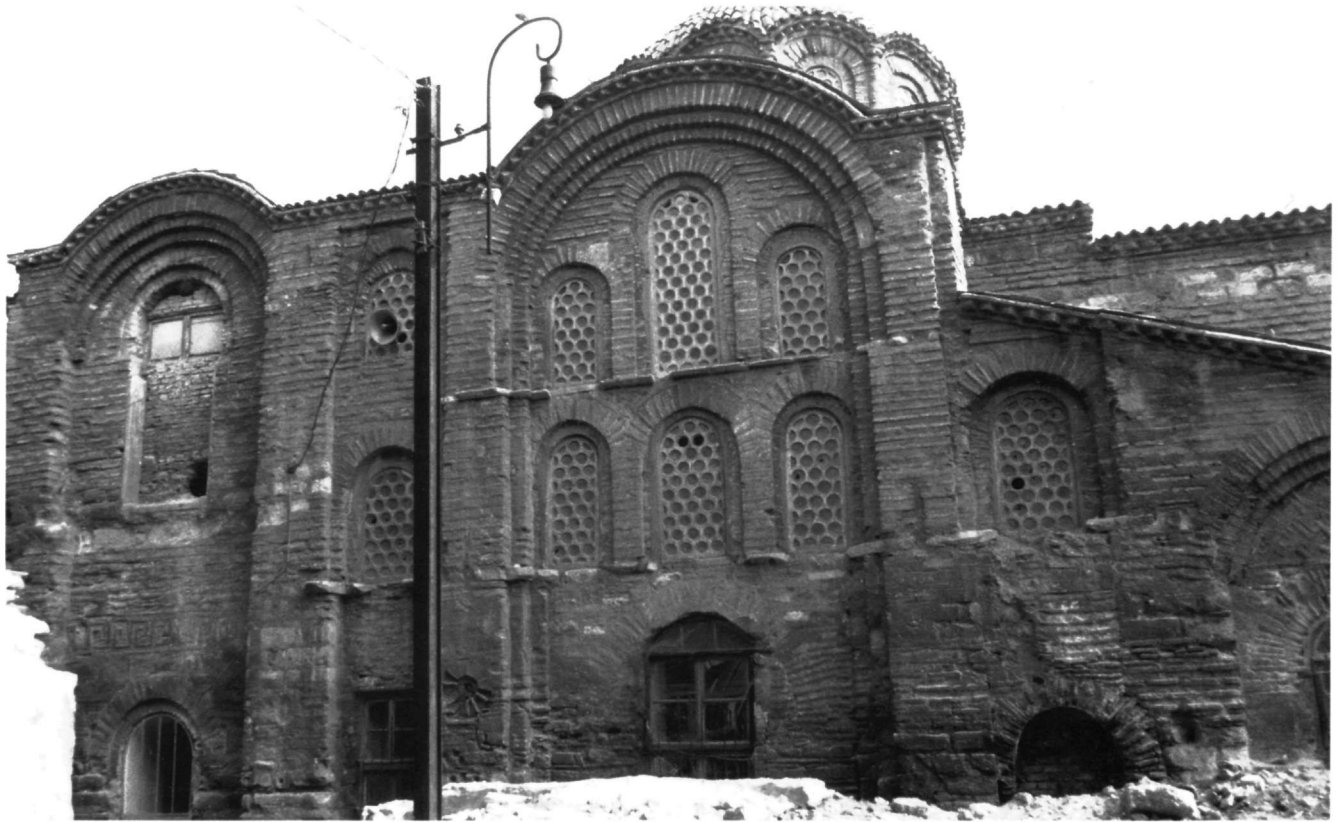
Fig. 5. Istanbul, *Christos ho Pantepoptes*. South façade.

the horizontal row of bricks above the gallery chamber appears a bit odd as well (Figs. 5-7). The exterior cornices were originally finely sculpted, and vestiges of the decoration survive. Those on the south façade project outward, well beyond the masonry surface, and this led Van Millingen to suggest that some of the external surfaces may have been revetted<sup>12</sup>. This seems unlikely: there is no evidence for setting pins or cramps, but the possibility of a painted plaster surface like that at the church of the Virgin Eleousa at Veljusa, built *ca.* 1080, might be considered<sup>13</sup>. Several areas of fine white plaster can be observed on the remains of a stepped arch on the south façade of the exonarthex (Fig. 11). The context appears to be Byzantine and probably middle Byzantine, as will be discussed below. Unfortunately the surface is weathered, and it is unclear if it was painted.

çade are intriguing. On the south façade, the arches are normally stilted and have triple setbacks (Figs. 5-6). However, the pilasters are simple, single-stepped, and they do not reflect the complexity of the arches. Most pilasters become narrower above the level of the cornice in order to accommodate the setback arches. In addition, on the narthex and on the diakonikon façades, the innermost arch of the triple setback springs from corbelled bricks. The combination of complex arches and simple pilasters may be seen in several twelfth-century buildings in the capital, such as the Pantokrator and the Gül Camii. This contrasts with the emphatically three-dimensional façade articulation of some earlier buildings of the eleventh century, such as the Panagia Chalkeon in Thessaloniki, the narthex of the Koimesis in Nicaea

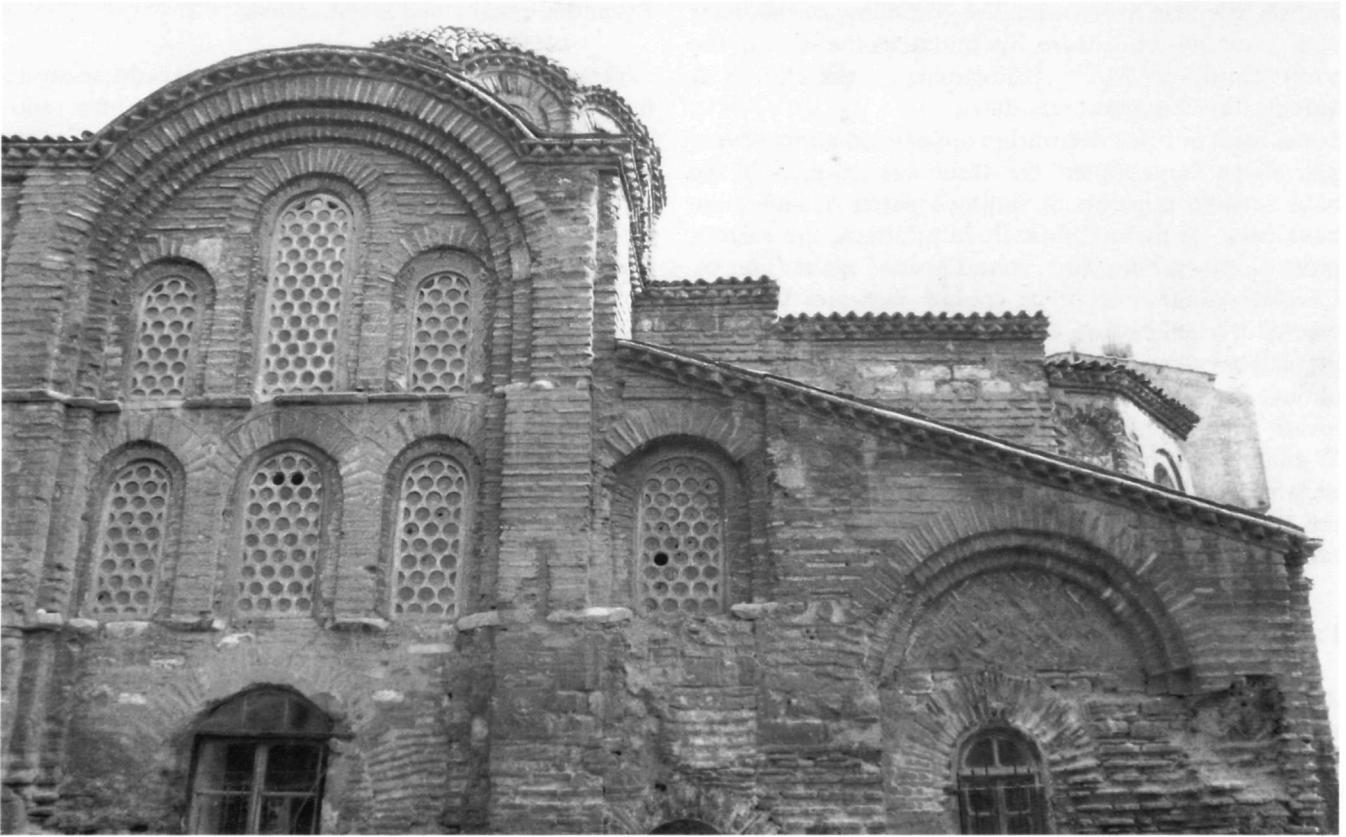
*Fig. 6. Istanbul, Christos ho Pantepotes. South façade, eastern portion.*

*Fig. 7. Istanbul, Christos ho Pantepotes. View from south-east.*

ably along the eastern portions of the south façade and in some arches (Figs. 6-7). In these areas, roofing tiles often are used as filler. The refaced pastophoria apses utilize the recessed brick technique, but here it clearly represents a modern addition that helped to secure the new facing to the existing surface (Fig. 7). In any event, the employment of the technique is certainly not uniform, and reference to the Pantepoptes in this context should be qualified.

Some form of brick decoration appears on almost every pier of the Pantepotes. The three western piers of the naos include roundels or bullseye patterns, and these have been frequently noted<sup>21</sup>. In addition, the eastern most pier includes a tiny, round-headed niche (Fig. 6). Careful examination of its context indicates that this was an original feature, although most of the surrounding masonry has been replaced. The niche is positioned almost directly at the angled springing of the façade arcade. The niche head is filled with bricks forming a W-shaped chevron pattern<sup>22</sup>. Such a detail, seeming to negate the structural expression of the pier, is unusual in the architecture of the eleventh century, although certainly more common in the Palaeologan period<sup>23</sup>.

A similar feature appears on the main apse as well. The three facets of the apse once opened with extremely tall windows, the outline of which can still be discerned around the stone fill (Figs. 7-8)<sup>24</sup>. The pier to the south of the window contains a small niche in the original masonry, positioned flanking the lower portion of the window opening (Fig. 8). A symmetrical counterpart appears to the north, although it is covered with plaster. Like the niche at the southeast corner, the south apse niche has a chevron field in its conch. A fragment of a herringbone frieze is preserved at the upper level of the south faced as well.

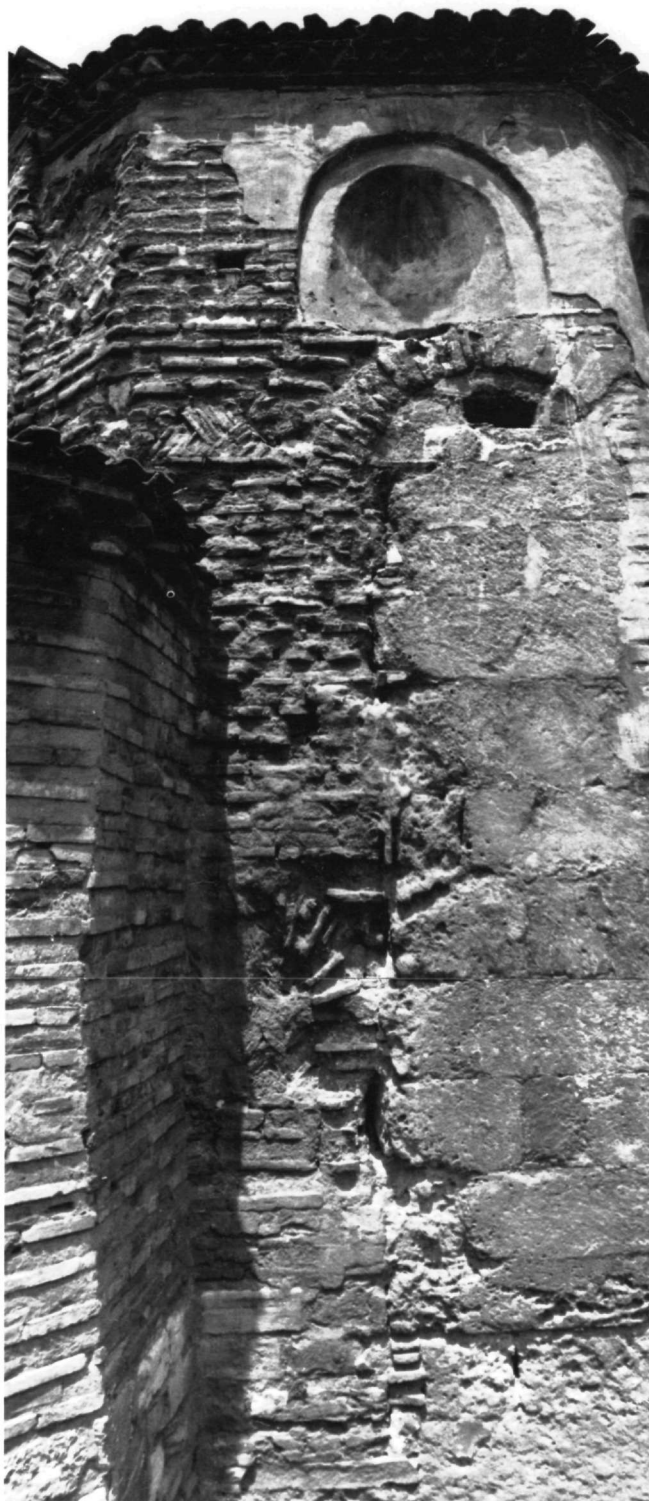
Fig. 8. Istanbul, *Christos ho Pantepoptes*. Main apse, detail of south facet.

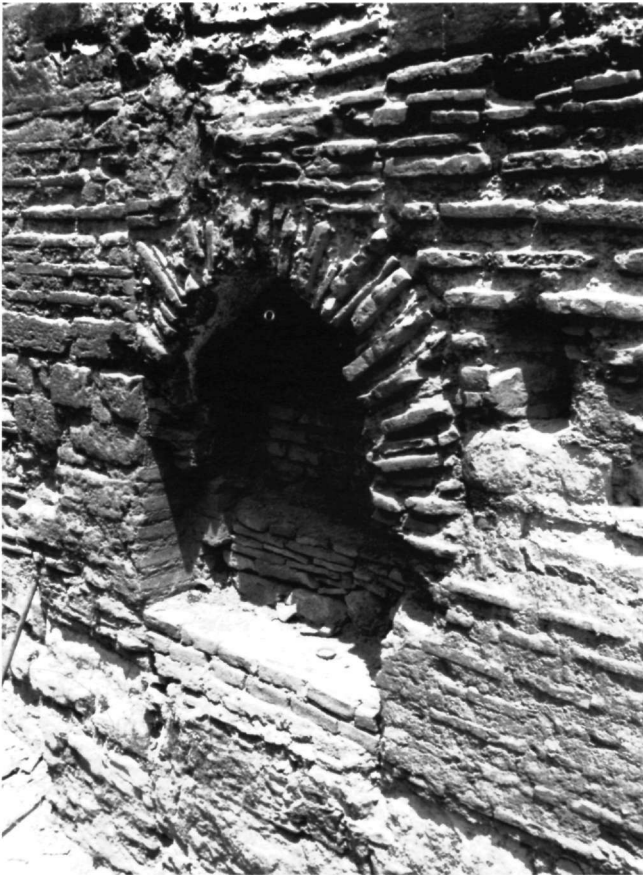
Fig. 9. Istanbul, *Christos ho Pantepoptes*. South façade, detail of niche.

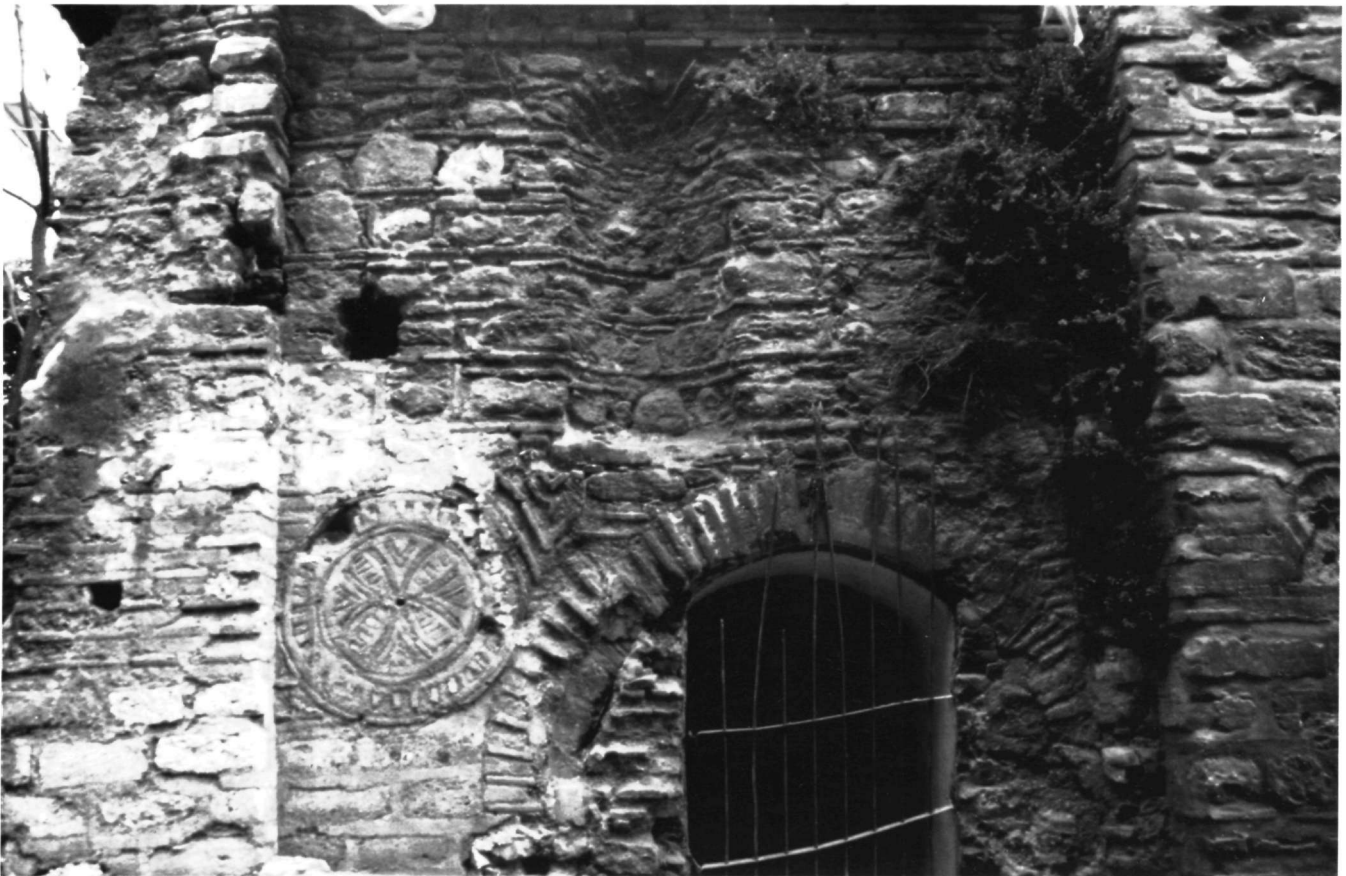
Fig. 11. Istanbul, *Christos ho Pantepoptes*. Exonarthex, south façade.

At the western corner of the south façade, a large roundel enclosing a cross appears, executed in brick and curved tiles (Fig. 11). This had been hidden until recently by the base of the minaret. This area of wall surface had been covered since the late fifteenth century, preserving in pristine condition the colors and the details. Between the roundel and the arch is a curved chevron pattern: its asymmetrical form followed the lines of the roundel and the arch.

The exterior masonry of the rebuilt portion is normally an alternation of two courses of brick to one of rough stone (Figs. 10-11). The arches on the west façade are outlined in brick, and recessed tiles appear sporadically in the arches. Decorative niches appear in the west and south façades, although at different levels. In addition, the pier to the south of the main entrance seems to have included a decorative niche, plastered on its inner sur-
