### Binbirkilise Revisited: The 1887 Photographs of John Henry Haynes

## BİNBİRKİLİSE REVISITED: THE 1887 PHOTOGRAPHS OF JOHN HENRY HAYNES

The early Byzantine site of Binbirkilise (the Thousand and One Churches) near Karaman in Lycaonia is best known today from the 1907 documentation by Sir William M. Ramsay and Gertrude Bell. Unknown to them, however, was the visit in 1887 by the American archaeologist John Henry Haynes, who took photographs of Churches 8, 10, 13, 32, and 39. Because of severe damage to the buildings between 1887 and 1907, Haynes's photographs provide important details of the buildings not available to later scholars.

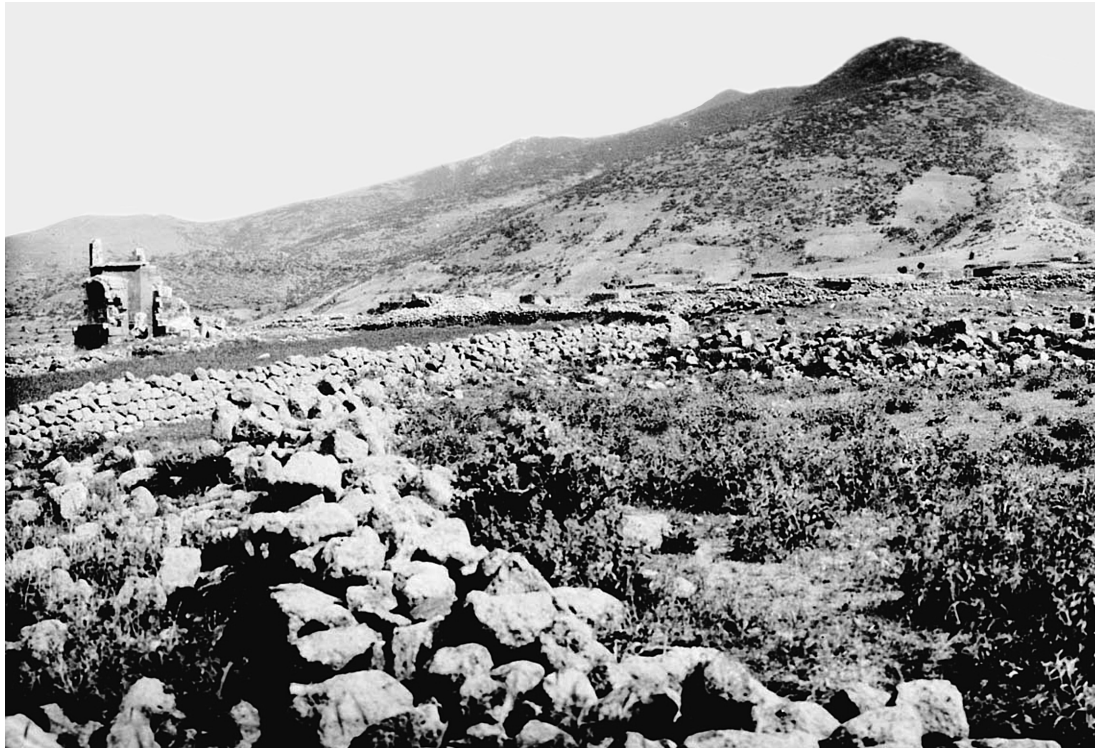
Fig. 2. Binbirkilise, view of the ruins of Churches 8 and 13, seen from the northwest, by Gertrude Bell, 1907 (courtesy of the University of Newcastle Gertrude Bell Archive).

tion of the site with Sir William M. Ramsay (Fig. 2).<sup>5</sup> Bell's analysis of the architecture is the most complete and remains authoritative. While she incorporated the observations of earlier visitors into her study of the architecture, their accounts provide little evidence not visible to her during her time at the site. Many of the buildings in the lower city had fallen sometime between Laborde's visit and Bell's, and it is often assumed to be the result of gradual deterioration over time. As Ramsay commented, "The destruction of this ancient city has proceeded comparatively slowly, but it goes on steadily."<sup>6</sup> Ramsay had first examined the site with Sir Charles Wilson in 1882, but his account places the destruction of the monuments considerably later. For example, he writes, "Church 8 was

Haynes's photograph of Churches 8 and 13 (Fig. 3) is taken from the southeast rather than the southwest, as were the views of Bell and Laborde. By the time Bell had arrived on the scene, Church 8 had fallen but was still recognizable, while Church 13 was nothing but a pile of rubble – so much so that Bell didn't bother to record it.<sup>15</sup> In Bell's photograph (Fig. 2), its foundations appear immediately to the right of Church 8, just behind the rock fence. Haynes's

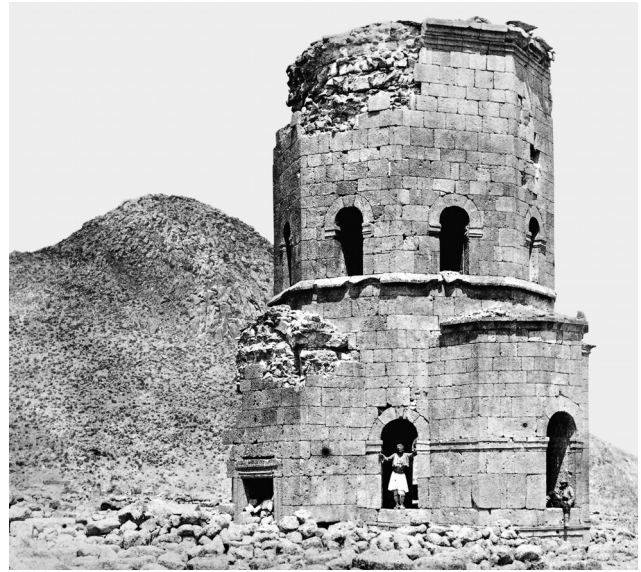
Fig. 5. Binbirkilise, view of the ruins of Church 8, seen from the northwest, by John Henry Haynes, 1887 (Harvard University, Aga Khan Visual Resources).

Impressively, Church 8 stands its full height, its domed octagonal core amplified with barrel-vaulted projections on three sides and an apse on the fourth (Figs 5, 6A). Church 8 has long been of interest to scholars because of its similarities to the martyrion described by Gregory of Nysa.<sup>18</sup> Haynes's photograph confirms that this was, indeed, an impressive building, and typical of Haynes, he poses his traveling companions in the windows. Seen from the southeast, the faceted apse projects to the right, terminating in a single arched window. The transept arm extend-

ing to the left terminates in a door. The central octagon rises through a clerestory zone below the dome, disguised behind the rising walls of the octagon. Where the facing has fallen away, the mortared rubble core of the wall is exposed. The octagon is rotated so that its corners, rather than its flat walls, are on axis. As a consequence, the lower diagonal windows (where one of Haynes's companions stands) are set at the corners, while the clerestory windows are positioned within each facet of the octagon. The lack of vertical alignment adds to the visual interest of the building.

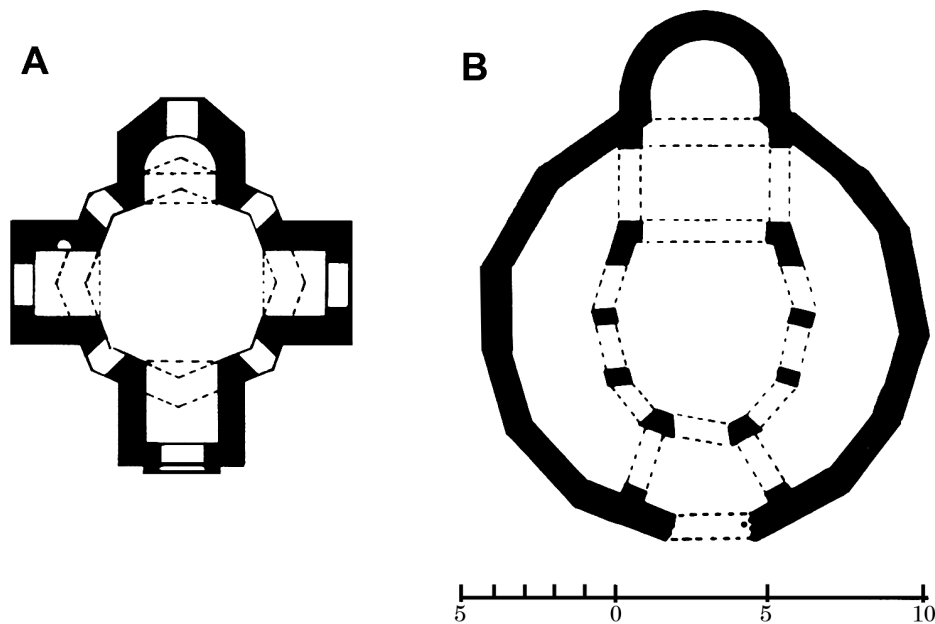
Fig. 6. Binbirkilise, plans of Churches 8 and 10 (after Gertrude Bell with author's modifications).

Church 10 was also centrally planned, but much more irregular than Church 8, and its masonry rougher (Figs 6B, 7).<sup>22</sup> Its lower level was partially standing when Bell cleared its interior and examined it. She was aided in her

Haynes’s photograph provides the missing details, although at first glance it is rather confusing. We see the building from the south, with its lower level standing the full length. The upper level of the outer wall stands only on the eastern (right) side, where it rises above a string course. To the west (left), the outer wall has fallen, and we see the rising inner wall, pierced by small rectangular windows at the gallery level, as noted by Davis. Immediately below this is the rubble extrados of the annular barrel vault covering the ambulatory on the lower level. To the west and east, Bell indicated pilasters engaged to the outer wall flanking the entrance and the apse, with arches connecting to the piers at the ends of the arcades (Fig. 6B, with author’s modifications). Haynes photograph shows vaulting on the upper level in both of these bays. The apse
