Δελτίον ΧΑΕ 34 (2013), Περίοδος Δ'. Στη μνήμη του Τίτου Παπαμαστοράκη (1961-2010)

Robert OUSTERHOUT

BİNBİRKİLİSE REVISITED: THE 1887 PHOTOGRAPHS OF JOHN HENRY HAYNES

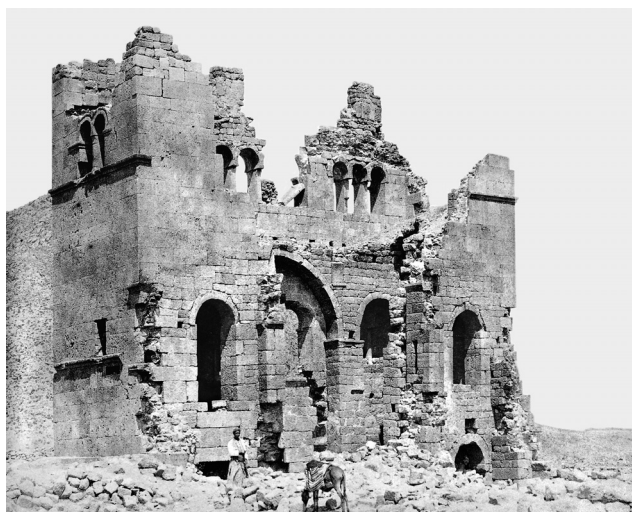
Fig. 4. Binbirkilise, view of the ruins of Church 13, seen from the northwest, by John Henry Haynes, 1887 (Harvard University, Aga Khan Visual Resources).

views provide our only photographic record of it, including a detailed view of the standing remains (Fig. 4).

ble inside the narthex of Church 13. These are of different character, with the inner thickness rougher than the outer and supporting a transverse barrel vault. Directly behind the remains of the vault, putlog holes appear in the inner west wall, four stone courses below the gallery windows. The details suggest that the separation between the two levels of the narthex was originally a wooden floor, but that this was replaced by vaulting at a later date. Ramsay and Bell had observed similar evidence of rebuilding elsewhere, which they attributed to a period of revival, *ca.* 850-1070, following widespread destruction during the Arab incursions. As what is visible appears to be an insertion into a standing building rather than the repair or reconstruction of a damaged building, this more likely represents the updating of a building that had existed over a long period of time.¹⁷

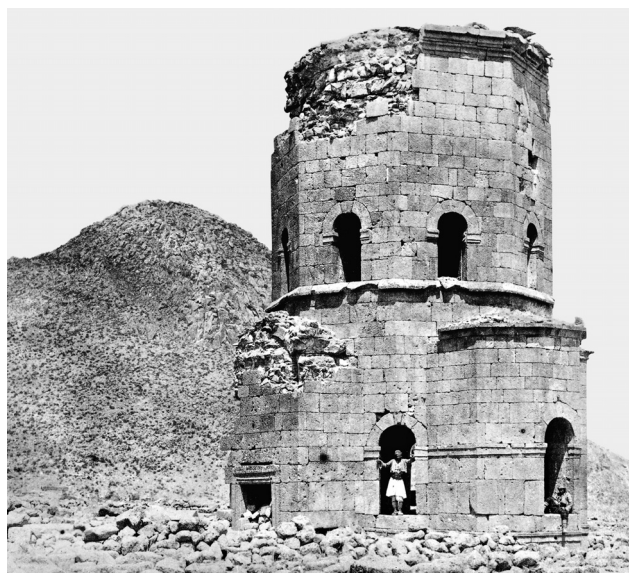
Fig. 5. Binbirkilise, view of the ruins of Church 8, seen from the northwest, by John Henry Haynes, 1887 (Harvard University, Aga Khan Visual Resources).

Impressively, Church 8 stands its full height, its domed octagonal core amplified with barrel-vaulted projections on three sides and an apse on the fourth (Figs 5, 6A). Church 8 has long been of interest to scholars because of its similarities to the martyrion described by Gregory of Nyssa.¹⁸ Haynes's photograph confirms that this was, indeed, an impressive building, and typical of Haynes, he poses his traveling companions in the windows. Seen from the southeast, the faceted apse projects to the right, terminating in a single arched window. The transept arm extend-

ing to the left terminates in a door. The central octagon rises through a clerestory zone below the dome, disguised behind the rising walls of the octagon. Where the facing has fallen away, the mortared rubble core of the wall is exposed. The octagon is rotated so that its corners, rather than its flat walls, are on axis. As a consequence, the lower diagonal windows (where one of Haynes's companions stands) are set at the corners, while the clerestory windows are positioned within each facet of the octagon. The lack of vertical alignment adds to the visual interest of the building.

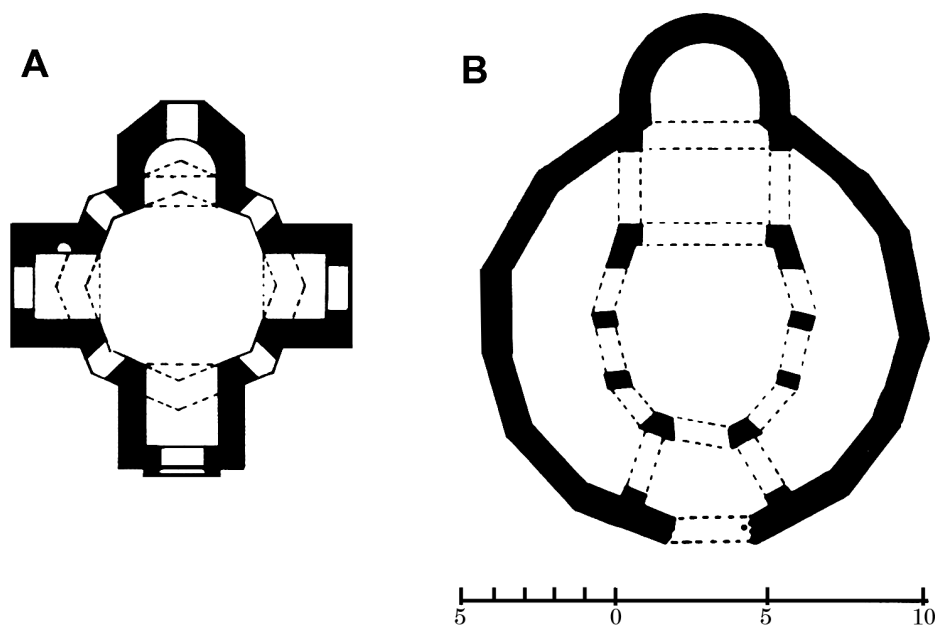
Fig. 6. Binbirkilise, plans of Churches 8 and 10 (after Gertrude Bell with author's modifications).

Church 10 was also centrally planned, but much more irregular than Church 8, and its masonry rougher (Figs 6B, 7).²² Its lower level was partially standing when Bell cleared its interior and examined it. She was aided in her
