Δελτίον ΧΑΕ 34 (2013), Περίοδος Δ'. Στη μνήμη του Τίτου Παπαμαστοράκη (1961-2010)

**Επανεξετάζοντας την τοποθεσία Binbirkilise: Οι φωτογραφίες του John Henry Haynes του 1887**

## BİNBİRKİLİSE REVISITED: THE 1887 PHOTOGRAPHS OF JOHN HENRY HAYNES

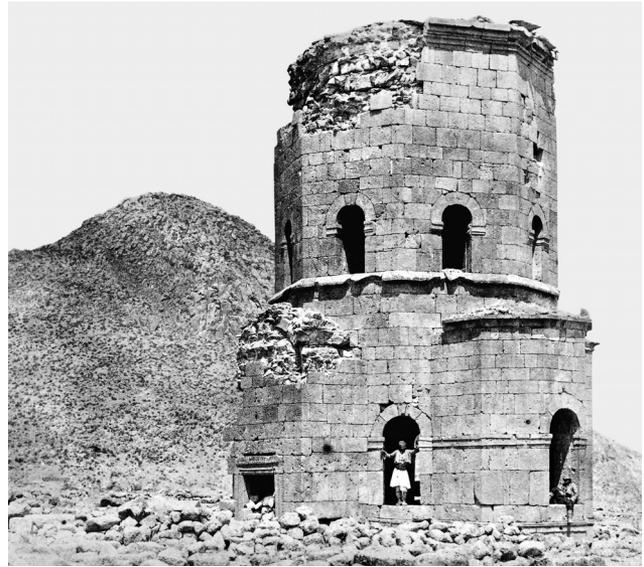
Fig. 5. Binbirkilise, view of the ruins of Church 8, seen from the northwest, by John Henry Haynes, 1887 (Harvard University, Aga Khan Visual Resources).

Impressively, Church 8 stands its full height, its domed octagonal core amplified with barrel-vaulted projections on three sides and an apse on the fourth (Figs 5, 6A). Church 8 has long been of interest to scholars because of its similarities to the martyrion described by Gregory of Nysa.<sup>18</sup> Haynes's photograph confirms that this was, indeed, an impressive building, and typical of Haynes, he poses his traveling companions in the windows. Seen from the southeast, the faceted apse projects to the right, terminating in a single arched window. The transept arm extend-

ing to the left terminates in a door. The central octagon rises through a clerestory zone below the dome, disguised behind the rising walls of the octagon. Where the facing has fallen away, the mortared rubble core of the wall is exposed. The octagon is rotated so that its corners, rather than its flat walls, are on axis. As a consequence, the lower diagonal windows (where one of Haynes's companions stands) are set at the corners, while the clerestory windows are positioned within each facet of the octagon. The lack of vertical alignment adds to the visual interest of the building.

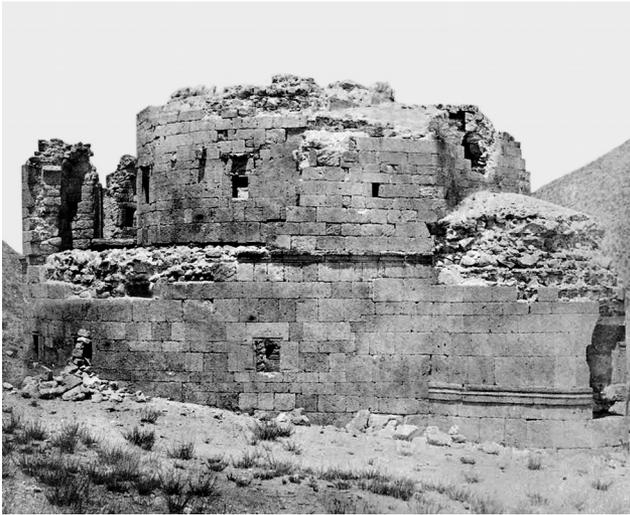
Fig. 7. Binbirkilise, Church 10 seen from the southeast, by John Henry Haynes, 1887 (Harvard University, Aga Khan Visual Resources).

Church 10 was also centrally planned, but much more irregular than Church 8, and its masonry rougher (Figs 6B, 7).<sup>22</sup> Its lower level was partially standing when Bell cleared its interior and examined it. She was aided in her

Haynes’s photograph shows the church from the south with its apse to the right. His caption calls it “A ruined Building (Church?) with twelve sides and an apse.” The building is actually fourteen-sided, with the apse taking one side of the polygon, and while solidly built, it was very irregular. The central space is oval – actually an irregular octagon, flanked by triple arcades to the north and south. Bell had cleaned the interior to clarify the plan, but by 1907 much of the upper level had disappeared, and she was hard pressed to match Davis’s description to the standing remains. Where, for example, is the “small door to the north?” She suggests, rather tentatively, that the internal arcades are Davis’s pentagonal screen. Nor do the windows match Davis’s description.

Haynes’s photograph provides the missing details, although at first glance it is rather confusing. We see the building from the south, with its lower level standing the full length. The upper level of the outer wall stands only on the eastern (right) side, where it rises above a string course. To the west (left), the outer wall has fallen, and we see the rising inner wall, pierced by small rectangular windows at the gallery level, as noted by Davis. Immediately below this is the rubble extrados of the annular barrel vault covering the ambulatory on the lower level. To the west and east, Bell indicated pilasters engaged to the outer wall flanking the entrance and the apse, with arches connecting to the piers at the ends of the arcades (Fig. 6B, with author’s modifications). Haynes photograph shows vaulting on the upper level in both of these bays. The apse

must have had a tall, vaulted sanctuary bay preceding it, opening to the central octagon. Davis’s four small rectangular windows, just below “the cupola of the apse,” may have been in the east wall of this bay, above the vault of the apse, rather than in the apse itself. If the sanctuary vault opened directly into the central space, Davis’s “pentagonal screen on arches” may simply have been the upper level wall, pierced by (most likely) five windows. Within the gallery, stone corbels appear immediately above the square windows, but there is no evidence of vaulting. We may assume these areas were covered by raking wooden roofs.
