Δελτίον ΧΑΕ 34 (2013), Περίοδος Δ'. Στη μνήμη του Τίτου Παπαμαστοράκη (1961-2010)

Επανεξετάζοντας την τοποθεσία Binbirkilise: Οι φωτογραφίες του John Henry Haynes του 1887

Robert Ousterhout

BİNBİRKİLİSE REVISITED: THE 1887 PHOTOGRAPHS OF JOHN HENRY HAYNES

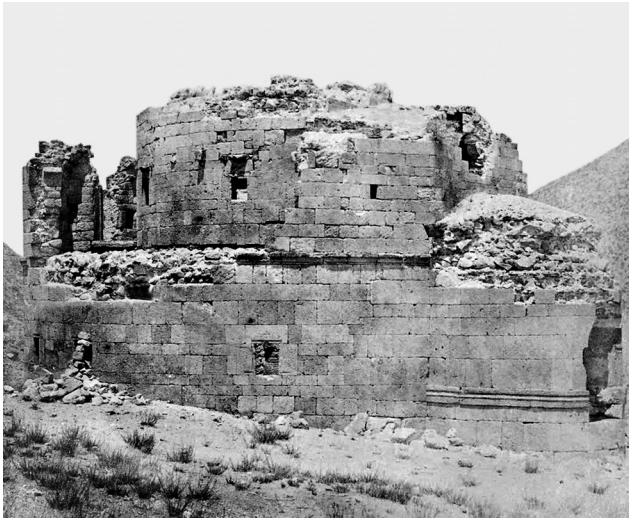
Fig. 7. Binbirkilise, Church 10 seen from the southeast, by John Henry Haynes, 1887 (Harvard University, Aga Khan Visual Resources).

Church 10 was also centrally planned, but much more irregular than Church 8, and its masonry rougher (Figs 6B, 7).²² Its lower level was partially standing when Bell cleared its interior and examined it. She was aided in her

Haynes’s photograph shows the church from the south with its apse to the right. His caption calls it “A ruined Building (Church?) with twelve sides and an apse.” The building is actually fourteen-sided, with the apse taking one side of the polygon, and while solidly built, it was very irregular. The central space is oval – actually an irregular octagon, flanked by triple arcades to the north and south. Bell had cleaned the interior to clarify the plan, but by 1907 much of the upper level had disappeared, and she was hard pressed to match Davis’s description to the standing remains. Where, for example, is the “small door to the north?” She suggests, rather tentatively, that the internal arcades are Davis’s pentagonal screen. Nor do the windows match Davis’s description.

Haynes’s photograph provides the missing details, although at first glance it is rather confusing. We see the building from the south, with its lower level standing the full length. The upper level of the outer wall stands only on the eastern (right) side, where it rises above a string course. To the west (left), the outer wall has fallen, and we see the rising inner wall, pierced by small rectangular windows at the gallery level, as noted by Davis. Immediately below this is the rubble extrados of the annular barrel vault covering the ambulatory on the lower level. To the west and east, Bell indicated pilasters engaged to the outer wall flanking the entrance and the apse, with arches connecting to the piers at the ends of the arcades (Fig. 6B, with author’s modifications). Haynes photograph shows vaulting on the upper level in both of these bays. The apse

must have had a tall, vaulted sanctuary bay preceding it, opening to the central octagon. Davis’s four small rectangular windows, just below “the cupola of the apse,” may have been in the east wall of this bay, above the vault of the apse, rather than in the apse itself. If the sanctuary vault opened directly into the central space, Davis’s “pentagonal screen on arches” may simply have been the upper level wall, pierced by (most likely) five windows. Within the gallery, stone corbels appear immediately above the square windows, but there is no evidence of vaulting. We may assume these areas were covered by raking wooden roofs.

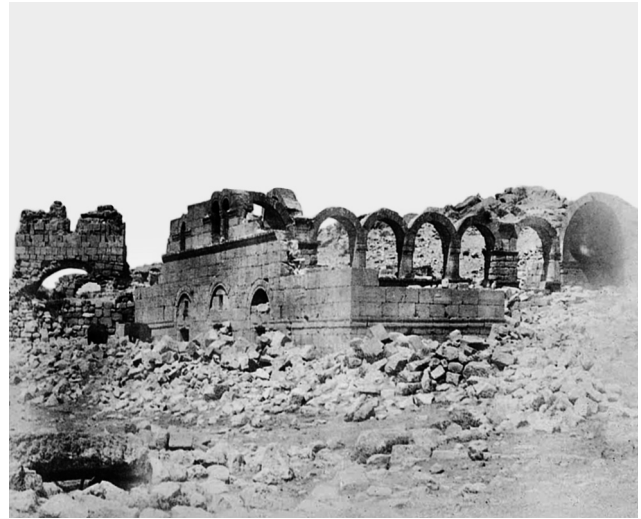
Fig. 8. Binbirkilise, Churches 32 and 39 seen from the southwest, by John Henry Haynes, 1887 (Harvard University, Aga Khan Visual Resources).

Haynes included a single photograph from the upper city of Değle in his folio, showing Churches 32 and 39 from the southwest (Fig. 8). Both are unique buildings at Binbirkilise, as Bell observed.²⁶ Church 32 is a three-aisled basilica with galleries. Haynes’s view shows the arcade of the north gallery fully intact, as well as the vault of the apse, faded on the right side of the photograph. Portions of the narthex gallery are still standing as well. These features were still visible to Crowfoot but partially damaged by the time Bell recorded them.²⁷ By 1909 Bell reported all the upper portions of the building had fallen. The broad west façade of the church had three portals set within arches, and its width was extended by chambers projecting to the north and south; the south chamber is clearly visible in the foreground of Haynes’s photograph.

Church 39, visible in the background, is probably not a church, but a nine-bayed, cross-in-square hall, quite different in character and date from the neighboring church. A central tower rose above the lower vaults, its the surviving wall detailed with niches and bands of brick. This is most likely a construction of the Middle Byzantine period and corresponds to a variety of centrally planned halls
