Δελτίον ΧΑΕ 34 (2013), Περίοδος Δ'. Στη μνήμη του Τίτου Παπαμαστοράκη (1961-2010)

**Επανεξετάζοντας την τοποθεσία Binbirkilise: Οι φωτογραφίες του John Henry Haynes του 1887**

Robert Ousterhout

## BİNBİRKİLİSE REVISITED: THE 1887 PHOTOGRAPHS OF JOHN HENRY HAYNES

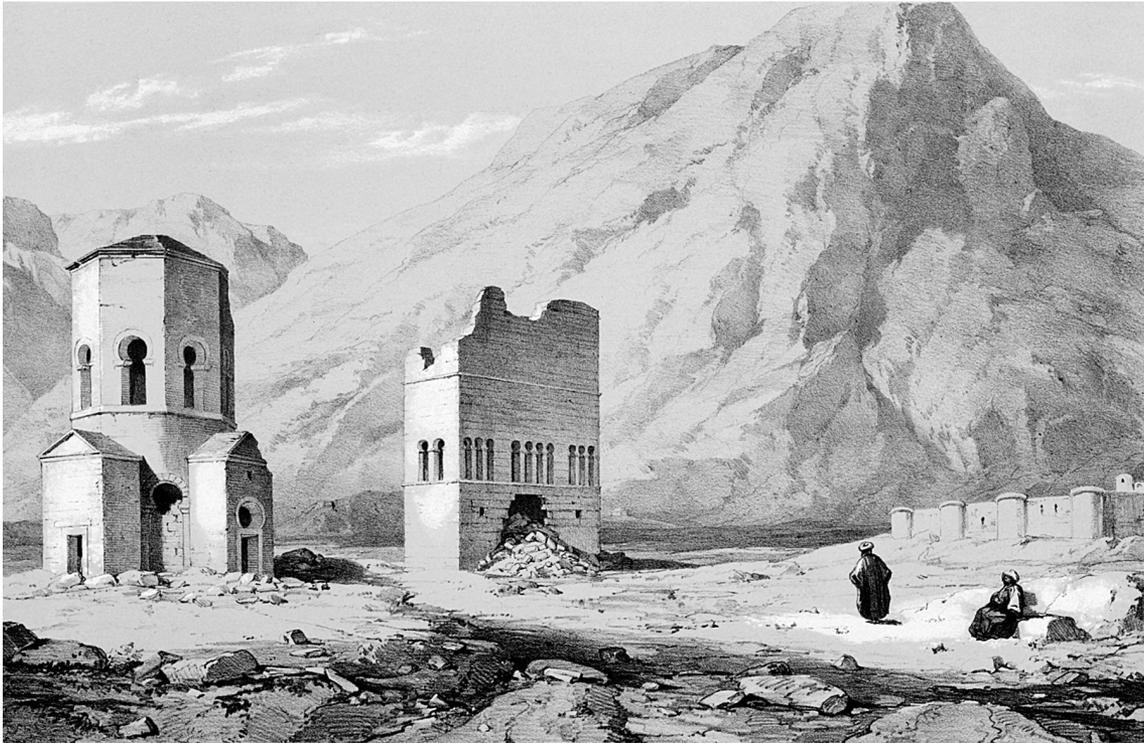
Fig. 1. Binbirkilise, view of Churches 8 and 13 seen from the northwest, by Léon de Laborde, 1826.

Our earliest graphic representations of the site come from the 1826 visit of Léon de Laborde, whose romantic views emphasize the barrenness of the site while exaggerating and regularizing the features of the standing remains (Fig. 1).<sup>2</sup> Other scholars had visited the site but

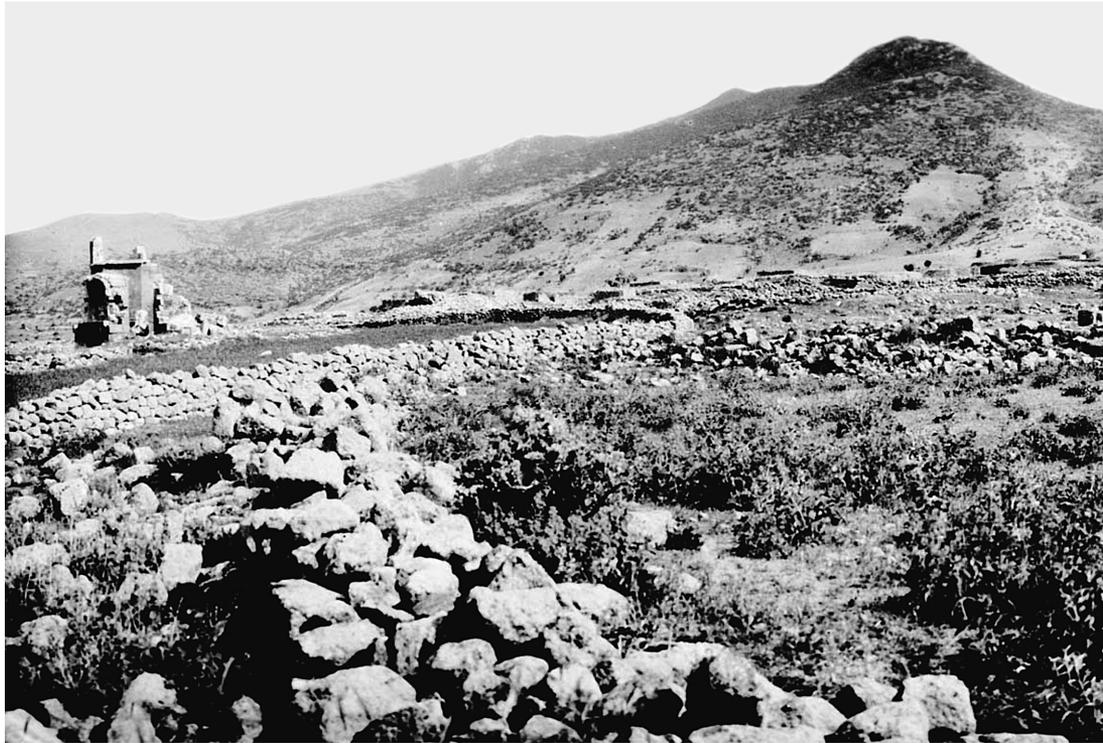
Fig. 2. Binbirkilise, view of the ruins of Churches 8 and 13, seen from the northwest, by Gertrude Bell, 1907 (courtesy of the University of Newcastle Gertrude Bell Archive).

tion of the site with Sir William M. Ramsay (Fig. 2).<sup>5</sup> Bell's analysis of the architecture is the most complete and remains authoritative. While she incorporated the observations of earlier visitors into her study of the architecture, their accounts provide little evidence not visible to her during her time at the site. Many of the buildings in the lower city had fallen sometime between Laborde's visit and Bell's, and it is often assumed to be the result of gradual deterioration over time. As Ramsay commented, "The destruction of this ancient city has proceeded comparatively slowly, but it goes on steadily."<sup>6</sup> Ramsay had first examined the site with Sir Charles Wilson in 1882, but his account places the destruction of the monuments considerably later. For example, he writes, "Church 8 was

Haynes's photograph of Churches 8 and 13 (Fig. 3) is taken from the southeast rather than the southwest, as were the views of Bell and Laborde. By the time Bell had arrived on the scene, Church 8 had fallen but was still recognizable, while Church 13 was nothing but a pile of rubble – so much so that Bell didn't bother to record it.<sup>15</sup> In Bell's photograph (Fig. 2), its foundations appear immediately to the right of Church 8, just behind the rock fence. Haynes's

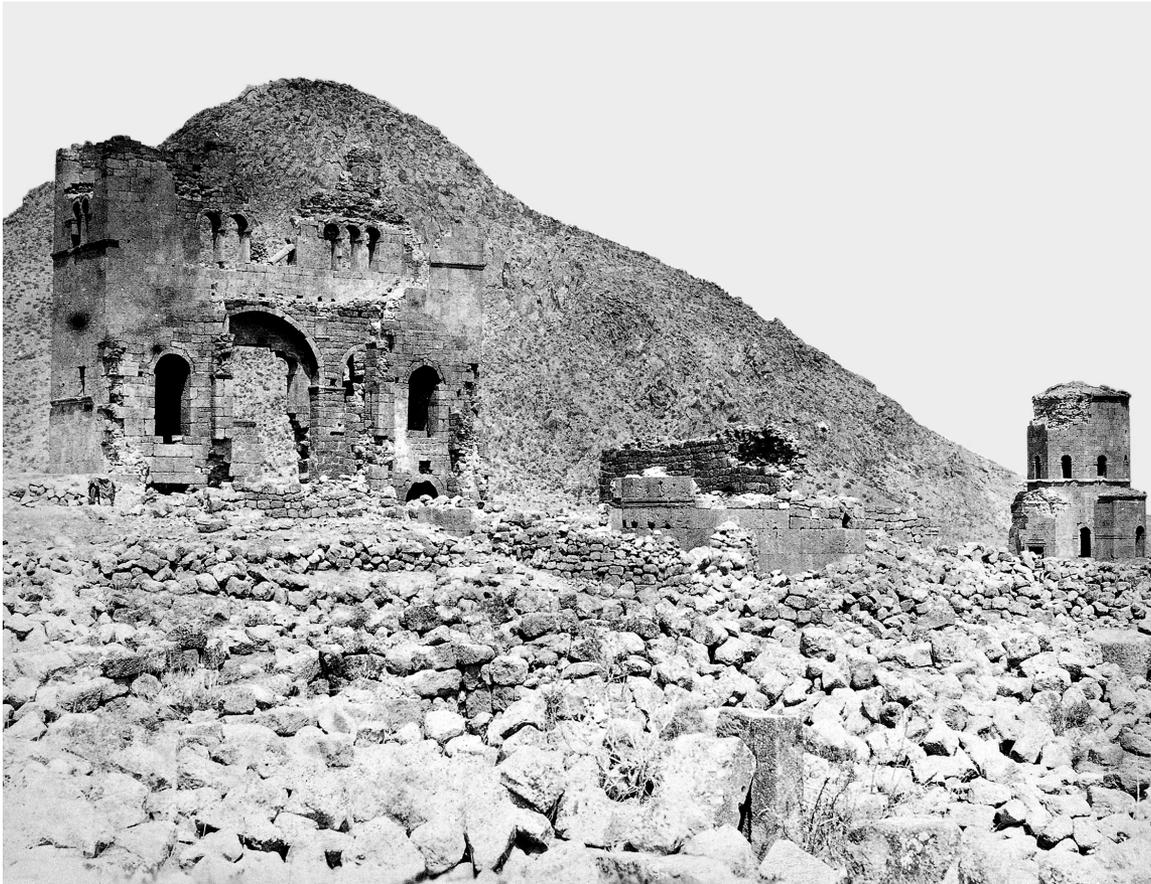
Fig. 3. Binbirkilise, view of the ruins of Churches 8 and 13, seen from the southeast, by John Henry Haynes, 1887 (Harvard University, Aga Khan Visual Resources).

Church 13 may be reconstructed as a basilica with a two-storied narthex. While Laborde had depicted the west façade of the building, representing it as a simple, rectangular tower, Haynes shows the inner wall, where the narthex once joined to the nave, with walls extending from it to the east. In our Fig. 3, the narthex stands almost its full height, to the left, while the remains of the apse appear between it and Church 8, in the distance to the right. Changes in the masonry surface of the narthex block indicate the position of the angled roofs of the side aisles, allowing the restitution of the building as a three-aisled basilica with the nave rising above the level of the side aisles. This is in contrast to what Bell calls a "barn church," in which the side aisles and nave rise to the same height, and a clerestory would not have been possible.<sup>16</sup> Both types existed side-by-side at Binbirkilise.

The last detail is probably the remnant of a system of tie beams to brace the dome, rather than a false ceiling. By the time of Bell's analysis, all traces of the wooden bracing had disappeared, along with the dome. And while the apse was covered by a half-dome, the projecting porches must have been covered by barrel vaults, not cupolas. The description of the building as a "tower" conforms to the visual impression recorded by Haynes. Holzmann, who drew a reconstruction of the church in 1904, supposed the octagon to have been covered by a cloister vault that was exposed on the exterior, but this is clearly incorrect.<sup>20</sup> Our Fig. 3 shows the remains of a shallow pyramidal roof, which is how Restle has reconstructed it.<sup>21</sup>

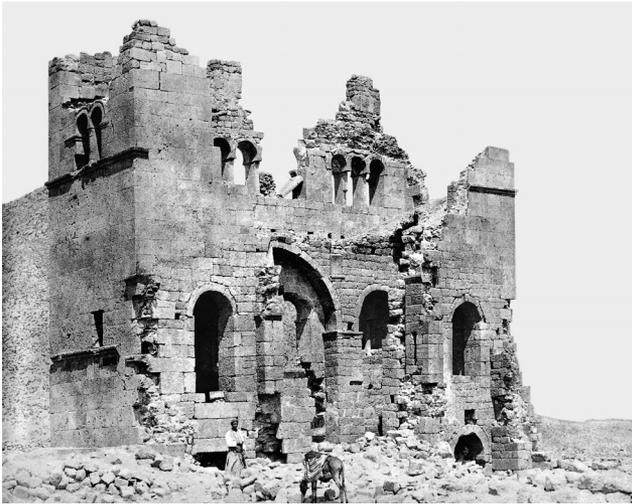
Fig. 4. Binbirkilise, view of the ruins of Church 13, seen from the northwest, by John Henry Haynes, 1887 (Harvard University, Aga Khan Visual Resources).

views provide our only photographic record of it, including a detailed view of the standing remains (Fig. 4).

ble inside the narthex of Church 13. These are of different character, with the inner thickness rougher than the outer and supporting a transverse barrel vault. Directly behind the remains of the vault, putlog holes appear in the inner west wall, four stone courses below the gallery windows. The details suggest that the separation between the two levels of the narthex was originally a wooden floor, but that this was replaced by vaulting at a later date. Ramsay and Bell had observed similar evidence of rebuilding elsewhere, which they attributed to a period of revival, *ca.* 850-1070, following widespread destruction during the Arab incursions. As what is visible appears to be an insertion into a standing building rather than the repair or reconstruction of a damaged building, this more likely represents the updating of a building that had existed over a long period of time.<sup>17</sup>

from the central bay, with limited access from the side aisles. At Church 13, there is no indication of an internal division within the narthex, while the access from the side aisles is not entirely clear. The large arched openings seem to be windows between interior spaces, with low passageways beneath them. That to the south is covered by a lintel, while that to the north is arched. Without a sense of the original ground level, however, it is impossible to determine just how low these openings were.

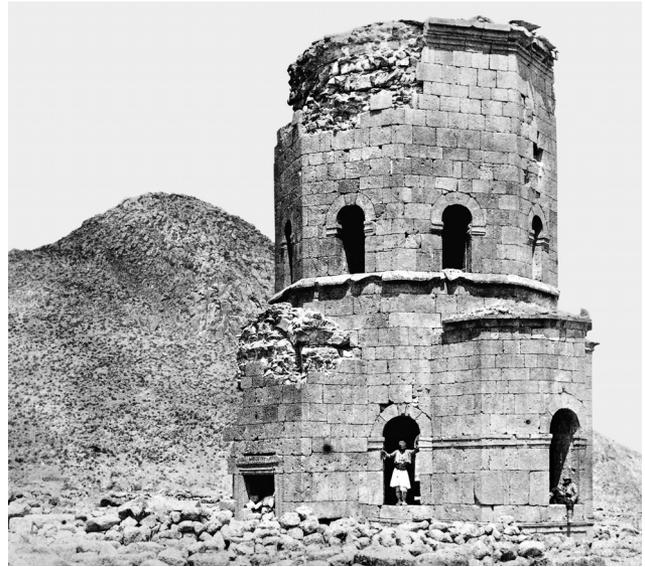
Fig. 5. Binbirkilise, view of the ruins of Church 8, seen from the northwest, by John Henry Haynes, 1887 (Harvard University, Aga Khan Visual Resources).

Impressively, Church 8 stands its full height, its domed octagonal core amplified with barrel-vaulted projections on three sides and an apse on the fourth (Figs 5, 6A). Church 8 has long been of interest to scholars because of its similarities to the martyrion described by Gregory of Nysa.<sup>18</sup> Haynes's photograph confirms that this was, indeed, an impressive building, and typical of Haynes, he poses his traveling companions in the windows. Seen from the southeast, the faceted apse projects to the right, terminating in a single arched window. The transept arm extend-

ing to the left terminates in a door. The central octagon rises through a clerestory zone below the dome, disguised behind the rising walls of the octagon. Where the facing has fallen away, the mortared rubble core of the wall is exposed. The octagon is rotated so that its corners, rather than its flat walls, are on axis. As a consequence, the lower diagonal windows (where one of Haynes's companions stands) are set at the corners, while the clerestory windows are positioned within each facet of the octagon. The lack of vertical alignment adds to the visual interest of the building.

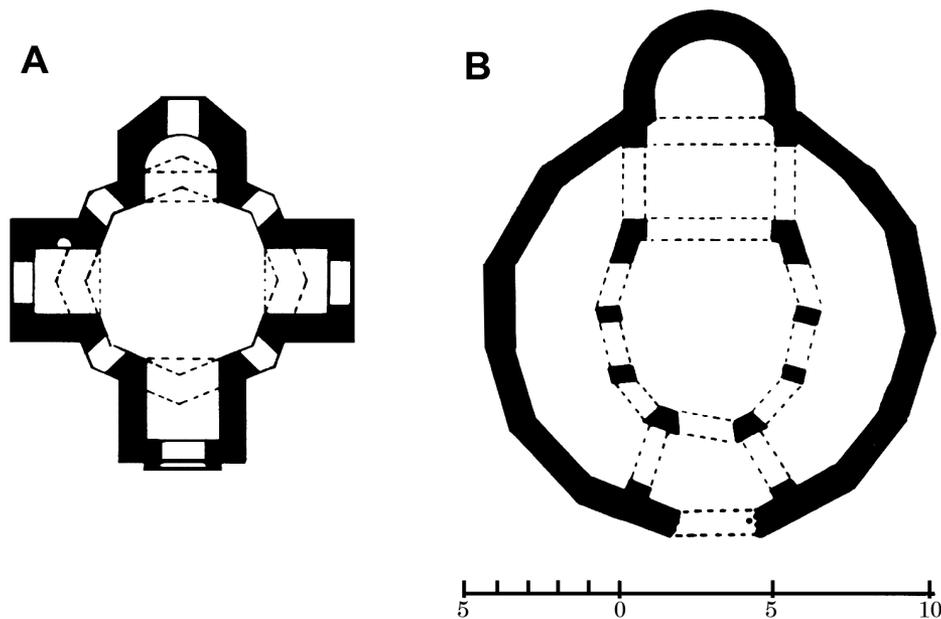
Fig. 6. Binbirkilise, plans of Churches 8 and 10 (after Gertrude Bell with author's modifications).

Church 10 was also centrally planned, but much more irregular than Church 8, and its masonry rougher (Figs 6B, 7).<sup>22</sup> Its lower level was partially standing when Bell cleared its interior and examined it. She was aided in her

Haynes’s photograph provides the missing details, although at first glance it is rather confusing. We see the building from the south, with its lower level standing the full length. The upper level of the outer wall stands only on the eastern (right) side, where it rises above a string course. To the west (left), the outer wall has fallen, and we see the rising inner wall, pierced by small rectangular windows at the gallery level, as noted by Davis. Immediately below this is the rubble extrados of the annular barrel vault covering the ambulatory on the lower level. To the west and east, Bell indicated pilasters engaged to the outer wall flanking the entrance and the apse, with arches connecting to the piers at the ends of the arcades (Fig. 6B, with author’s modifications). Haynes photograph shows vaulting on the upper level in both of these bays. The apse

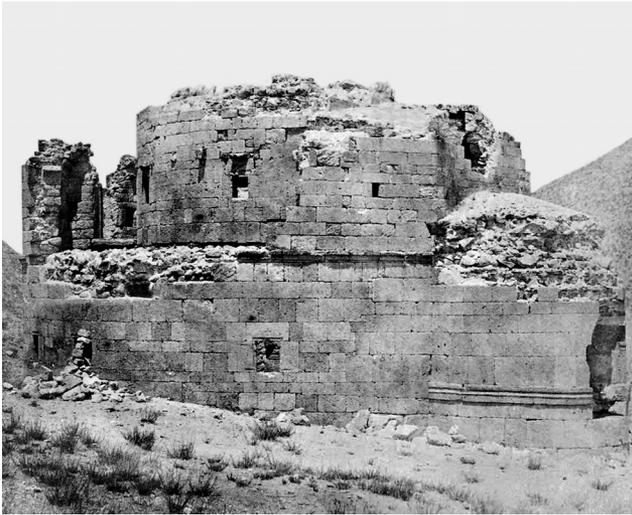
Fig. 7. Binbirkilise, Church 10 seen from the southeast, by John Henry Haynes, 1887 (Harvard University, Aga Khan Visual Resources).

Haynes’s photograph shows the church from the south with its apse to the right. His caption calls it “A ruined Building (Church?) with twelve sides and an apse.” The building is actually fourteen-sided, with the apse taking one side of the polygon, and while solidly built, it was very irregular. The central space is oval – actually an irregular octagon, flanked by triple arcades to the north and south. Bell had cleaned the interior to clarify the plan, but by 1907 much of the upper level had disappeared, and she was hard pressed to match Davis’s description to the standing remains. Where, for example, is the “small door to the north?” She suggests, rather tentatively, that the internal arcades are Davis’s pentagonal screen. Nor do the windows match Davis’s description.

must have had a tall, vaulted sanctuary bay preceding it, opening to the central octagon. Davis’s four small rectangular windows, just below “the cupola of the apse,” may have been in the east wall of this bay, above the vault of the apse, rather than in the apse itself. If the sanctuary vault opened directly into the central space, Davis’s “pentagonal screen on arches” may simply have been the upper level wall, pierced by (most likely) five windows. Within the gallery, stone corbels appear immediately above the square windows, but there is no evidence of vaulting. We may assume these areas were covered by raking wooden roofs.

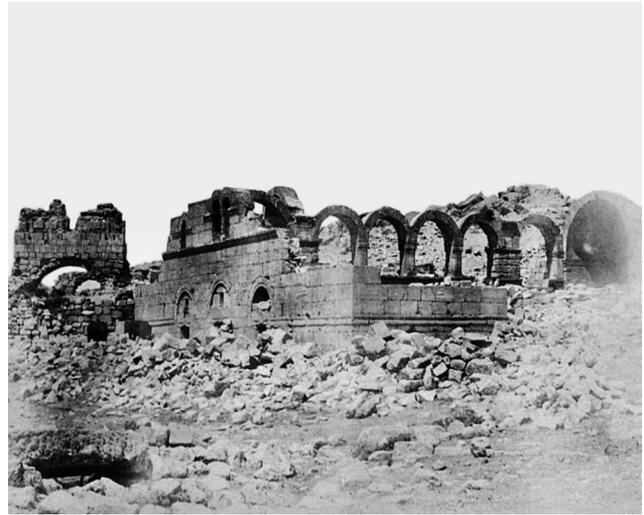
Fig. 8. Binbirkilise, Churches 32 and 39 seen from the southwest, by John Henry Haynes, 1887 (Harvard University, Aga Khan Visual Resources).

Haynes included a single photograph from the upper city of Değle in his folio, showing Churches 32 and 39 from the southwest (Fig. 8). Both are unique buildings at Binbirkilise, as Bell observed.<sup>26</sup> Church 32 is a three-aisled basilica with galleries. Haynes’s view shows the arcade of the north gallery fully intact, as well as the vault of the apse, faded on the right side of the photograph. Portions of the narthex gallery are still standing as well. These features were still visible to Crowfoot but partially damaged by the time Bell recorded them.<sup>27</sup> By 1909 Bell reported all the upper portions of the building had fallen. The broad west façade of the church had three portals set within arches, and its width was extended by chambers projecting to the north and south; the south chamber is clearly visible in the foreground of Haynes’s photograph.

Church 39, visible in the background, is probably not a church, but a nine-bayed, cross-in-square hall, quite different in character and date from the neighboring church. A central tower rose above the lower vaults, its the surviving wall detailed with niches and bands of brick. This is most likely a construction of the Middle Byzantine period and corresponds to a variety of centrally planned halls
