Δελτίον ΧΑΕ 34 (2013), Περίοδος Δ'. Στη μνήμη του Τίτου Παπαμαστοράκη (1961-2010)

**Επανεξετάζοντας την τοποθεσία Binbirkilise: Οι φωτογραφίες του John Henry Haynes του 1887**

## BİNBİRKİLİSE REVISITED: THE 1887 PHOTOGRAPHS OF JOHN HENRY HAYNES

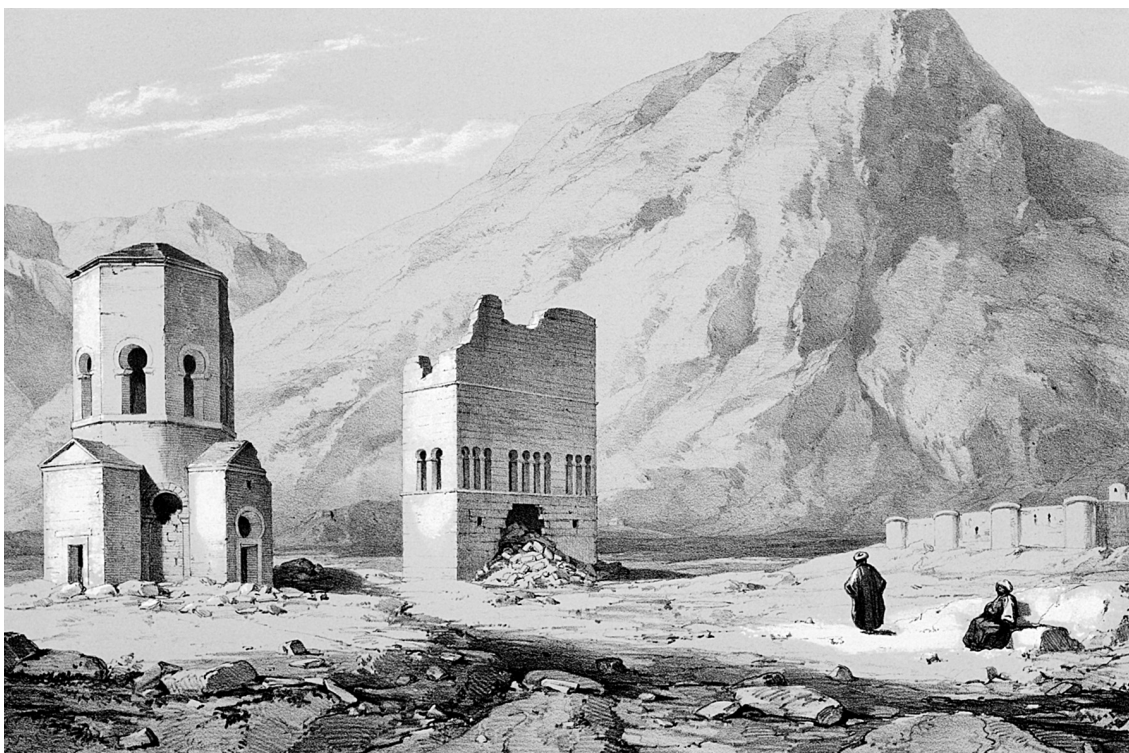
Fig. 1. Binbirkilise, view of Churches 8 and 13 seen from the northwest, by Léon de Laborde, 1826.

Our earliest graphic representations of the site come from the 1826 visit of Léon de Laborde, whose romantic views emphasize the barrenness of the site while exaggerating and regularizing the features of the standing remains (Fig. 1).<sup>2</sup> Other scholars had visited the site but

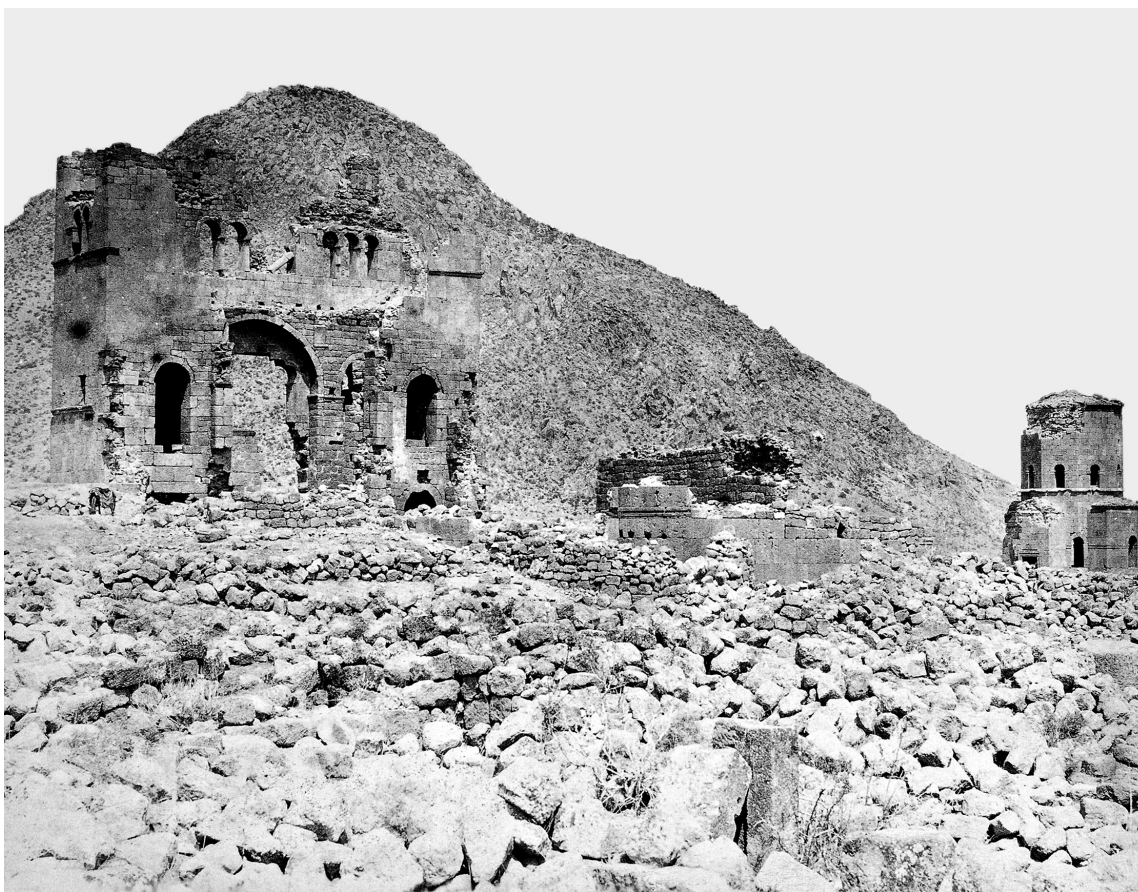
Fig. 3. Binbirkilise, view of the ruins of Churches 8 and 13, seen from the southeast, by John Henry Haynes, 1887 (Harvard University, Aga Khan Visual Resources).

Haynes's photograph of Churches 8 and 13 (Fig. 3) is taken from the southeast rather than the southwest, as were the views of Bell and Laborde. By the time Bell had arrived on the scene, Church 8 had fallen but was still recognizable, while Church 13 was nothing but a pile of rubble – so much so that Bell didn't bother to record it.<sup>15</sup> In Bell's photograph (Fig. 2), its foundations appear immediately to the right of Church 8, just behind the rock fence. Haynes's

Church 13 may be reconstructed as a basilica with a two-storied narthex. While Laborde had depicted the west façade of the building, representing it as a simple, rectangular tower, Haynes shows the inner wall, where the narthex once joined to the nave, with walls extending from it to the east. In our Fig. 3, the narthex stands almost its full height, to the left, while the remains of the apse appear between it and Church 8, in the distance to the right. Changes in the masonry surface of the narthex block indicate the position of the angled roofs of the side aisles, allowing the restitution of the building as a three-aisled basilica with the nave rising above the level of the side aisles. This is in contrast to what Bell calls a "barn church," in which the side aisles and nave rise to the same height, and a clerestory would not have been possible.<sup>16</sup> Both types existed side-by-side at Binbirkilise.

The last detail is probably the remnant of a system of tie beams to brace the dome, rather than a false ceiling. By the time of Bell's analysis, all traces of the wooden bracing had disappeared, along with the dome. And while the apse was covered by a half-dome, the projecting porches must have been covered by barrel vaults, not cupolas. The description of the building as a "tower" conforms to the visual impression recorded by Haynes. Holzmann, who drew a reconstruction of the church in 1904, supposed the octagon to have been covered by a cloister vault that was exposed on the exterior, but this is clearly incorrect.<sup>20</sup> Our Fig. 3 shows the remains of a shallow pyramidal roof, which is how Restle has reconstructed it.<sup>21</sup>
