Δελτίον ΧΑΕ 34 (2013), Περίοδος Δ'. Στη μνήμη του Τίτου Παπαμαστοράκη (1961-2010)

Robert OUSTERHOUT

BİNBİRKİLİSE REVISITED: THE 1887 PHOTOGRAPHS OF JOHN HENRY HAYNES

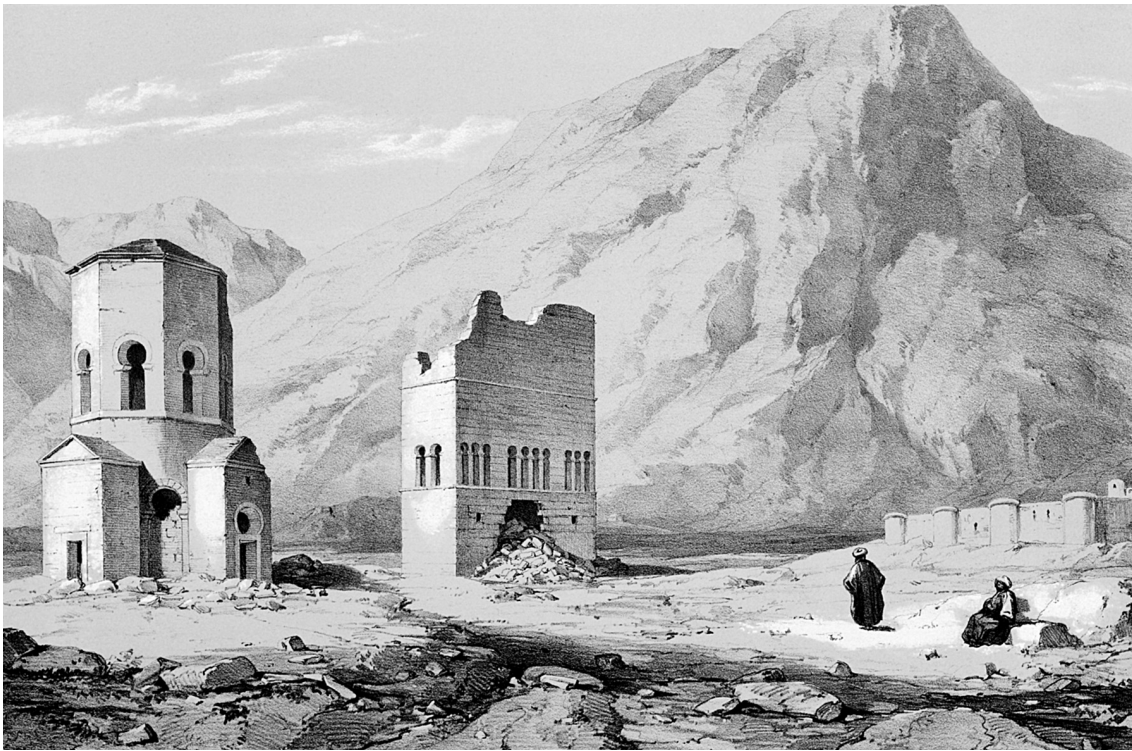
Fig. 1. Binbirkilise, view of Churches 8 and 13 seen from the northwest, by Léon de Laborde, 1826.

Our earliest graphic representations of the site come from the 1826 visit of Léon de Laborde, whose romantic views emphasize the barrenness of the site while exaggerating and regularizing the features of the standing remains (Fig. 1).² Other scholars had visited the site but

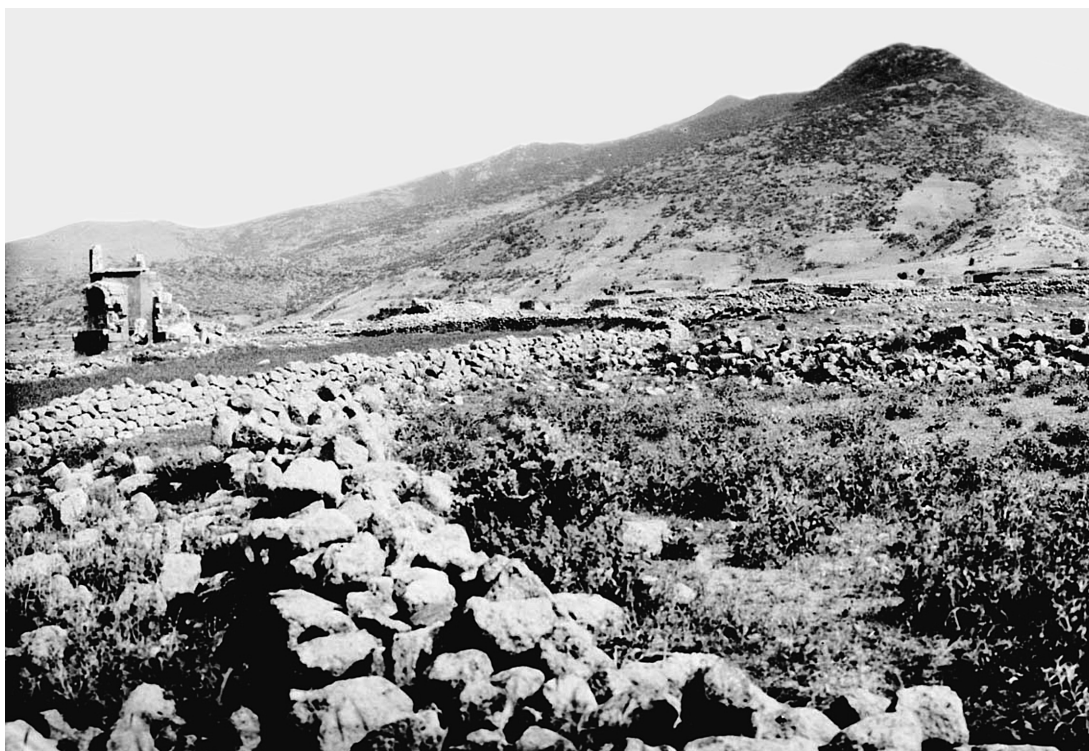
Fig. 2. Binbirkilise, view of the ruins of Churches 8 and 13, seen from the northwest, by Gertrude Bell, 1907 (courtesy of the University of Newcastle Gertrude Bell Archive).

tion of the site with Sir William M. Ramsay (Fig. 2).⁵ Bell's analysis of the architecture is the most complete and remains authoritative. While she incorporated the observations of earlier visitors into her study of the architecture, their accounts provide little evidence not visible to her during her time at the site. Many of the buildings in the lower city had fallen sometime between Laborde's visit and Bell's, and it is often assumed to be the result of gradual deterioration over time. As Ramsay commented, "The destruction of this ancient city has proceeded comparatively slowly, but it goes on steadily."⁶ Ramsay had first examined the site with Sir Charles Wilson in 1882, but his account places the destruction of the monuments considerably later. For example, he writes, "Church 8 was

Haynes's photograph of Churches 8 and 13 (Fig. 3) is taken from the southeast rather than the southwest, as were the views of Bell and Laborde. By the time Bell had arrived on the scene, Church 8 had fallen but was still recognizable, while Church 13 was nothing but a pile of rubble – so much so that Bell didn't bother to record it.¹⁵ In Bell's photograph (Fig. 2), its foundations appear immediately to the right of Church 8, just behind the rock fence. Haynes's

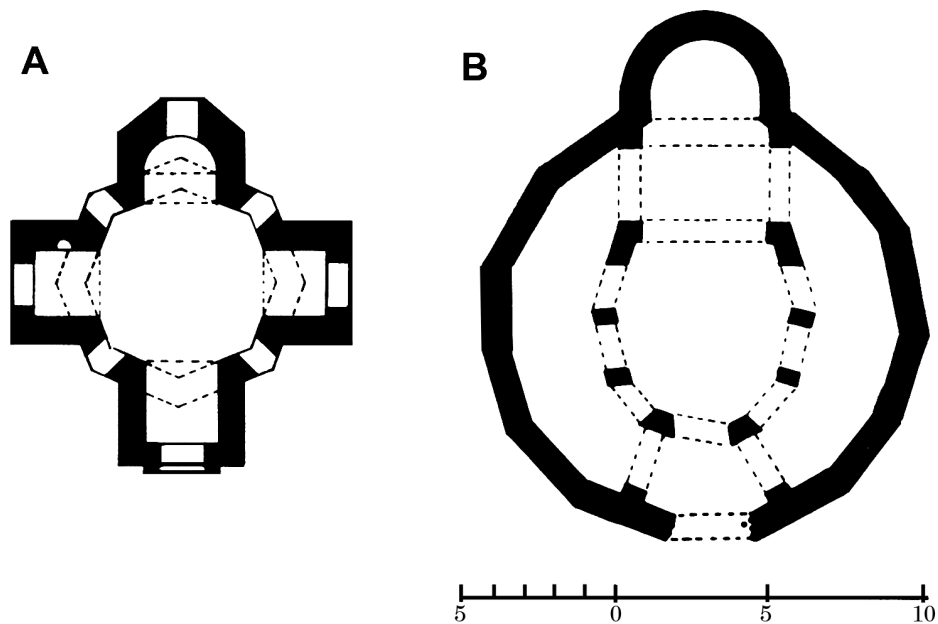
Fig. 6. Binbirkilise, plans of Churches 8 and 10 (after Gertrude Bell with author's modifications).

Impressively, Church 8 stands its full height, its domed octagonal core amplified with barrel-vaulted projections on three sides and an apse on the fourth (Figs 5, 6A). Church 8 has long been of interest to scholars because of its similarities to the martyrion described by Gregory of Nysa.¹⁸ Haynes's photograph confirms that this was, indeed, an impressive building, and typical of Haynes, he poses his traveling companions in the windows. Seen from the southeast, the faceted apse projects to the right, terminating in a single arched window. The transept arm extend-

Church 10 was also centrally planned, but much more irregular than Church 8, and its masonry rougher (Figs 6B, 7).²² Its lower level was partially standing when Bell cleared its interior and examined it. She was aided in her

Haynes’s photograph provides the missing details, although at first glance it is rather confusing. We see the building from the south, with its lower level standing the full length. The upper level of the outer wall stands only on the eastern (right) side, where it rises above a string course. To the west (left), the outer wall has fallen, and we see the rising inner wall, pierced by small rectangular windows at the gallery level, as noted by Davis. Immediately below this is the rubble extrados of the annular barrel vault covering the ambulatory on the lower level. To the west and east, Bell indicated pilasters engaged to the outer wall flanking the entrance and the apse, with arches connecting to the piers at the ends of the arcades (Fig. 6B, with author’s modifications). Haynes photograph shows vaulting on the upper level in both of these bays. The apse

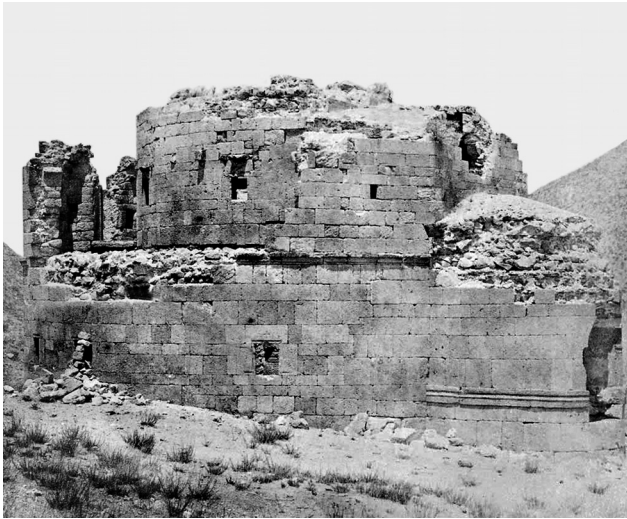
Fig. 7. Binbirkilise, Church 10 seen from the southeast, by John Henry Haynes, 1887 (Harvard University, Aga Khan Visual Resources).

Haynes’s photograph shows the church from the south with its apse to the right. His caption calls it “A ruined Building (Church?) with twelve sides and an apse.” The building is actually fourteen-sided, with the apse taking one side of the polygon, and while solidly built, it was very irregular. The central space is oval – actually an irregular octagon, flanked by triple arcades to the north and south. Bell had cleaned the interior to clarify the plan, but by 1907 much of the upper level had disappeared, and she was hard pressed to match Davis’s description to the standing remains. Where, for example, is the “small door to the north?” She suggests, rather tentatively, that the internal arcades are Davis’s pentagonal screen. Nor do the windows match Davis’s description.

must have had a tall, vaulted sanctuary bay preceding it, opening to the central octagon. Davis’s four small rectangular windows, just below “the cupola of the apse,” may have been in the east wall of this bay, above the vault of the apse, rather than in the apse itself. If the sanctuary vault opened directly into the central space, Davis’s “pentagonal screen on arches” may simply have been the upper level wall, pierced by (most likely) five windows. Within the gallery, stone corbels appear immediately above the square windows, but there is no evidence of vaulting. We may assume these areas were covered by raking wooden roofs.
