Δελτίον ΧΑΕ 34 (2013), Περίοδος Δ'. Στη μνήμη του Τίτου Παπαμαστοράκη (1961-2010)

Επανεξετάζοντας την τοποθεσία Binbirkilise: Οι φωτογραφίες του John Henry Haynes του 1887

Robert OUSTERHOUT

BİNBİRKİLİSE REVISITED: THE 1887 PHOTOGRAPHS OF JOHN HENRY HAYNES

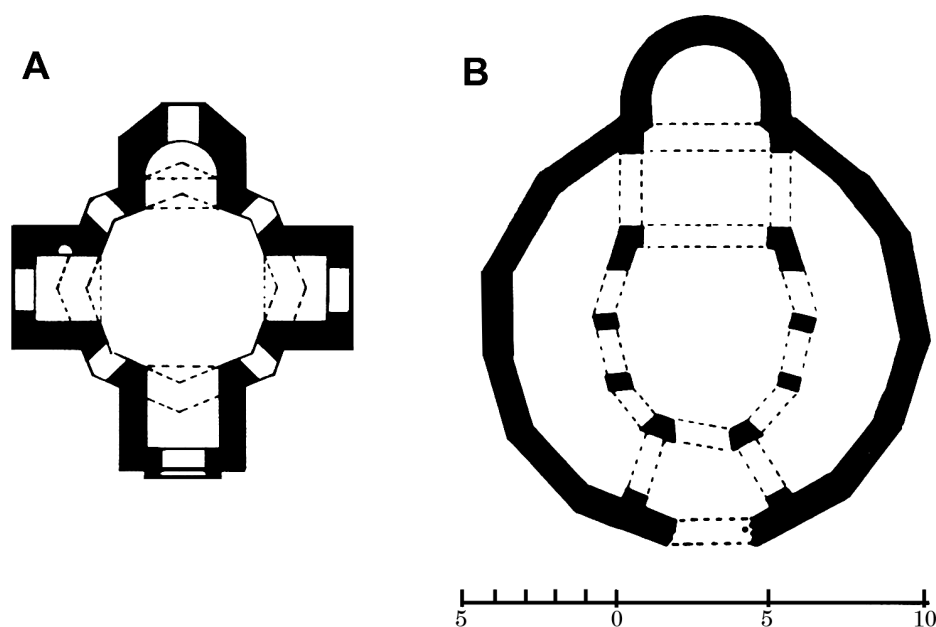
Fig. 6. Binbirkilise, plans of Churches 8 and 10 (after Gertrude Bell with author's modifications).

Impressively, Church 8 stands its full height, its domed octagonal core amplified with barrel-vaulted projections on three sides and an apse on the fourth (Figs 5, 6A). Church 8 has long been of interest to scholars because of its similarities to the martyrion described by Gregory of Nyssa.¹⁸ Haynes's photograph confirms that this was, indeed, an impressive building, and typical of Haynes, he poses his traveling companions in the windows. Seen from the southeast, the faceted apse projects to the right, terminating in a single arched window. The transept arm extend-

Church 10 was also centrally planned, but much more irregular than Church 8, and its masonry rougher (Figs 6B, 7).²² Its lower level was partially standing when Bell cleared its interior and examined it. She was aided in her

Haynes’s photograph provides the missing details, although at first glance it is rather confusing. We see the building from the south, with its lower level standing the full length. The upper level of the outer wall stands only on the eastern (right) side, where it rises above a string course. To the west (left), the outer wall has fallen, and we see the rising inner wall, pierced by small rectangular windows at the gallery level, as noted by Davis. Immediately below this is the rubble extrados of the annular barrel vault covering the ambulatory on the lower level. To the west and east, Bell indicated pilasters engaged to the outer wall flanking the entrance and the apse, with arches connecting to the piers at the ends of the arcades (Fig. 6B, with author’s modifications). Haynes photograph shows vaulting on the upper level in both of these bays. The apse
