Δελτίον ΧΑΕ 34 (2013), Περίοδος Δ'. Στη μνήμη του Τίτου Παπαμαστοράκη (1961-2010)

Επανεξετάζοντας την τοποθεσία Binbirkilise: Οι φωτογραφίες του John Henry Haynes του 1887

BİNBİRKİLİSE REVISITED: THE 1887 PHOTOGRAPHS OF JOHN HENRY HAYNES

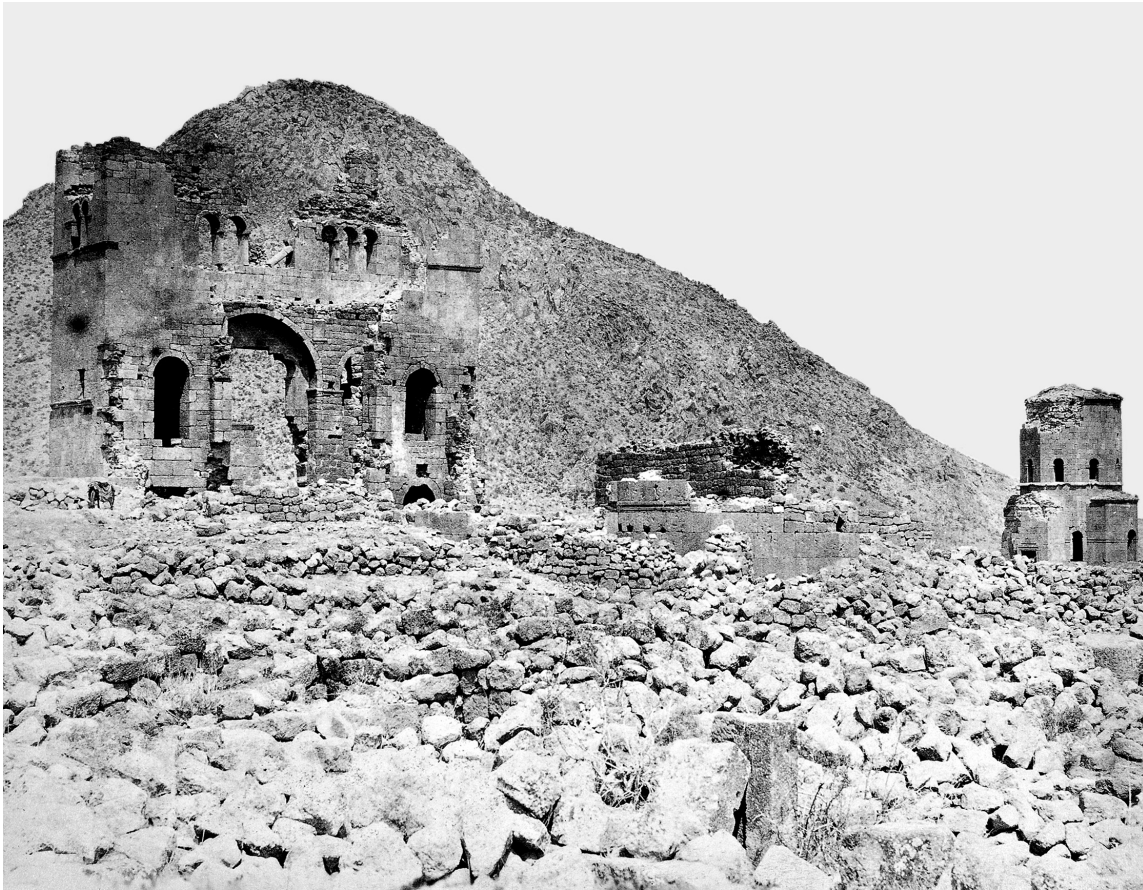
Fig. 3. Binbirkilise, view of the ruins of Churches 8 and 13, seen from the southeast, by John Henry Haynes, 1887 (Harvard University, Aga Khan Visual Resources).

Haynes's photograph of Churches 8 and 13 (Fig. 3) is taken from the southeast rather than the southwest, as were the views of Bell and Laborde. By the time Bell had arrived on the scene, Church 8 had fallen but was still recognizable, while Church 13 was nothing but a pile of rubble – so much so that Bell didn't bother to record it.¹⁵ In Bell's photograph (Fig. 2), its foundations appear immediately to the right of Church 8, just behind the rock fence. Haynes's

Church 13 may be reconstructed as a basilica with a two-storied narthex. While Laborde had depicted the west façade of the building, representing it as a simple, rectangular tower, Haynes shows the inner wall, where the narthex once joined to the nave, with walls extending from it to the east. In our Fig. 3, the narthex stands almost its full height, to the left, while the remains of the apse appear between it and Church 8, in the distance to the right. Changes in the masonry surface of the narthex block indicate the position of the angled roofs of the side aisles, allowing the restitution of the building as a three-aisled basilica with the nave rising above the level of the side aisles. This is in contrast to what Bell calls a "barn church," in which the side aisles and nave rise to the same height, and a clerestory would not have been possible.¹⁶ Both types existed side-by-side at Binbirkilise.

The last detail is probably the remnant of a system of tie beams to brace the dome, rather than a false ceiling. By the time of Bell's analysis, all traces of the wooden bracing had disappeared, along with the dome. And while the apse was covered by a half-dome, the projecting porches must have been covered by barrel vaults, not cupolas. The description of the building as a "tower" conforms to the visual impression recorded by Haynes. Holzmann, who drew a reconstruction of the church in 1904, supposed the octagon to have been covered by a cloister vault that was exposed on the exterior, but this is clearly incorrect.²⁰ Our Fig. 3 shows the remains of a shallow pyramidal roof, which is how Restle has reconstructed it.²¹

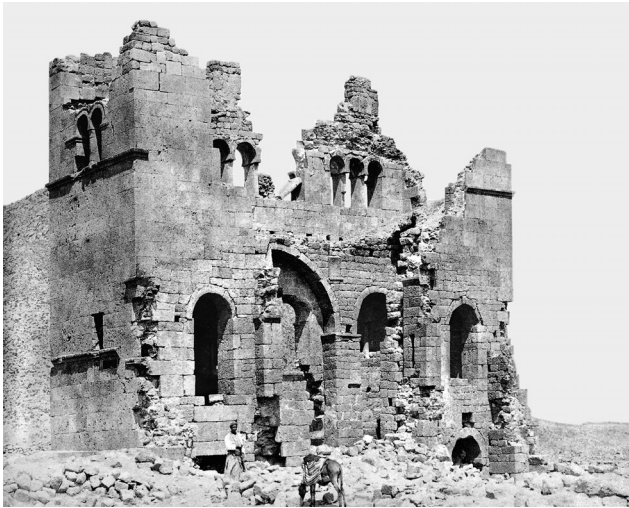
Fig. 4. Binbirkilise, view of the ruins of Church 13, seen from the northwest, by John Henry Haynes, 1887 (Harvard University, Aga Khan Visual Resources).

views provide our only photographic record of it, including a detailed view of the standing remains (Fig. 4).

ble inside the narthex of Church 13. These are of different character, with the inner thickness rougher than the outer and supporting a transverse barrel vault. Directly behind the remains of the vault, putlog holes appear in the inner west wall, four stone courses below the gallery windows. The details suggest that the separation between the two levels of the narthex was originally a wooden floor, but that this was replaced by vaulting at a later date. Ramsay and Bell had observed similar evidence of rebuilding elsewhere, which they attributed to a period of revival, *ca.* 850-1070, following widespread destruction during the Arab incursions. As what is visible appears to be an insertion into a standing building rather than the repair or reconstruction of a damaged building, this more likely represents the updating of a building that had existed over a long period of time.¹⁷

from the central bay, with limited access from the side aisles. At Church 13, there is no indication of an internal division within the narthex, while the access from the side aisles is not entirely clear. The large arched openings seem to be windows between interior spaces, with low passageways beneath them. That to the south is covered by a lintel, while that to the north is arched. Without a sense of the original ground level, however, it is impossible to determine just how low these openings were.
