Δελτίον ΧΑΕ 34 (2013), Περίοδος Δ'. Στη μνήμη του Τίτου Παπαμαστοράκη (1961-2010)

Επανεξετάζοντας την τοποθεσία Binbirkilise: Οι φωτογραφίες του John Henry Haynes του 1887

Robert OUSTERHOUT

BİNBİRKİLİSE REVISITED: THE 1887 PHOTOGRAPHS OF JOHN HENRY HAYNES

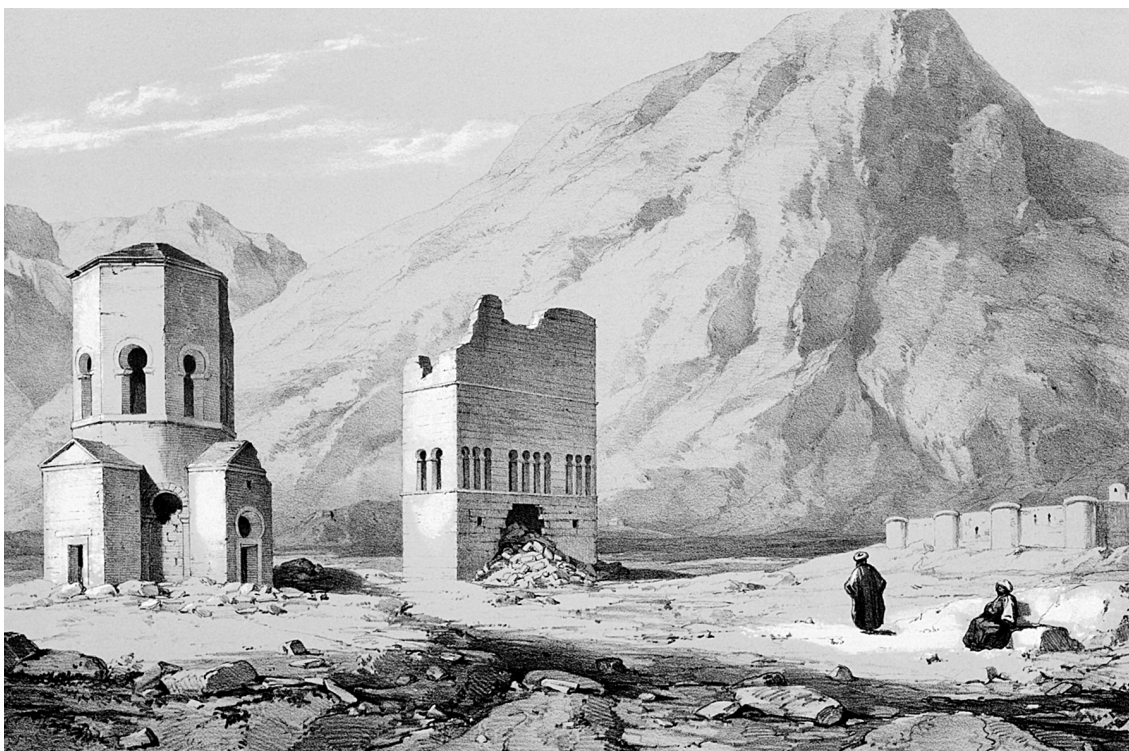
Fig. 1. Binbirkilise, view of Churches 8 and 13 seen from the northwest, by Léon de Laborde, 1826.

Our earliest graphic representations of the site come from the 1826 visit of Léon de Laborde, whose romantic views emphasize the barrenness of the site while exaggerating and regularizing the features of the standing remains (Fig. 1).² Other scholars had visited the site but
