Επανεξετάζοντας την τοποθεσία Binbirkilise: Οι φωτογραφίες του John Henry Haynes του 1887

BİN BİRKLİSE REVISITED: THE 1887 PHOTOGRAPHS OF JOHN HENRY HAYNES

The early Byzantine site of Binbirkilise (the Thousand and One Churches) near Karaman in Lycaonia is best known today from the 1907 documentation by Sir William M. Ramsay and Gertrude Bell. Unknown to them, however, was the visit in 1887 by the American archaeologist John Henry Haynes, who took photographs of Churches 8, 10, 13, 32, and 39. Because of severe damage to the buildings between 1887 and 1907, Haynes's photographs provide important details of the buildings not available to later scholars.

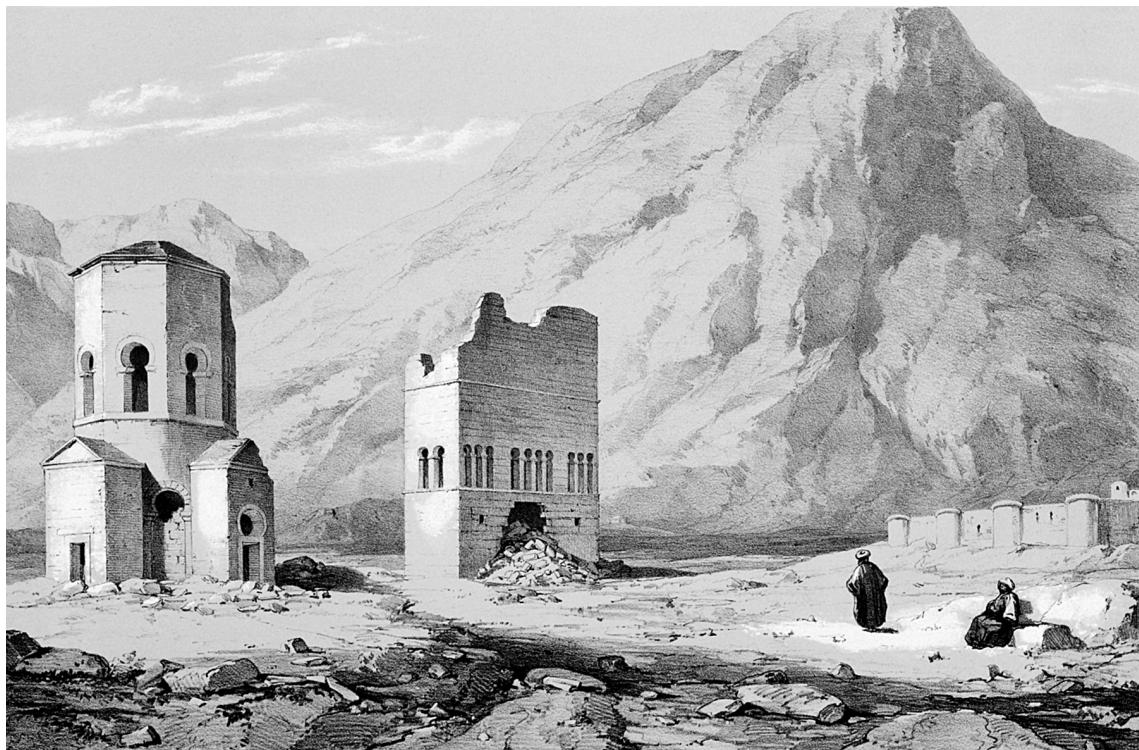
Fig. 1. Binbirkilise, view of Churches 8 and 13 seen from the northwest, by Léon de Laborde, 1826.

Our earliest graphic representations of the site come from the 1826 visit of Léon de Laborde, whose romantic views emphasize the barrenness of the site while exaggerating and regularizing the features of the standing remains (Fig. 1).² Other scholars had visited the site but

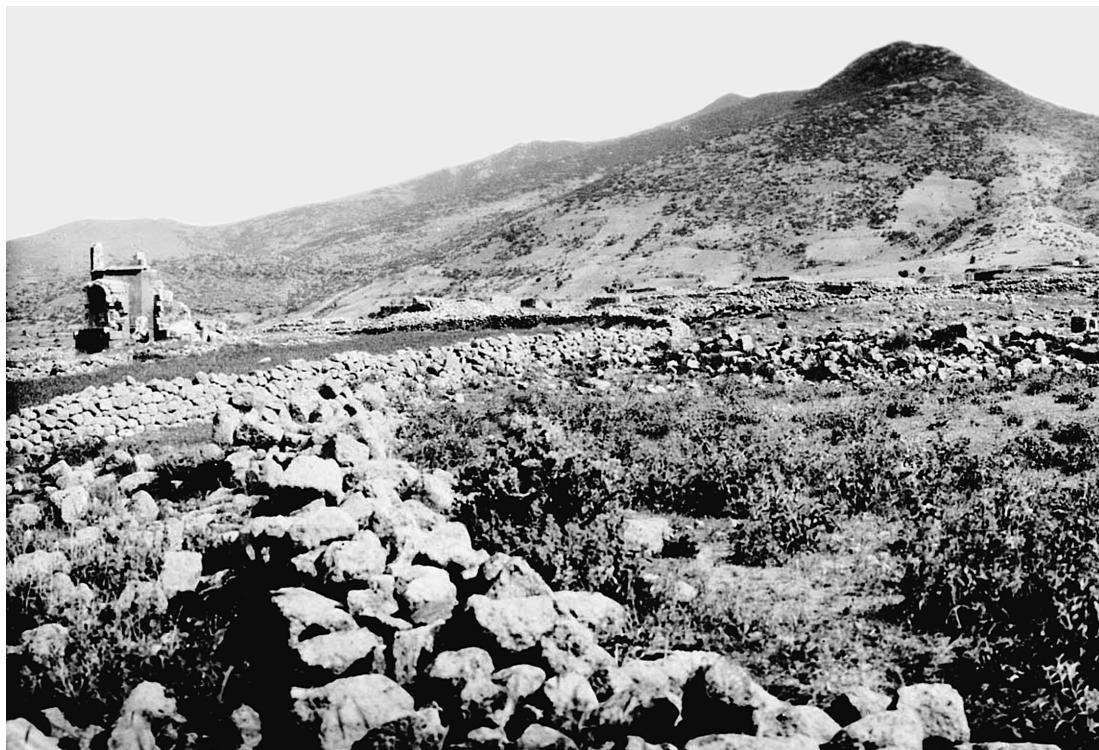
Fig. 2. Binbirkilise, view of the ruins of Churches 8 and 13, seen from the northwest, by Gertrude Bell, 1907 (courtesy of the University of Newcastle Gertrude Bell Archive).

tion of the site with Sir William M. Ramsay (Fig. 2).⁵ Bell's analysis of the architecture is the most complete and remains authoritative. While she incorporated the observations of earlier visitors into her study of the architecture, their accounts provide little evidence not visible to her during her time at the site. Many of the buildings in the lower city had fallen sometime between Laborde's visit and Bell's, and it is often assumed to be the result of gradual deterioration over time. As Ramsay commented, "The destruction of this ancient city has proceeded comparatively slowly, but it goes on steadily."⁶ Ramsay had first examined the site with Sir Charles Wilson in 1882, but his account places the destruction of the monuments considerably later. For example, he writes, "Church 8 was

Haynes's photograph of Churches 8 and 13 (Fig. 3) is taken from the southeast rather than the southwest, as were the views of Bell and Laborde. By the time Bell had arrived on the scene, Church 8 had fallen but was still recognizable, while Church 13 was nothing but a pile of rubble – so much so that Bell didn't bother to record it.¹⁵ In Bell's photograph (Fig. 2), its foundations appear immediately to the right of Church 8, just behind the rock fence. Haynes's

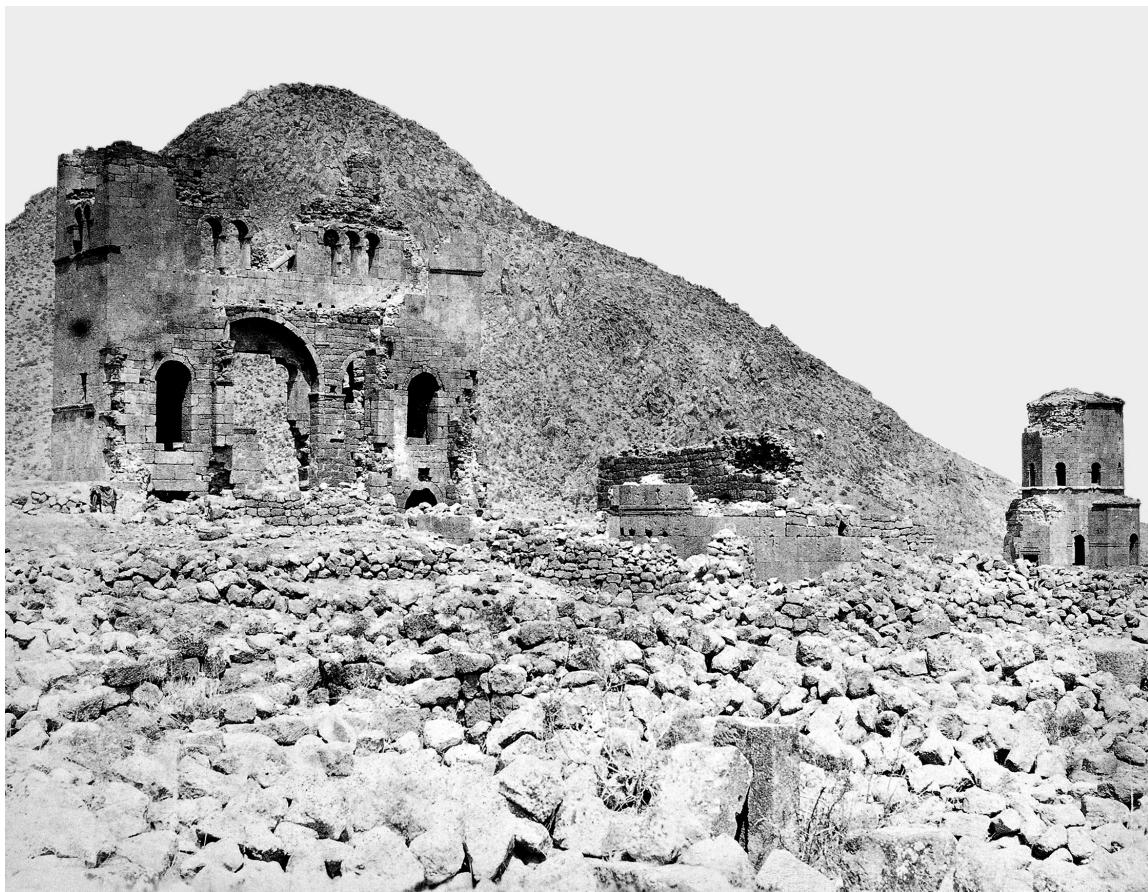
Fig. 3. Binbirkilise, view of the ruins of Churches 8 and 13, seen from the southeast, by John Henry Haynes, 1887 (Harvard University, Aga Khan Visual Resources).

The last detail is probably the remnant of a system of tie beams to brace the dome, rather than a false ceiling. By the time of Bell's analysis, all traces of the wooden bracing had disappeared, along with the dome. And while the apse was covered by a half-dome, the projecting porches must have been covered by barrel vaults, not cupolas. The description of the building as a "tower" conforms to the visual impression recorded by Haynes. Holzmann, who drew a reconstruction of the church in 1904, supposed the octagon to have been covered by a cloister vault that was exposed on the exterior, but this is clearly incorrect.²⁰ Our Fig. 3 shows the remains of a shallow pyramidal roof, which is how Restle has reconstructed it.²¹

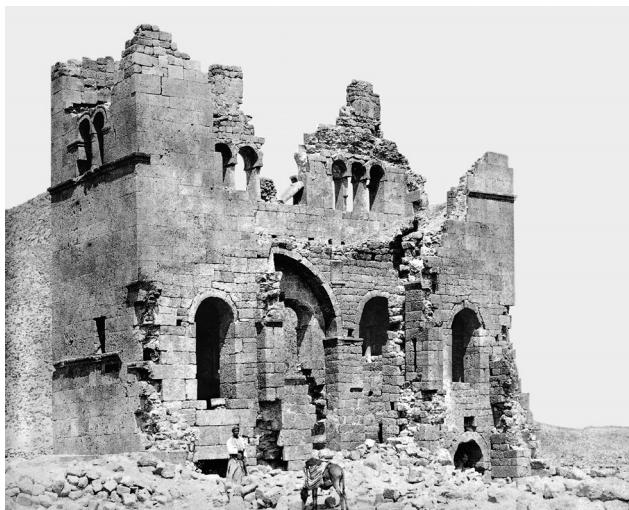
Fig. 4. Binbirkilise, view of the ruins of Church 13, seen from the northwest, by John Henry Haynes, 1887 (Harvard University, Aga Khan Visual Resources).

views provide our only photographic record of it, including a detailed view of the standing remains (Fig. 4). Church 13 may be reconstructed as a basilica with a two-storied narthex. While Laborde had depicted the west façade of the building, representing it as a simple, rectangular tower, Haynes shows the inner wall, where the narthex once joined to the nave, with walls extending from it to the east. In our Fig. 3, the narthex stands almost its full height, to the left, while the remains of the apse appear between it and Church 8, in the distance to the right. Changes in the masonry surface of the narthex block indicate the position of the angled roofs of the side aisles, allowing the restitution of the building as a three-aisled basilica with the nave rising above the level of the side aisles. This is in contrast to what Bell calls a “barn church,” in which the side aisles and nave rise to the same height, and a clerestory would not have been possible.¹⁶ Both types existed side-by-side at Binbirkilise. More interestingly, there are two thicknesses of walls visi-

ble inside the narthex of Church 13. These are of different character, with the inner thickness rougher than the outer and supporting a transverse barrel vault. Directly behind the remains of the vault, putlog holes appear in the inner west wall, four stone courses below the gallery windows. The details suggest that the separation between the two levels of the narthex was originally a wooden floor, but that this was replaced by vaulting at a later date. Ramsay and Bell had observed similar evidence of rebuilding elsewhere, which they attributed to a period of revival, *ca.* 850-1070, following widespread destruction during the Arab incursions. As what is visible appears to be an insertion into a standing building rather than the repair or reconstruction of a damaged building, this more likely represents the updating of a building that had existed over a long period of time.¹⁷

from the central bay, with limited access from the side aisles. At Church 13, there is no indication of an internal division within the narthex, while the access from the side aisles is not entirely clear. The large arched openings seem to be windows between interior spaces, with low passageways beneath them. That to the south is covered by a lintel, while that to the north is arched. Without a sense of the original ground level, however, it is impossible to determine just how low these openings were.

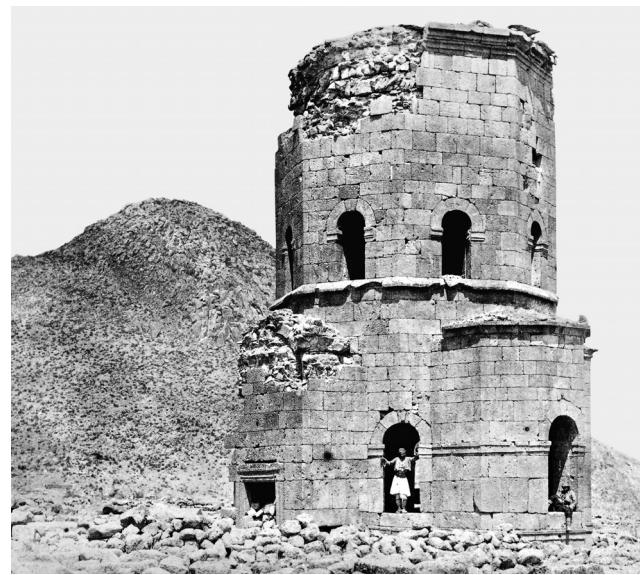
Fig. 5. Binbirkilise, view of the ruins of Church 8, seen from the northwest, by John Henry Haynes, 1887 (Harvard University, Aga Khan Visual Resources).

Impressively, Church 8 stands its full height, its domed octagonal core amplified with barrel-vaulted projections on three sides and an apse on the fourth (Figs 5, 6A). Church 8 has long been of interest to scholars because of its similarities to the martyrium described by Gregory of Nyssa.¹⁸ Haynes's photograph confirms that this was, indeed, an impressive building, and typical of Haynes, he poses his traveling companions in the windows. Seen from the southeast, the faceted apse projects to the right, terminating in a single arched window. The transept arm extend-

ing to the left terminates in a door. The central octagon rises through a clerestory zone below the dome, disguised behind the rising walls of the octagon. Where the facing has fallen away, the mortared rubble core of the wall is exposed. The octagon is rotated so that its corners, rather than its flat walls, are on axis. As a consequence, the lower diagonal windows (where one of Haynes's companions stands) are set at the corners, while the clerestory windows are positioned within each facet of the octagon. The lack of vertical alignment adds to the visual interest of the building.

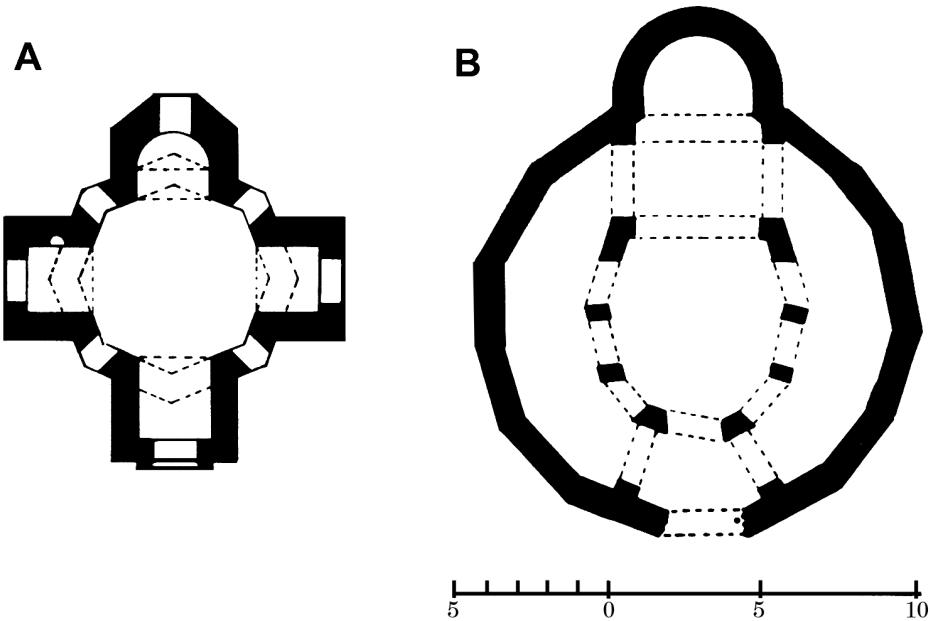
Fig. 6. Binbirkilise, plans of Churches 8 and 10 (after Gertrude Bell with author's modifications).

Church 10 was also centrally planned, but much more irregular than Church 8, and its masonry rougher (Figs 6B, 7).²² Its lower level was partially standing when Bell cleared its interior and examined it. She was aided in her

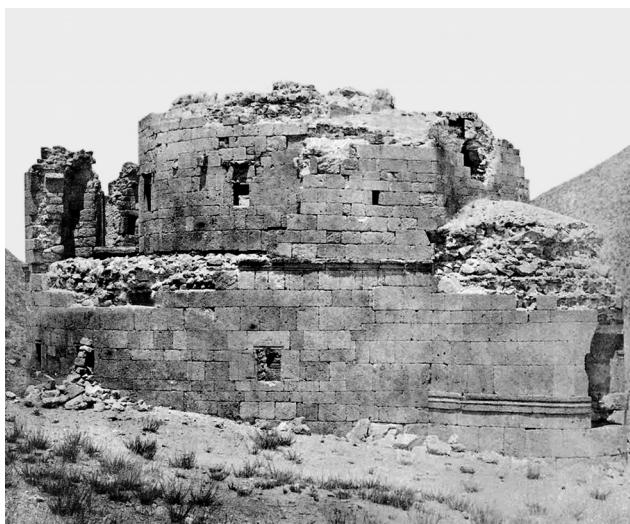
Fig. 7. Binbirkilise, Church 10 seen from the southeast, by John Henry Haynes, 1887 (Harvard University, Aga Khan Visual Resources).

Haynes’s photograph shows the church from the south with its apse to the right. His caption calls it “A ruined Building (Church?) with twelve sides and an apse.” The building is actually fourteen-sided, with the apse taking one side of the polygon, and while solidly built, it was very irregular. The central space is oval – actually an irregular octagon, flanked by triple arcades to the north and south. Bell had cleaned the interior to clarify the plan, but by 1907 much of the upper level had disappeared, and she was hard pressed to match Davis’s description to the standing remains. Where, for example, is the “small door to the north?” She suggests, rather tentatively, that the internal arcades are Davis’s pentagonal screen. Nor do the windows match Davis’s description.

Haynes’s photograph provides the missing details, although at first glance it is rather confusing. We see the building from the south, with its lower level standing the full length. The upper level of the outer wall stands only on the eastern (right) side, where it rises above a string course. To the west (left), the outer wall has fallen, and we see the rising inner wall, pierced by small rectangular windows at the gallery level, as noted by Davis. Immediately below this is the rubble extrados of the annular barrel vault covering the ambulatory on the lower level. To the west and east, Bell indicated pilasters engaged to the outer wall flanking the entrance and the apse, with arches connecting to the piers at the ends of the arcades (Fig. 6B, with author’s modifications). Haynes photograph shows vaulting on the upper level in both of these bays. The apse

must have had a tall, vaulted sanctuary bay preceding it, opening to the central octagon. Davis’s four small rectangular windows, just below “the cupola of the apse,” may have been in the east wall of this bay, above the vault of the apse, rather than in the apse itself. If the sanctuary vault opened directly into the central space, Davis’s “pentagonal screen on arches” may simply have been the upper level wall, pierced by (most likely) five windows. Within the gallery, stone corbels appear immediately above the square windows, but there is no evidence of vaulting. We may assume these areas were covered by raking wooden roofs.

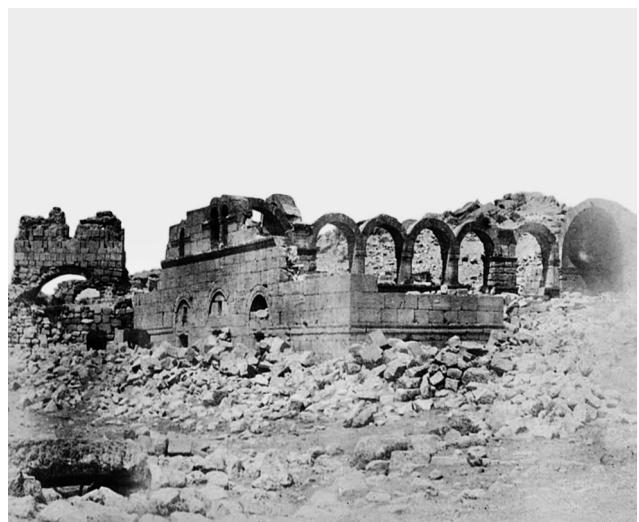
Fig. 8. Binbirkilise, Churches 32 and 39 seen from the southwest, by John Henry Haynes, 1887 (Harvard University, Aga Khan Visual Resources).

Haynes included a single photograph from the upper city of Değle in his folio, showing Churches 32 and 39 from the southwest (Fig. 8). Both are unique buildings at Binbirkilise, as Bell observed.²⁶ Church 32 is a three-aisled basilica with galleries. Haynes’s view shows the arcade of the north gallery fully intact, as well as the vault of the apse, faded on the right side of the photograph. Portions of the narthex gallery are still standing as well. These features were still visible to Crowfoot but partially damaged by the time Bell recorded them.²⁷ By 1909 Bell reported all the upper portions of the building had fallen. The broad west façade of the church had three portals set within arches, and its width was extended by chambers projecting to the north and south; the south chamber is clearly visible in the foreground of Haynes’s photograph.

Church 39, visible in the background, is probably not a church, but a nine-bayed, cross-in-square hall, quite different in character and date from the neighboring church. A central tower rose above the lower vaults, its the surviving wall detailed with niches and bands of brick. This is most likely a construction of the Middle Byzantine period and corresponds to a variety of centrally planned halls
