Δελτίον ΧΑΕ 34 (2013), Περίοδος Δ'. Στη μνήμη του Τίτου Παπαμαστοράκη (1961-2010)

*Robert OUSTERHOUT*

## BİNBİRKİLİSE REVISITED: THE 1887 PHOTOGRAPHS OF JOHN HENRY HAYNES

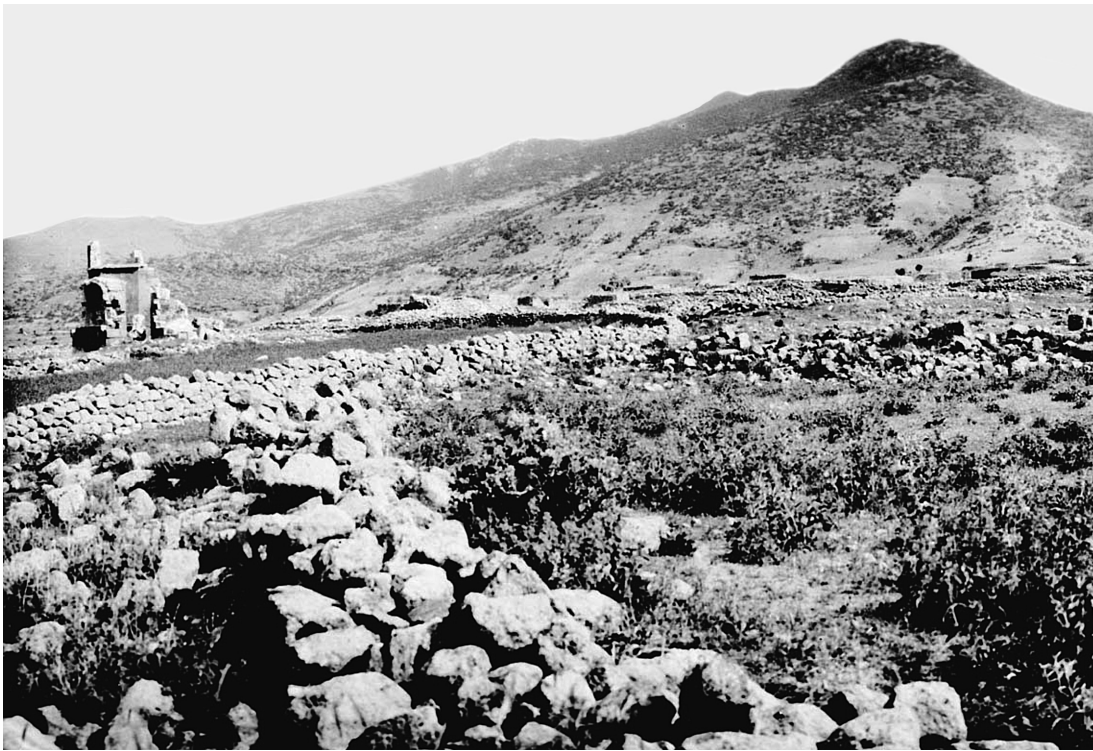
Fig. 2. Binbirkilise, view of the ruins of Churches 8 and 13, seen from the northwest, by Gertrude Bell, 1907 (courtesy of the University of Newcastle Gertrude Bell Archive).

tion of the site with Sir William M. Ramsay (Fig. 2).<sup>5</sup> Bell's analysis of the architecture is the most complete and remains authoritative. While she incorporated the observations of earlier visitors into her study of the architecture, their accounts provide little evidence not visible to her during her time at the site. Many of the buildings in the lower city had fallen sometime between Laborde's visit and Bell's, and it is often assumed to be the result of gradual deterioration over time. As Ramsay commented, "The destruction of this ancient city has proceeded comparatively slowly, but it goes on steadily."<sup>6</sup> Ramsay had first examined the site with Sir Charles Wilson in 1882, but his account places the destruction of the monuments considerably later. For example, he writes, "Church 8 was

Haynes's photograph of Churches 8 and 13 (Fig. 3) is taken from the southeast rather than the southwest, as were the views of Bell and Laborde. By the time Bell had arrived on the scene, Church 8 had fallen but was still recognizable, while Church 13 was nothing but a pile of rubble – so much so that Bell didn't bother to record it.<sup>15</sup> In Bell's photograph (Fig. 2), its foundations appear immediately to the right of Church 8, just behind the rock fence. Haynes's

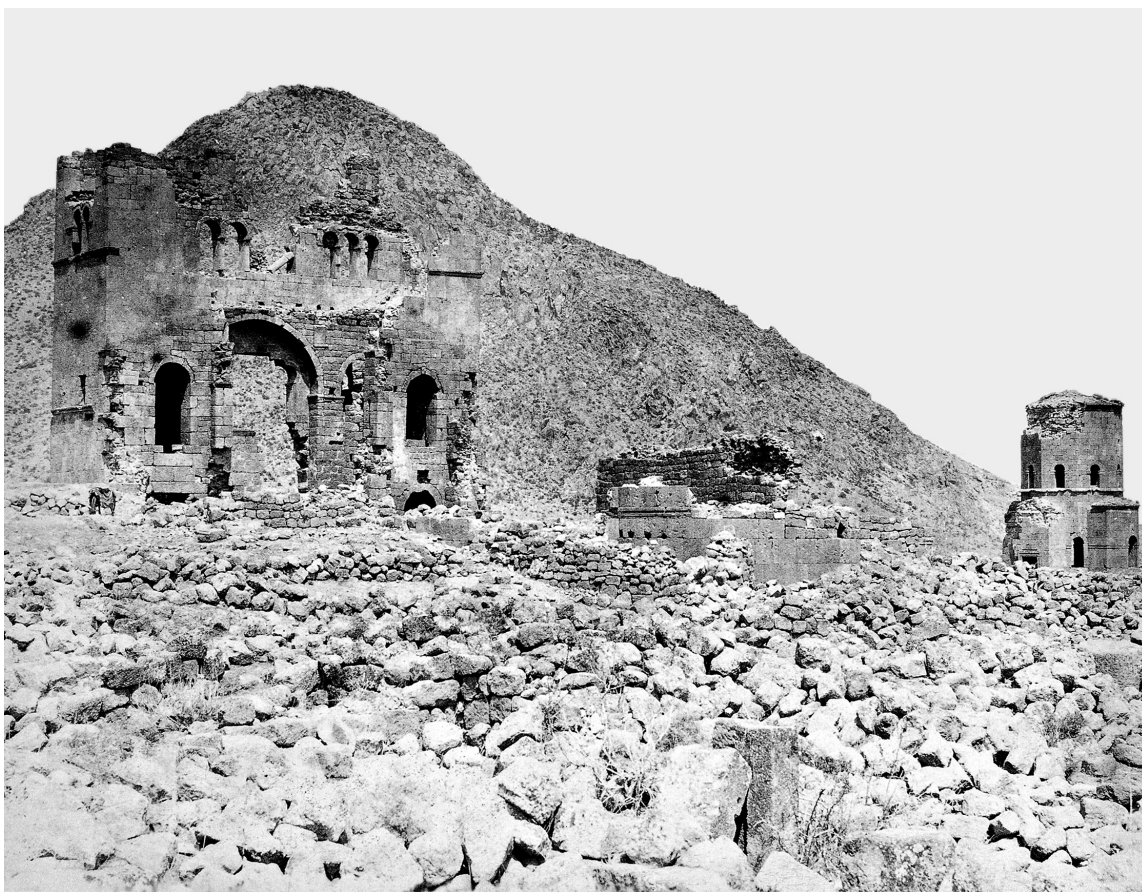
Fig. 3. Binbirkilise, view of the ruins of Churches 8 and 13, seen from the southeast, by John Henry Haynes, 1887 (Harvard University, Aga Khan Visual Resources).

Church 13 may be reconstructed as a basilica with a two-storied narthex. While Laborde had depicted the west façade of the building, representing it as a simple, rectangular tower, Haynes shows the inner wall, where the narthex once joined to the nave, with walls extending from it to the east. In our Fig. 3, the narthex stands almost its full height, to the left, while the remains of the apse appear between it and Church 8, in the distance to the right. Changes in the masonry surface of the narthex block indicate the position of the angled roofs of the side aisles, allowing the restitution of the building as a three-aisled basilica with the nave rising above the level of the side aisles. This is in contrast to what Bell calls a "barn church," in which the side aisles and nave rise to the same height, and a clerestory would not have been possible.<sup>16</sup> Both types existed side-by-side at Binbirkilise.

The last detail is probably the remnant of a system of tie beams to brace the dome, rather than a false ceiling. By the time of Bell's analysis, all traces of the wooden bracing had disappeared, along with the dome. And while the apse was covered by a half-dome, the projecting porches must have been covered by barrel vaults, not cupolas. The description of the building as a "tower" conforms to the visual impression recorded by Haynes. Holzmann, who drew a reconstruction of the church in 1904, supposed the octagon to have been covered by a cloister vault that was exposed on the exterior, but this is clearly incorrect.<sup>20</sup> Our Fig. 3 shows the remains of a shallow pyramidal roof, which is how Restle has reconstructed it.<sup>21</sup>

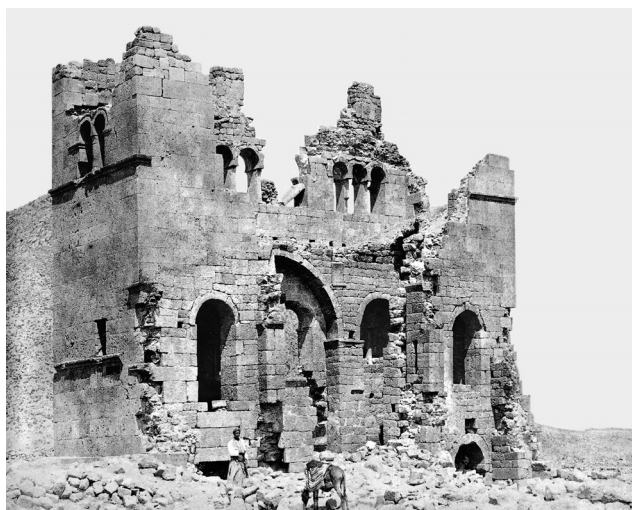
Fig. 4. Binbirkilise, view of the ruins of Church 13, seen from the northwest, by John Henry Haynes, 1887 (Harvard University, Aga Khan Visual Resources).

views provide our only photographic record of it, including a detailed view of the standing remains (Fig. 4).

ble inside the narthex of Church 13. These are of different character, with the inner thickness rougher than the outer and supporting a transverse barrel vault. Directly behind the remains of the vault, putlog holes appear in the inner west wall, four stone courses below the gallery windows. The details suggest that the separation between the two levels of the narthex was originally a wooden floor, but that this was replaced by vaulting at a later date. Ramsay and Bell had observed similar evidence of rebuilding elsewhere, which they attributed to a period of revival, *ca.* 850-1070, following widespread destruction during the Arab incursions. As what is visible appears to be an insertion into a standing building rather than the repair or reconstruction of a damaged building, this more likely represents the updating of a building that had existed over a long period of time.<sup>17</sup>

from the central bay, with limited access from the side aisles. At Church 13, there is no indication of an internal division within the narthex, while the access from the side aisles is not entirely clear. The large arched openings seem to be windows between interior spaces, with low passageways beneath them. That to the south is covered by a lintel, while that to the north is arched. Without a sense of the original ground level, however, it is impossible to determine just how low these openings were.

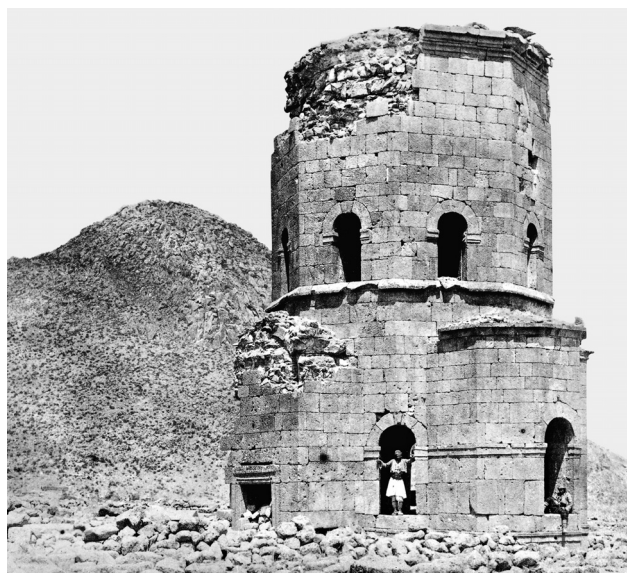
Fig. 5. Binbirkilise, view of the ruins of Church 8, seen from the northwest, by John Henry Haynes, 1887 (Harvard University, Aga Khan Visual Resources).

Impressively, Church 8 stands its full height, its domed octagonal core amplified with barrel-vaulted projections on three sides and an apse on the fourth (Figs 5, 6A). Church 8 has long been of interest to scholars because of its similarities to the martyrion described by Gregory of Nyssa.<sup>18</sup> Haynes's photograph confirms that this was, indeed, an impressive building, and typical of Haynes, he poses his traveling companions in the windows. Seen from the southeast, the faceted apse projects to the right, terminating in a single arched window. The transept arm extend-

ing to the left terminates in a door. The central octagon rises through a clerestory zone below the dome, disguised behind the rising walls of the octagon. Where the facing has fallen away, the mortared rubble core of the wall is exposed. The octagon is rotated so that its corners, rather than its flat walls, are on axis. As a consequence, the lower diagonal windows (where one of Haynes's companions stands) are set at the corners, while the clerestory windows are positioned within each facet of the octagon. The lack of vertical alignment adds to the visual interest of the building.

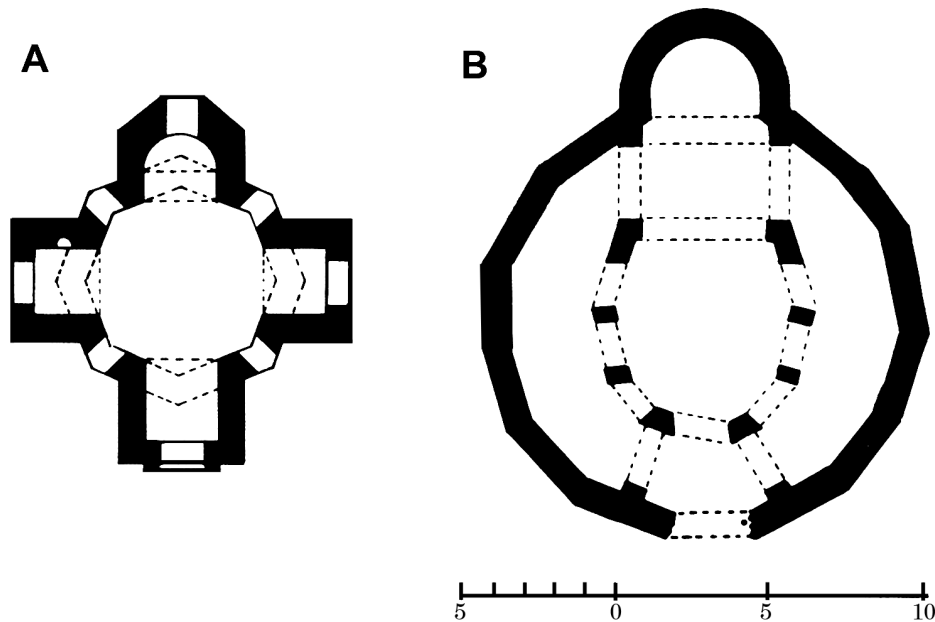
Fig. 6. Binbirkilise, plans of Churches 8 and 10 (after Gertrude Bell with author's modifications).

Church 10 was also centrally planned, but much more irregular than Church 8, and its masonry rougher (Figs 6B, 7).<sup>22</sup> Its lower level was partially standing when Bell cleared its interior and examined it. She was aided in her

Haynes’s photograph provides the missing details, although at first glance it is rather confusing. We see the building from the south, with its lower level standing the full length. The upper level of the outer wall stands only on the eastern (right) side, where it rises above a string course. To the west (left), the outer wall has fallen, and we see the rising inner wall, pierced by small rectangular windows at the gallery level, as noted by Davis. Immediately below this is the rubble extrados of the annular barrel vault covering the ambulatory on the lower level. To the west and east, Bell indicated pilasters engaged to the outer wall flanking the entrance and the apse, with arches connecting to the piers at the ends of the arcades (Fig. 6B, with author’s modifications). Haynes photograph shows vaulting on the upper level in both of these bays. The apse

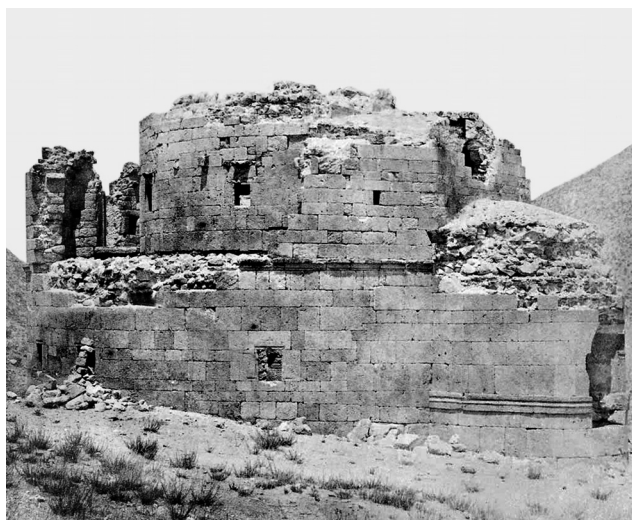
Fig. 7. Binbirkilise, Church 10 seen from the southeast, by John Henry Haynes, 1887 (Harvard University, Aga Khan Visual Resources).

Haynes’s photograph shows the church from the south with its apse to the right. His caption calls it “A ruined Building (Church?) with twelve sides and an apse.” The building is actually fourteen-sided, with the apse taking one side of the polygon, and while solidly built, it was very irregular. The central space is oval – actually an irregular octagon, flanked by triple arcades to the north and south. Bell had cleaned the interior to clarify the plan, but by 1907 much of the upper level had disappeared, and she was hard pressed to match Davis’s description to the standing remains. Where, for example, is the “small door to the north?” She suggests, rather tentatively, that the internal arcades are Davis’s pentagonal screen. Nor do the windows match Davis’s description.

must have had a tall, vaulted sanctuary bay preceding it, opening to the central octagon. Davis’s four small rectangular windows, just below “the cupola of the apse,” may have been in the east wall of this bay, above the vault of the apse, rather than in the apse itself. If the sanctuary vault opened directly into the central space, Davis’s “pentagonal screen on arches” may simply have been the upper level wall, pierced by (most likely) five windows. Within the gallery, stone corbels appear immediately above the square windows, but there is no evidence of vaulting. We may assume these areas were covered by raking wooden roofs.

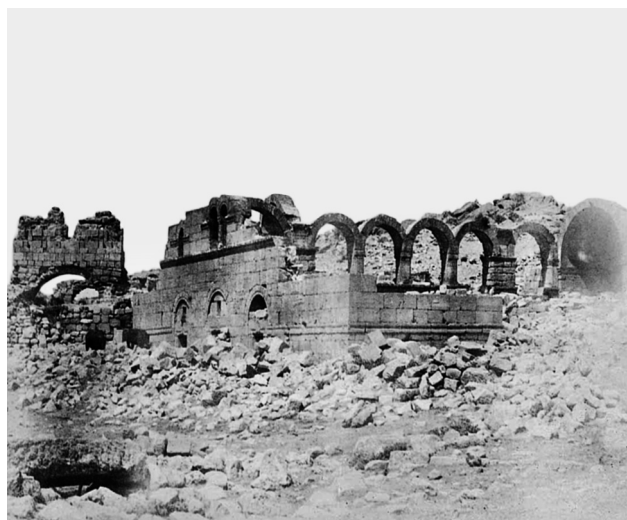
Fig. 8. Binbirkilise, Churches 32 and 39 seen from the southwest, by John Henry Haynes, 1887 (Harvard University, Aga Khan Visual Resources).

Haynes included a single photograph from the upper city of Değle in his folio, showing Churches 32 and 39 from the southwest (Fig. 8). Both are unique buildings at Binbirkilise, as Bell observed.<sup>26</sup> Church 32 is a three-aisled basilica with galleries. Haynes’s view shows the arcade of the north gallery fully intact, as well as the vault of the apse, faded on the right side of the photograph. Portions of the narthex gallery are still standing as well. These features were still visible to Crowfoot but partially damaged by the time Bell recorded them.<sup>27</sup> By 1909 Bell reported all the upper portions of the building had fallen. The broad west façade of the church had three portals set within arches, and its width was extended by chambers projecting to the north and south; the south chamber is clearly visible in the foreground of Haynes’s photograph.

Church 39, visible in the background, is probably not a church, but a nine-bayed, cross-in-square hall, quite different in character and date from the neighboring church. A central tower rose above the lower vaults, its the surviving wall detailed with niches and bands of brick. This is most likely a construction of the Middle Byzantine period and corresponds to a variety of centrally planned halls
