MINEROLOGICAL AND PHYSICO-CHEMICAL PROPERTIES OF THE BUILDING MATERIALS OF KOULE CASTLE, HERAKLION, CRETE

Karampatsou G.¹, Markopoulos Th.¹, Repouskou E.¹ and Triantafyllou G.¹

¹ Technical University of Crete, Dept. of Mineral Resources Engineering, GR-73100 Chania,
Greece gkarampatsou@isc.tuc.gr, markopou@mred.tuc.gr, repusku@mred.tuc.gr,
gtriant@mred.tuc.gr

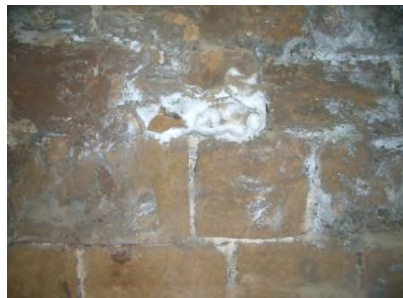
Figure 2 - Salt efflorescence on the external wall of Koule Castle, Heraklion, Crete.

Five core samples of rocks and masonry mortars have been extracted by the 13th Municipality of Byzantine Antiquities from different parts of the monument (Table 1). The core samples consist of three rock + mortar specimens and two rock specimens. Various analyses were carried out, in order to determine their physical and technical characteristics as well as their deterioration state. The rock specimens present in their majority salt efflorescence (Fig.2) due to the sea water that enters the Castle.

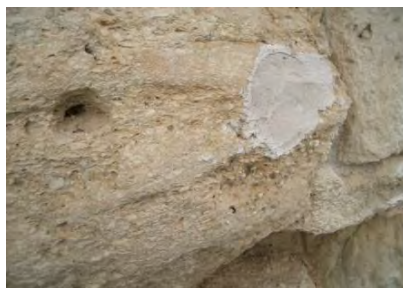
Figure 3 - Sampling position of a building stone from the internal wall of Koule Castle. The drill hole was covered with a non compatible mortar.

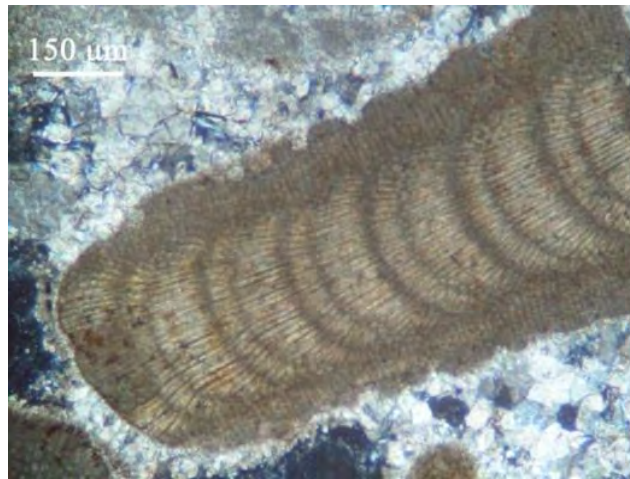
Figure 4 - Thin section photograph of bioclastic limestone. ⊥ pollars (specimen 1).

The building stones of Koule Castle are sedimentary rocks, excavated nearby the harbor of Heraklion, where the monument was constructed. In their majority, they are bioclastic limestones with various marine fossils (Fig.4), micritic breccias (Fig.5) and micritic conglomerate limestones. Dolomitic limestones exist only in the pavement of the Castle.

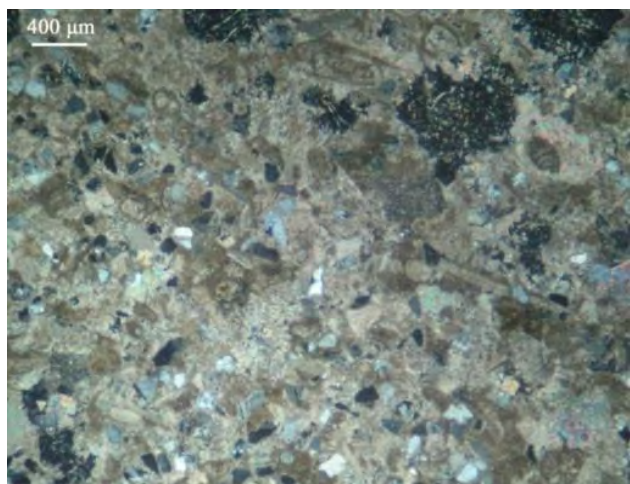
Figure 5 - Thin section photograph of micritic breccia limestone. ⊥ pollars (specimen 2).

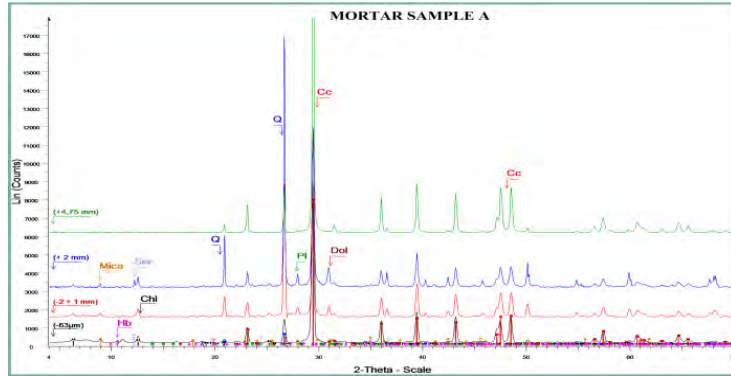
Cc: Calcite, Q: Quartz, Dol: Dolomite, Ser: Serpentine, Chl: Chlorite, Pl: Plagioclase, Hb: Hornblende

Figure 6 - XRD pattern of the binder and inert material of mortar sample A.

The mineralogical phases identified by means of XRD of the mortar samples are presented in the XRD patterns below (Figs. 6, 7 and 8).

Calcite and quartz were detected in the binder and in the inert material of the mortars. The quartz peaks in the XRD spectra are greater for the inert material while the calcite peaks are greater for the binder material of the mortars. Plagioclase, mica, chlorite and hornblende were detected in the binder and in the inert material of mortar samples A and C (Fig. 6, Fig. 8), while dolomite and serpentine exists only in the inert material of these mortars. Plagioclase, brucite and traces of mica and chlorite; were detected in the binder and in the inert material of mortar sample B. Consequently, the binder of the studied mortars consists mainly of calcite as a result of the lime carbonation. The inert material of the mortars consists mainly of quartz and secondarily of calcite. The presence of brucite in sample B (Fig. 7) is probably associated with the absence of adequate carbon dioxide in the interior parts of the castle. Furthermore, the presence of gypsum in sample C (Fig.8) is attributed to the process of mortar deterioration by sulfating. The sulfates, coming from the marine environment, were deposited on the surface and reacted with CaCO_3 , present in the mortar, according to Eqs. 1a and 1b. The mechanism of sulfating has not resulted in the formation of ettringite because of the absence of “calcium aluminate hydrate” ($3\text{CaO} \cdot \text{Al}_2\text{O}_3 \cdot 6\text{H}_2\text{O}$) (Sabbioni et al., 2001).

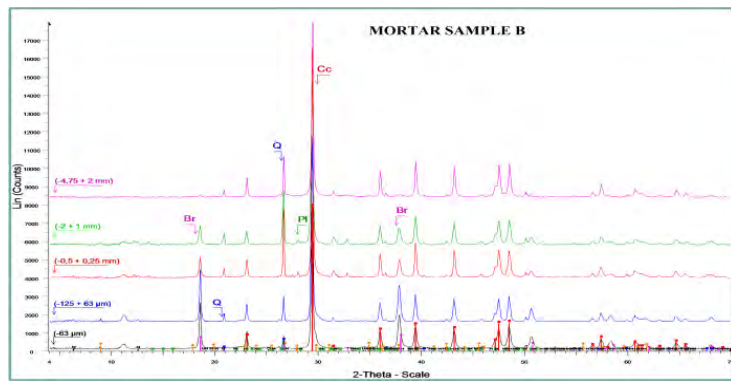
Br: Brucite

Figure 7 - XRD pattern of the binder and inert material of mortar sample B.

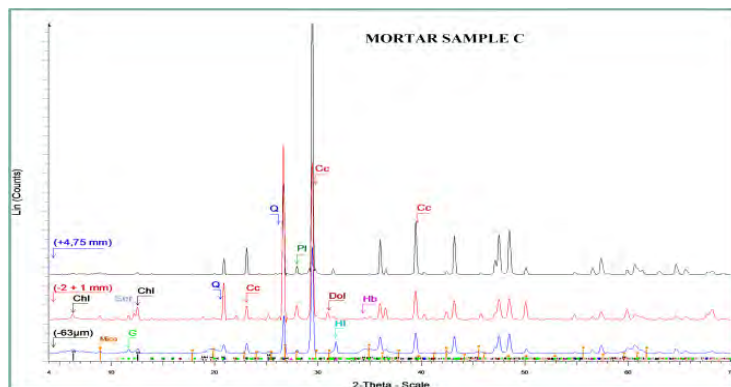
G: Gypsum Hl: Halite

Figure 8 - XRD pattern of the binder and inert material of mortar sample C.

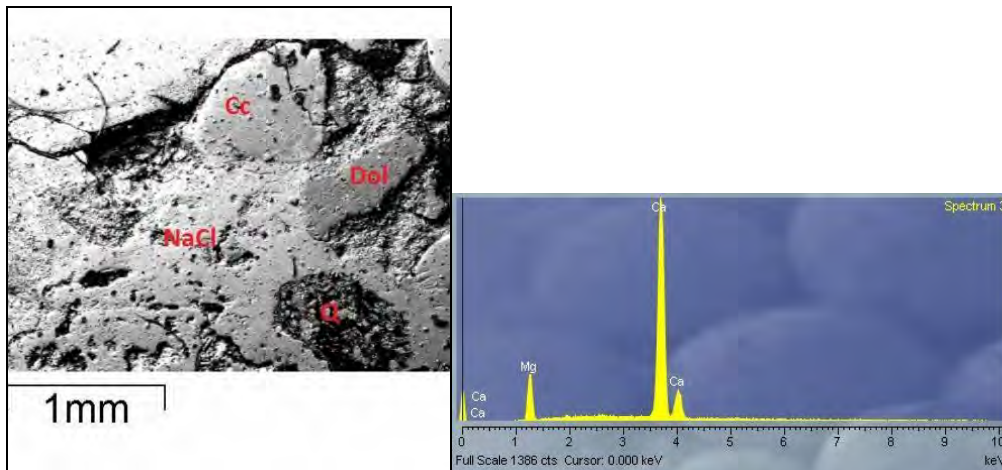
Figure 9 - Backscattering image of the mortar A and EDS analysis of dolomite.

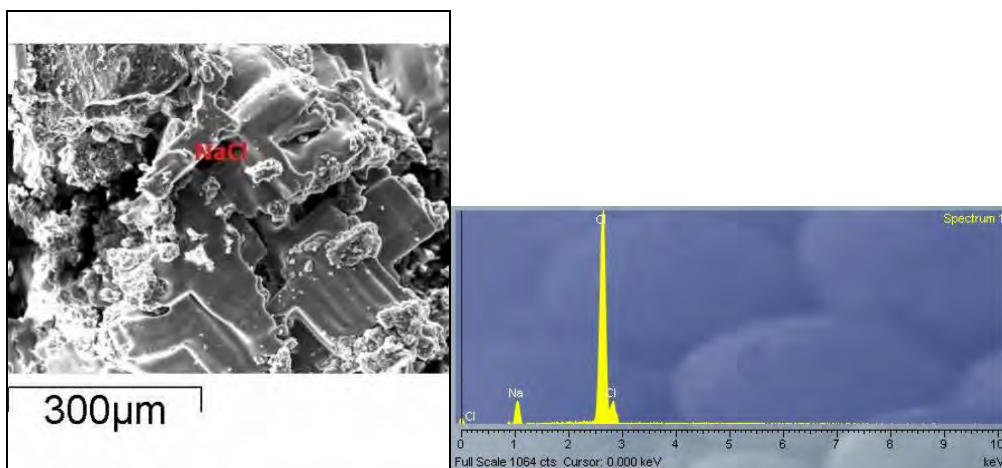
Figure 10 - SEM micrographic of the mortar C and EDS analysis of halite.

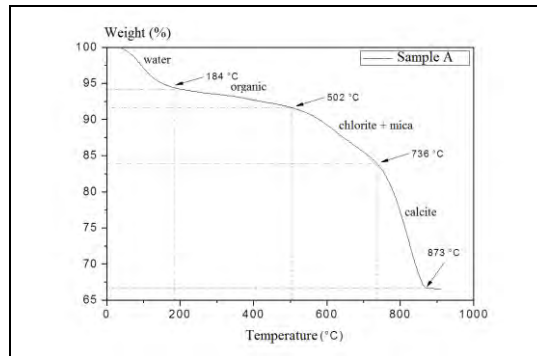
Figure 11 - Thermal curve of sample A.

Thermogravimetric (TG) analysis is necessary to establish the characteristics of the ancient mortars. TG analysis indicated a notable effect of calcite decomposition at about 900 °C, as a result of the carbonation of the original lime binder (Figs. 11, 12 and 13). Chlorite and mica decomposition took place at 500 °C – 600 °C in the samples A and C (Figs. 11 and 13). The losses of mass for the three mortars between 20 °C and 200 °C corresponded to the loss of water and to the loss of organic elements later. A greater loss of mass occurred between 20 °C and 200 °C in the sample C; which indicates the decomposition of the content gypsum. For the TG curve obtained of sample B, an endothermic peak was observed at about 400 °C which corresponds to the dissociation of brucite.

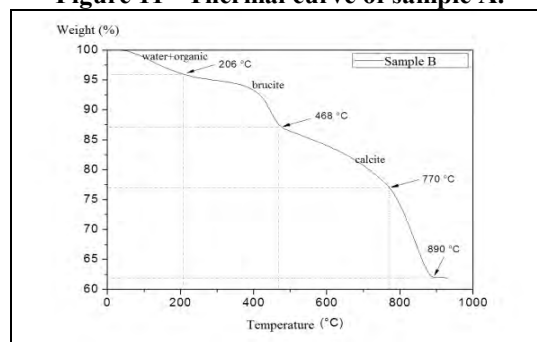
Figure 12 - Thermal curve of sample B.

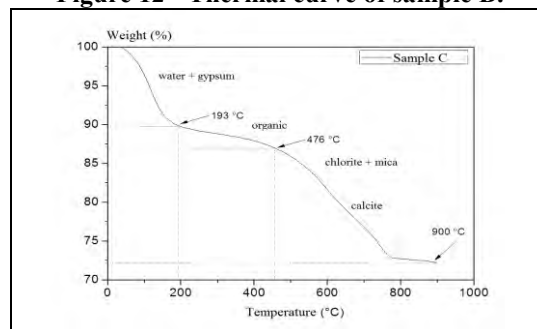
Figure 13 - Thermal curve of sample C.

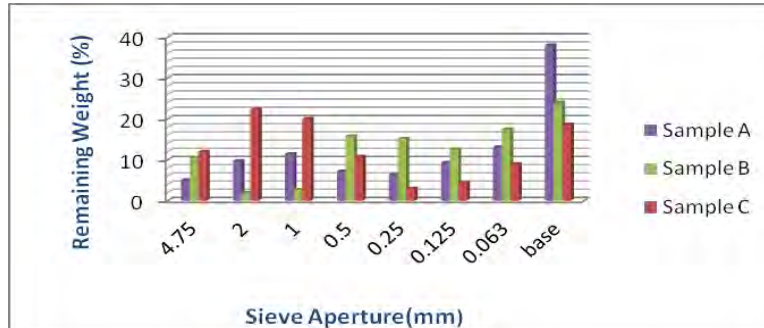
Figure 14 - Weight (%) of the samples which remains in every sieve aperture.

According to the histogram (Fig. 14) sample B presents a normal granulometric distribution. The inert to binder material ratio was determined 1.4/1, by volume. Sample A is the finest of the three studied mortars, due to the fact that more than 50% of this material is concentrated in the base

sieve. The inert to binder material ratio for the sample A was determined 0.96/1 by volume. Sample C contains much more aggregates than the other mortar samples. The inert to binder material ratio for the sample C was determined 2.6/1 by volume.
