## MACROSEISMICITY AND GEOLOGICAL EFFECTS OF THE WENCHUAN EARTHQUAKE (Ms 8.0R - 12 MAY 2008), SICHUAN, CHINA: MACRO-DISTRIBUTION AND COMPARISON OF EMS<sub>1998</sub> AND ESI<sub>2007</sub> INTENSITIES

**Lekkas, E.**

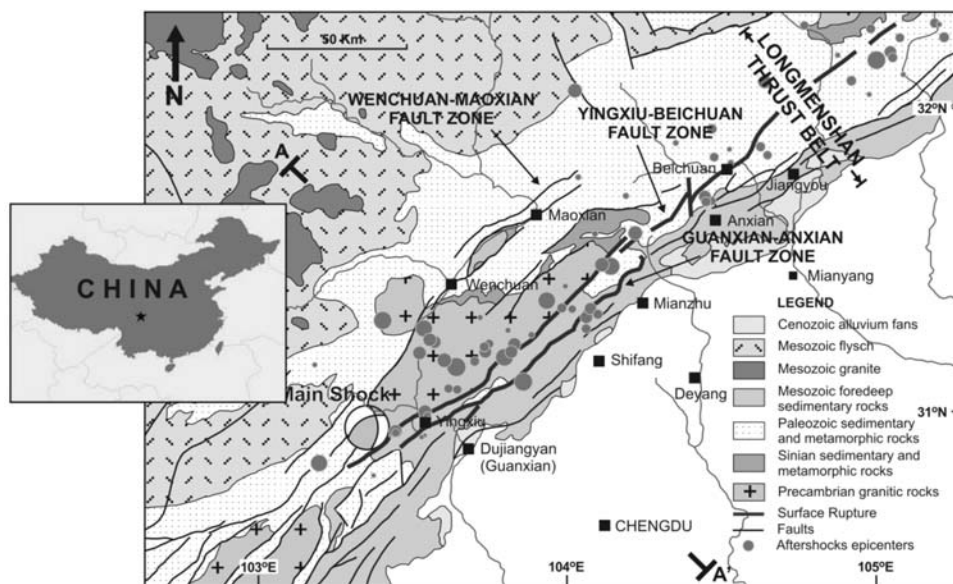
**Fig. 1:** Geological map of the greater earthquake affected region (12th May 2008) exhibiting the activated faults, the main shock location and the epicenters of the main aftershocks (modified, from Burchfiel et al. 1995, Densmore et al. 2007). For section AA' see Figure 2.

The epicenter of the earthquake was located in Yingxiu town (31.0°N, 103.4°E) in the southwest side of Wenchuan County, with a focal depth of 14 km according to the Chinese Earthquake Administration (CEA), 21 km from Dujiangyan (Guanxian), and 75 km from the capital of Sichuan province, Chengdu (Fig. 1).

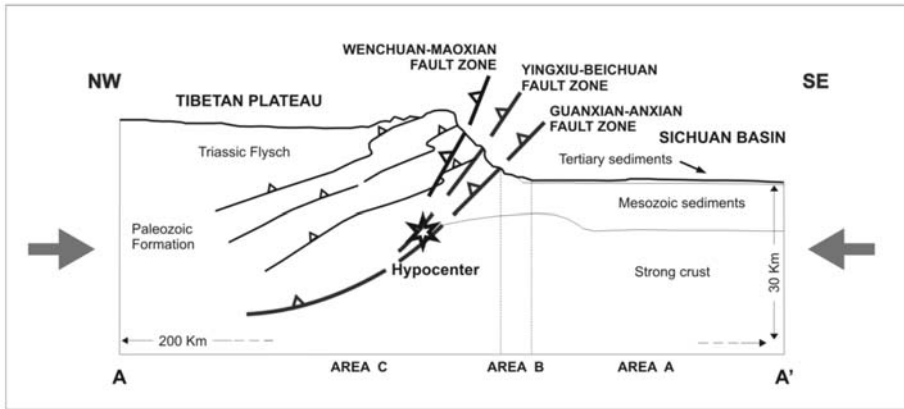
**Fig. 2:** Geological section trending NW-SE across the tectonic structure of the affected region with the activated faults and the epicenter location. The areas A, B and C are noted to exhibit variations of the intensities values (Burchfiel et al. 1995, Densmore et al. 2007).

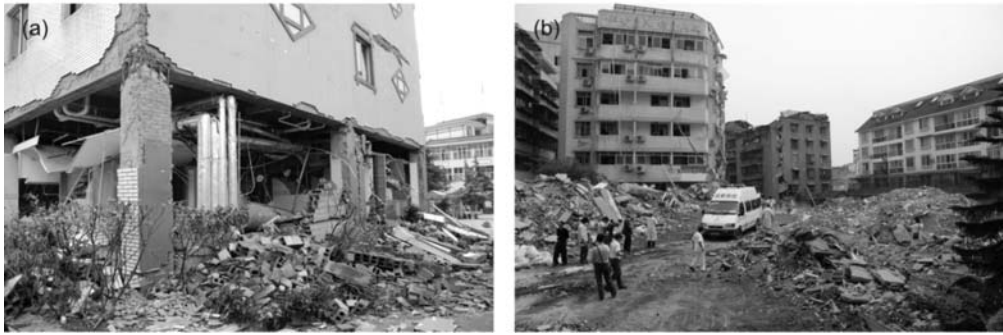
**Fig. 3:** View of a recently constructed building at the suburbs of Dujiangyan (Guanxian) with serious structural damages on the ground floor props. (type of construction D, damage degree 4) (a) and view of a hospital unit in the same town that totally collapsed (type of construction D, damage degree 5) (b).

**B1. Dujiangyan Region:** The town of Dujiangyan (Guanxian) is located 20 km east of the epicenter, 50 km west of the capital city Chengdu, in the zone defined by the boundary between the lowland and the high relief regions. It is located only 5 km towards the SE of the seismic fault trace. The town develops in its greater extent on a large scale alluvial fan, formed by the Min River that drains a wide mountainous region, while some of its branches run through the town. In the town, approximately 300 constructions totally or partially collapsed while 20% of the buildings suffered serious construction damages. Mainly multistory buildings collapsed, modern and older, constructed of reinforced concrete. Most collapses were located on the foothills of the mountainous region towards the west and the morphologically higher areas and less on the lowlands. Especially interesting are the new buildings under construction that follow modern anti-seismic design regulation at the higher elevations of the town that collapsed or underwent serious structural damages. In these areas, it seems that the nature of the founding ground which is composed of remnants of river deposits and debris of limited thickness on the rocky background played a determinant role. It is estimated that 30% of the building collapses observed in this town were located on similar deposits (Fig. 3). Finally it should be mentioned that schools, hospitals and tenths of factories and industrial constructions collapsed in the

greater urban area while all sort of infrastructure suffered serious damage. The estimated general intensity value in the area is on the order of VIII<sub>EMS-1998</sub>, while locally it approached IX<sub>EMS-1998</sub>.

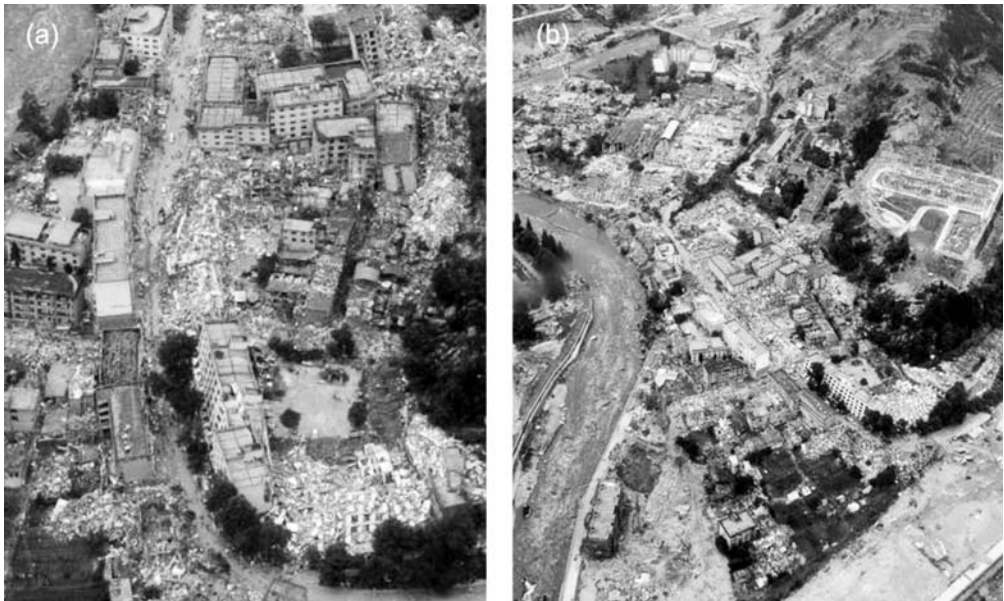
**Fig. 4:** Oblique aerial view of residential constructions in the Wenchuan and Beinchuan towns that suffered total destruction. These towns were founded on river terraces in the mountainous region. Large scale landslides on the surrounding slopes contributed to the destruction of the residential constructions (Xinhua News Agency China 2008, Reuters 2008).

In all settlements, the constructions collapsed or suffered considerable structural damage to an extent that exceeded 50% (Fig. 4). It is indicative that only a small percentage of the constructions, that did not exceed 20%, was left intact. In addition, infrastructures such as bridges, tunnels and dams either collapsed or suffered considerable damage. Finally, in the greater region, landslides and rock falls were recorded due to the high energy relief and the unconsolidated lithologies, that caused additional damage in settlements and infrastructure. The general estimated intensity for this region is  $X_{EMS-1998}$  and locally approaches  $XI_{EMS-1998}$ .

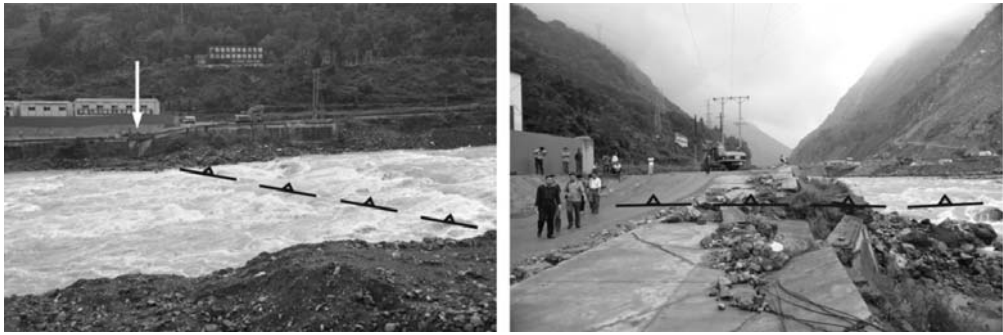
**Fig 5:** Views of the Yingxiu-Beinchuan seismic fault at the outskirts of Yingxiu town.

**C1.** As reported above, this earthquake generated a 220 km surface rupture along the Yingxiu-Beinchuan fault and a 72 km surface rupture along the Guanxian-Anxian fault (Figs 1, 5). Maximum vertical and horizontal displacements of 6.2 m and 4.9 m, respectively, were observed along the Yingxiu-Beinchuan fault, whereas a maximum vertical displacement of 3.5 m occurred along the Guanxian-Anxian fault (Hao et al., 2008).

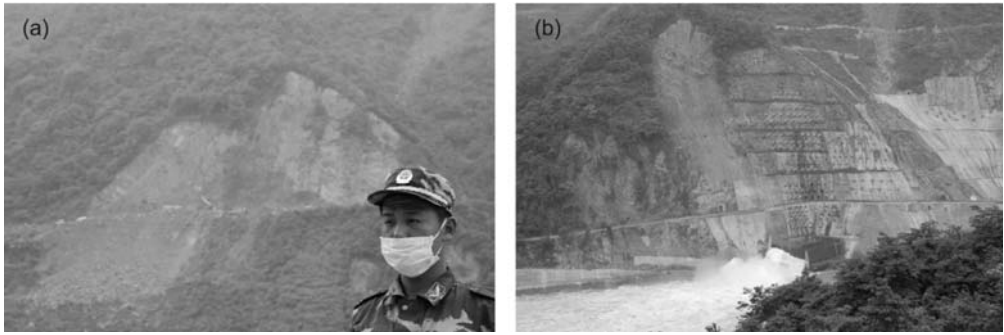
**Fig. 6:** View of large-scale landslides that were triggered in the mountainous region along river Min (a) and view of the Zipingpu Dam (b).

**C3.** Intense water undulations were recorded in the lakes of the area either due to the earthquake tremor or due to landslides triggered at the banks. It is worth mentioning that at the artificial lake of the Zipingpu dam the waves caused by the extensive landslides in the surrounding mountains exceeded 10 meters in height causing the death of about 100 fishermen.

**C5.** Large landslides and rock-falls ( $>10^5-10^6$  m<sup>3</sup>) were frequently recorded, practically regardless of equilibrium state of slopes (Figs 6, 7), causing many temporary or permanent barrier lakes. River banks, artificial embankments, and sides of excavations collapsed. Levees and earth dams incurred serious damages (Lekkas 2008b, Zhao et al. 2008, Xu et al. 2009).
