## Bulletin of the Geological Society of Greece

Vol. 43, 2010

## EVALUATION OF SOIL EROSION AND SUSCEPTIBILITY TO LANDSLIDE MANIFESTATION AS A CONSEQUENCE OF WILDFIRE EVENTS AFFECTED THE ZACHARO MUNICIPALITY, PELOPONNESUS, GREECE

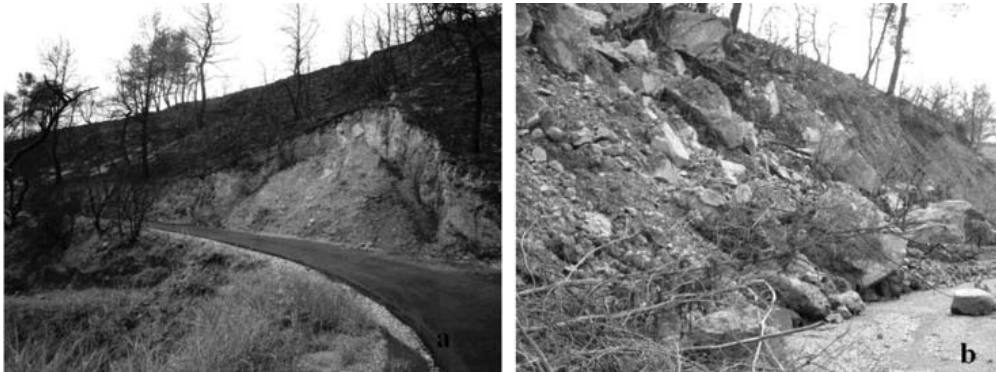
**Fig. 5:** Significant Landslide phenomena in (a) the road of Koumouthekla – Makistos and (b) outside the Koumouthekla village.

The instability problems were mainly connected with the neogene sediments, the flysch formations and the schist-chert series of Pindos zone. They were also observed in highly weathered zones of carbonate formations and in sites where the main discontinuity systems of the rock formations had the same direction to the natural or artificial slopes. They appear in large cultivated areas and on the main road network (Fig.5a & 5b).

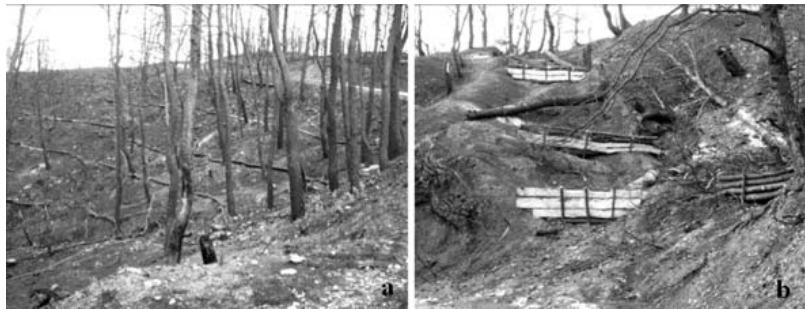
**Fig. 7:** Log or brunch barriers (a) and small wooden dams (b) for soil erosion protection.

Regarding the construction of log-barriers on slopes, the burned trees should have been cut down, trimmed, and their branches and/or logs should have been placed on the ground along certain contour lines (Figure 7). As a result, water runoff is not permitted to follow a straight down-slope path. The water is forced to meander back and forth between logs; thus is reducing its velocity and allow water with sufficient time to percolate into the soil. Log-barriers of 3 to 9m long and 40 to 60cm in diameter should be used in areas of high vulnerability indicated by the model (Fig. 6).

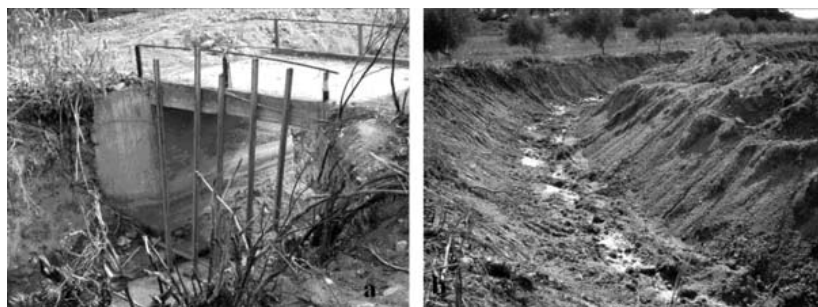
**Fig. 8:** Debris Rack (metallic fence) (a), widening and clearance of river network (b).

The debris racks (metallic fences) have to be installed in the main drainage pathways and for working effectively, the local authorities are obligated to continuously inspect and when necessary remove the captured material (Fig. 8a & 8b).

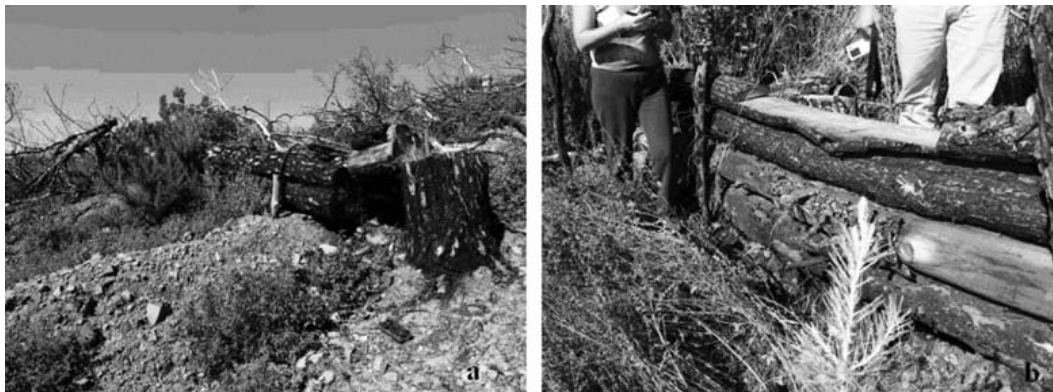
**Fig. 9:** Failure of log-barrier (a), and effective implementation (b).

Evaluating the applied measures, it was revealed that the grain size of the material produced by soil erosion processes is a significant factor for the effectiveness of the log-barriers. Indeed, large amount of fine-grained material makes the effectiveness of the log-barriers insufficient. The consequences of the present high or low amount of fine-grained soils are shown in Figure 9. Finally, the construction of log-barriers in carbonate formations was found to be inappropriate having in most cases negative influence.
