## APPLICATION OF TERRESTRIAL LASER SCANNING (LIDAR) IN ROCK SLOPE STABILITY. AN EXAMPLE FROM NORTHERN GREECE

*The scope of this study is to investigate the failure mechanisms of the eastern coastal zone of Mount Athos, using the LiDar device for the 3D mapping of the structural features of the rock mass. Therefore emphasis was given to the study of the planes of discontinuities that can trigger potential failures. All slopes were scanned by LiDar device in order to capture their structure and especially the orientation and the spacing of the discontinuities. The data were processed in order to produce the microtectonic model of the slopes and evaluate the potential slope failures. Finally some remedial measures are proposed. The results and the reliability as well as the constrictions of the applied methodology are discussed for future applications.*

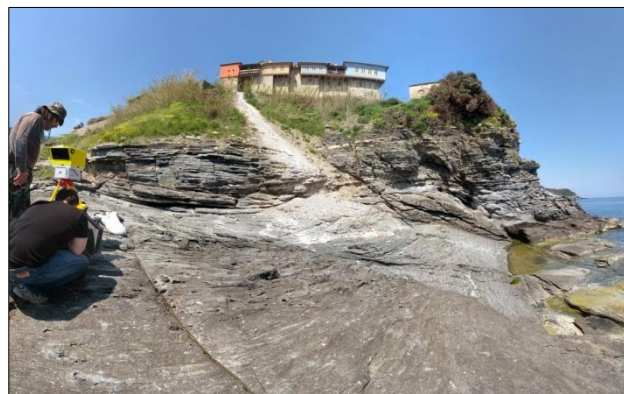
**Figure 1 - The LiDar device used for the scanning of the slopes of the Pantocratora's Holy Monastery, Agio Oros (Triger Geologists-Consultants, 2014, personal communication).**

The advantages of the device are numerous: The target can be a wide range of materials (rock, clouds, rain). Scanning can be performed from a distance even in inaccessible places, and exported results are of high-resolution. The most important is the high quantity and density of measurements (Monserrat and Crosetto, 2008). Finally, scanning and data processing consume less time. There are three types of equipment. The terrestrial which is mounted on a tripod, the mobile type on any vehicle or onboard and the airborne that uses an aircraft. For the present investigation a terrestrial LiDar scanner of Optech company was used with scanning distances specifications 3 to 1000m and accuracy of 14mm. Figure 1 shows the device scanning the southern slope around the monastery.

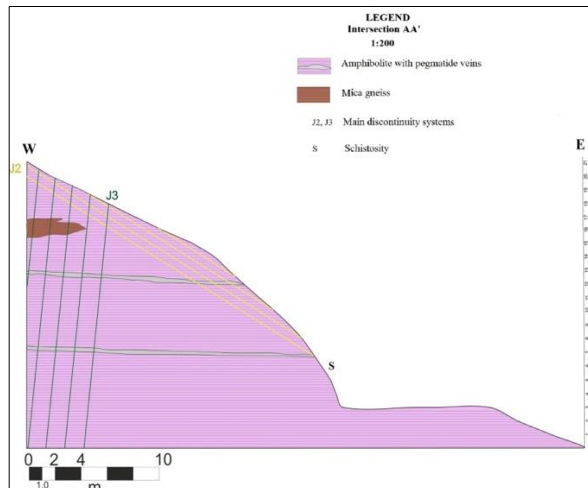
**Figure 3 - Cross-section at location #No.2(058°/096°) (Discontinuities are shown indicatively).**

The site specific area of the Monastery is a rocky hill at the end of a forested slope. Almost vertical slopes are formed next to the sea front with a maximum height of 30 m. Geological mapping in the investigated area showed amphibolites with intercalations of pegmatite veins and mica gneiss (Figure 2). Cross-sections #No.2 and #No.9 reflect the geology, geometry and tectonic structure of the slopes (Figures 3-4).

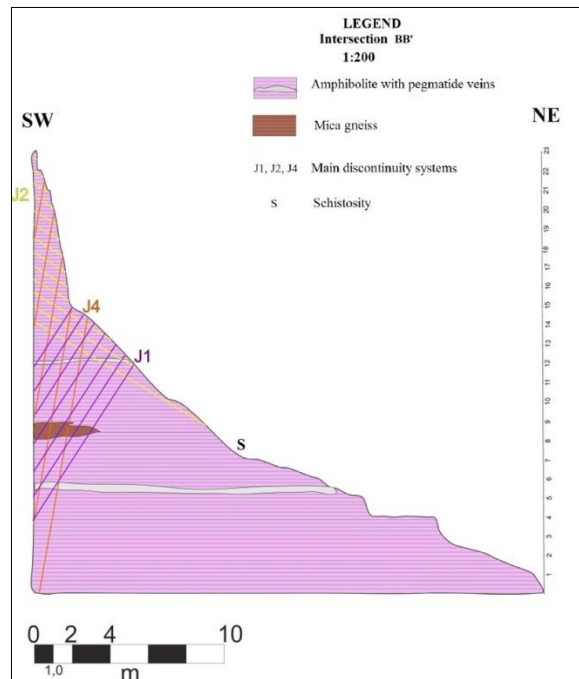
**Figure 4 - Cross-section at location #No.9(082°/058°) (Discontinuities are shown indicatively).**

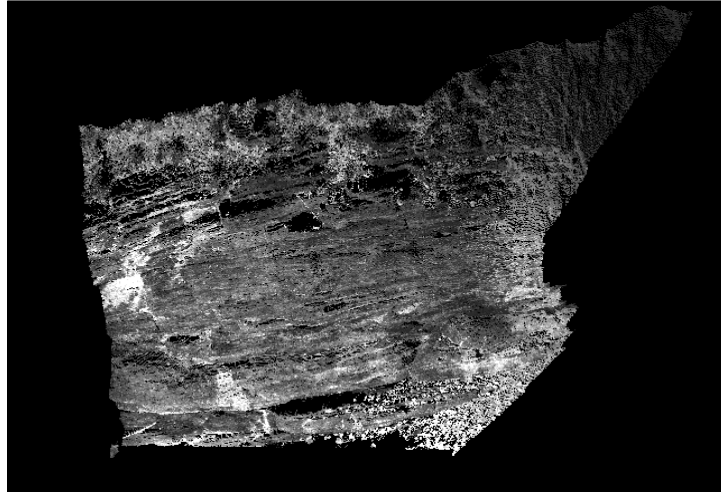
**Figure 5 - The point cloud of a slope of the area as seen via Split-FX software (Split Engineering, 2010).**

The slopes were scanned by the terrestrial laser scanning (LiDar). The scattered light is collected by an optical lens and driven in the shooting and recording system. The output of the scanning is referred to as "point cloud" and consists of millions of points that represent a three-dimensional form of the respective surface. After the scan software that can process the point cloud should be applied. Each manufacturer usually includes their own software. For our investigation the Split-FX software (Split Engineering 2010) was used (Figure 5).

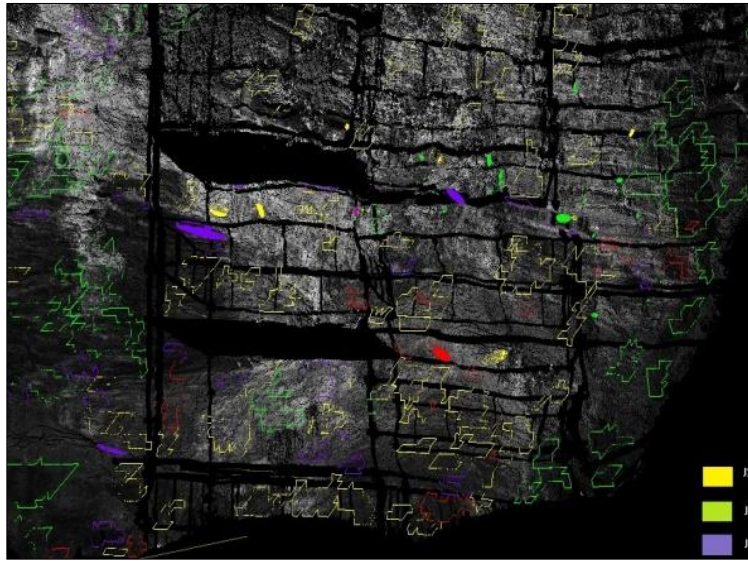
**Figure 7 - Major planes of discontinuities as derived from Split-Fx.**

Subsequently it is essential to produce the main families of discontinuities. Discontinuities with similar dip/dip direction belong to the same group/family and have the same behavior at a potential failure. The Split-FX enables the use of a Schmidt stereographic projection. Figure 7 shows the final format of the point cloud after the above mentioned process at position #No.9. Finally, the spacing of each set was measured which helps to override discontinuities that are superficial and give emphasis to persistent ones which influence most the slope stability. This helps also to estimate the volume of the potential rock blocks, which is beyond the scope of the present paper. Finally the spacing measurement gives a more realistic model of the slope.

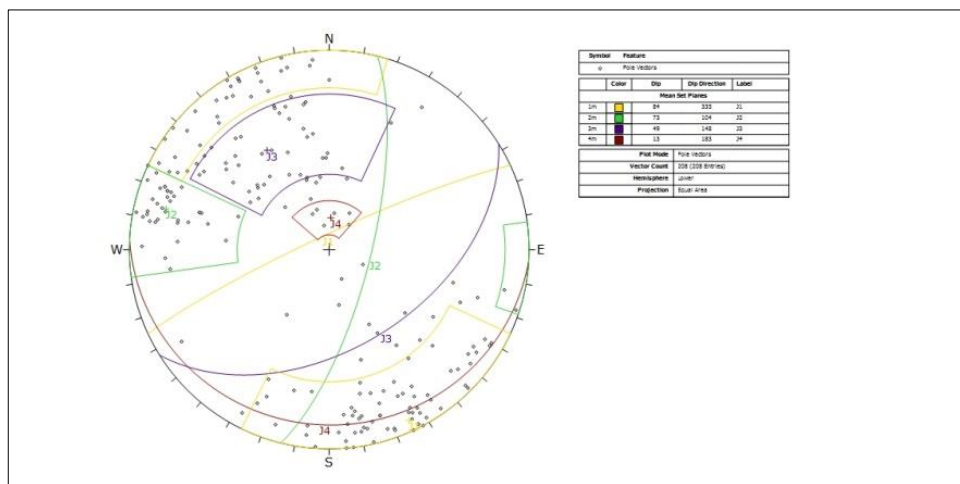
**Figure 8 - Schmidt diagram showing the sets of discontinuities of the location #No.9 as derived from Split-Fx.**

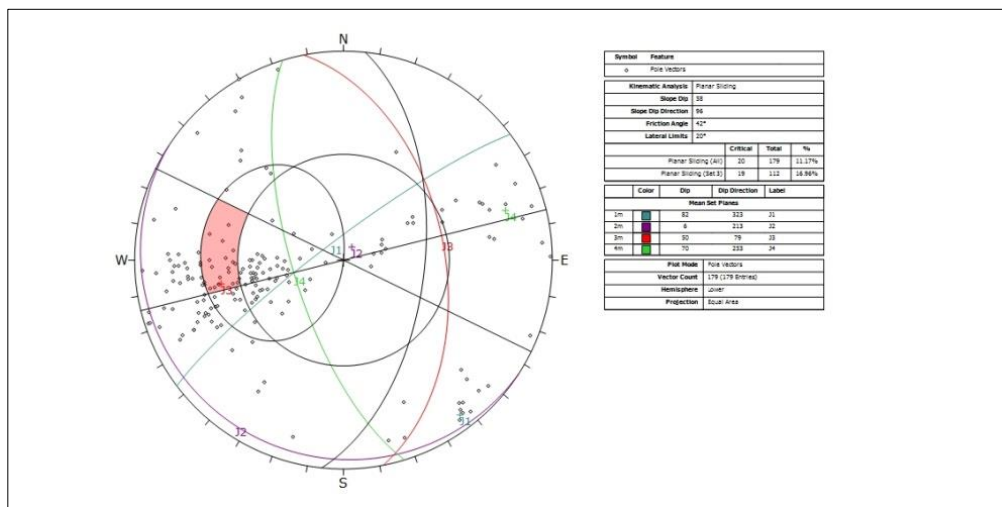
**Figure 9 - Potential planar failure in location #No. 2.**

Kinematic analysis was carried out for every location so as to evaluate the potential failures. Location #No.2 produced planar, wedge and flexural failures and direct toppling, while location #No.9 produced wedge failure and direct toppling. Figure 9 shows an example of kinematic analysis at location #No.9.
