LANDSLIDE GEOHAZARD FOR PIPELINES OF NATURAL GAS TRANSPORT

GROUNDWATER QUALITATIVE CHARACTERISTICS OF MYGDONIA BASIN. INVESTIGATION OF THE POLLUTION SOURCES AND SUITABILITY FOR HUMAN USE

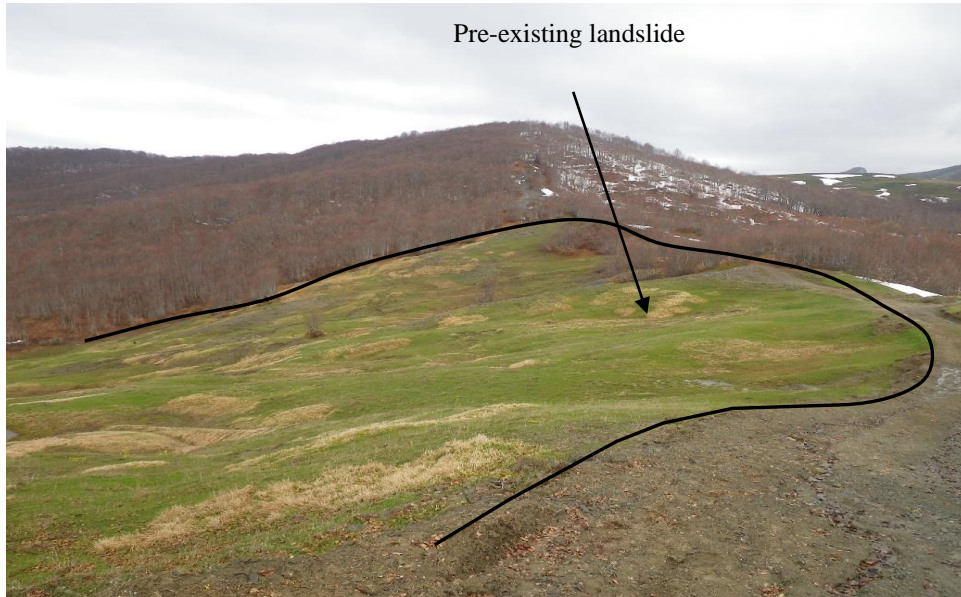
Figure 1 - Pre-existing landslide on the flank of a ridge, where a pipeline route runs.

- reactivation of pre-existing landslides where part or all of a previous landslide mass is involved in new movements, along pre-existing shear surfaces (Figure 1).

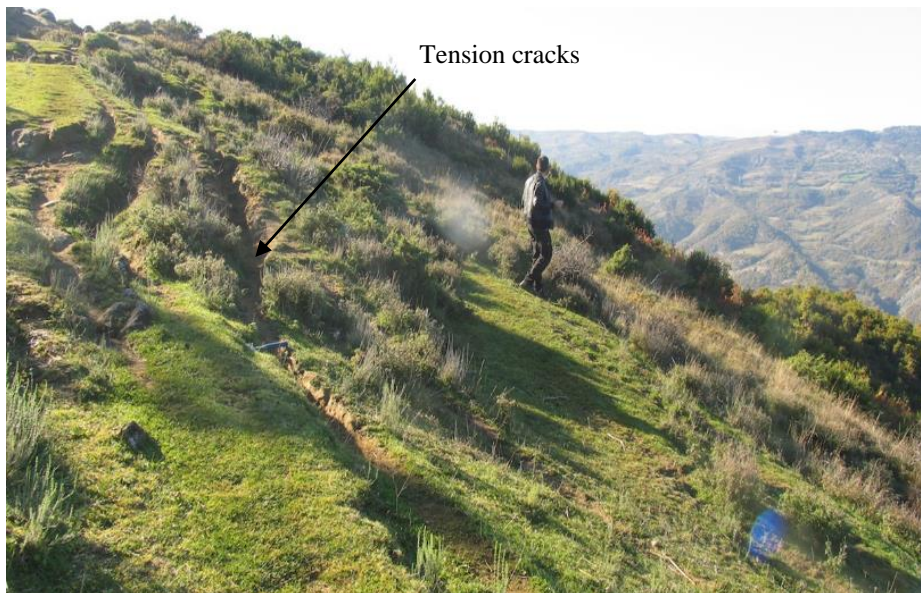
Figure 2 - Tension cracks along a ridge flank, indicating potential for upslope retrogression of pre-existing landslides.

- expansion of a pre-existing landslide, typically involving uphill or lateral retrogression of the main landslide head (Figure 2 and Figure 3), or the downhill advance of debris lobes on the toe area.

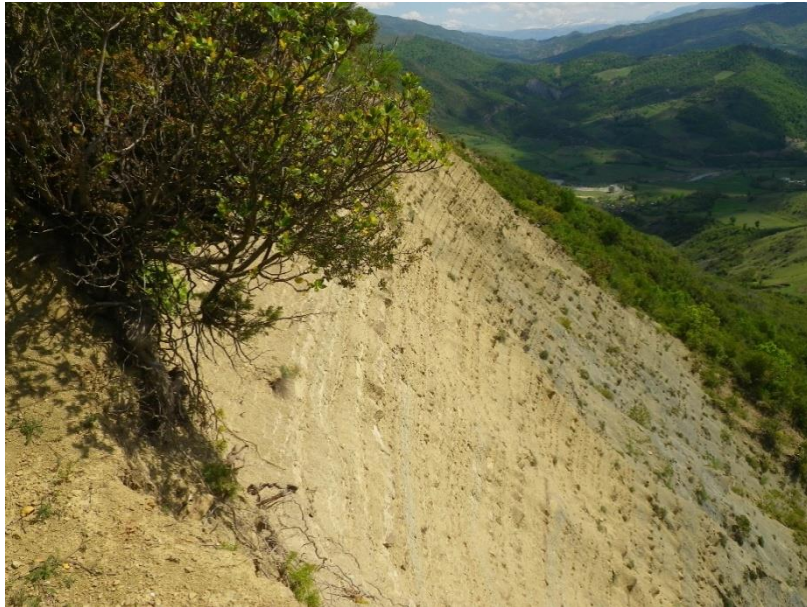
Figure 3 - Very steep landslide back scar extending to the ridge crest, with potential for further upslope retrogression.

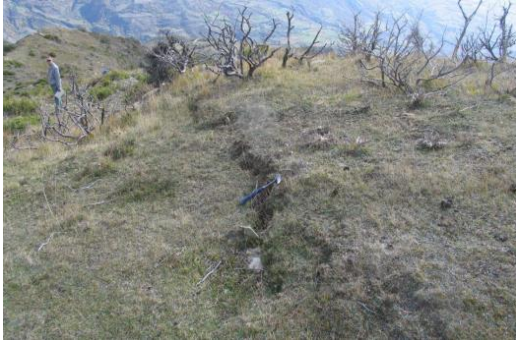
Figure 5- Fresh cracks.

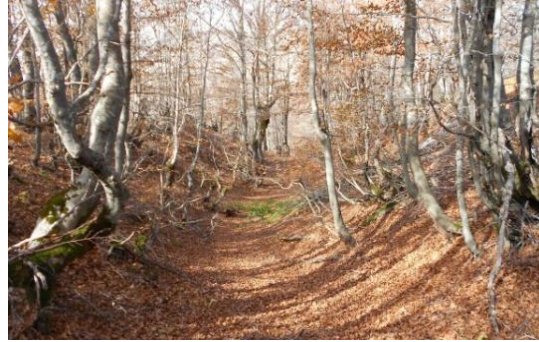
Figure 6 - Opening at the top and parallel to the ridge indicating movement.

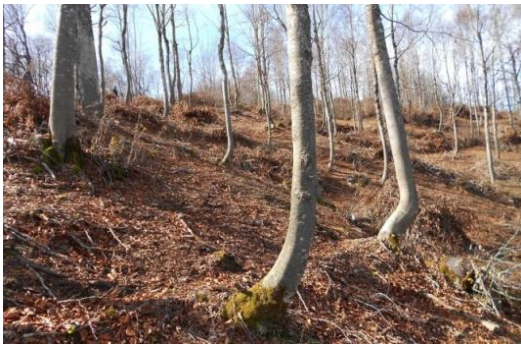
Figure 7 - Deformed vegetation due to landsliding. The knick of the trunk points to the movement direction.

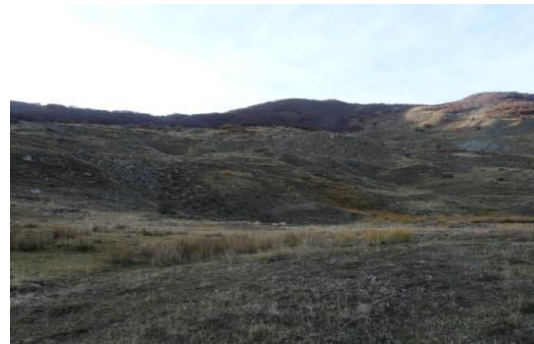
Figure 8 - Visible irregularities in topography.

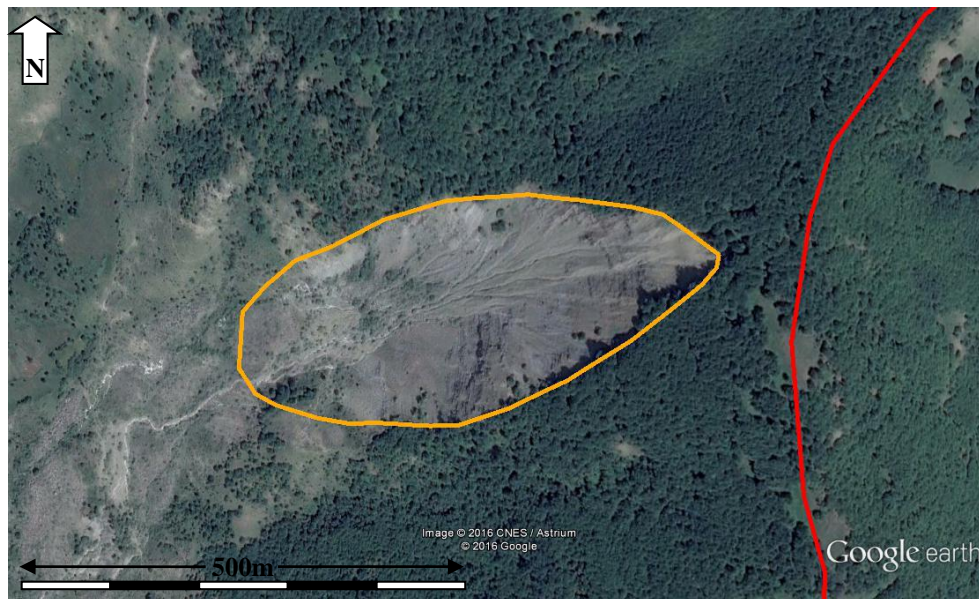
Figure 9 - Overview of a geohazard area (orange line) in close proximity with a proposed pipeline RoW (red line). In such cases, avoidance by rerouting is the preferred option. When the landslide hazard is not avoided, it must be feasibly constructed, with reasonable low risk or reasonable engineering remedial measures.

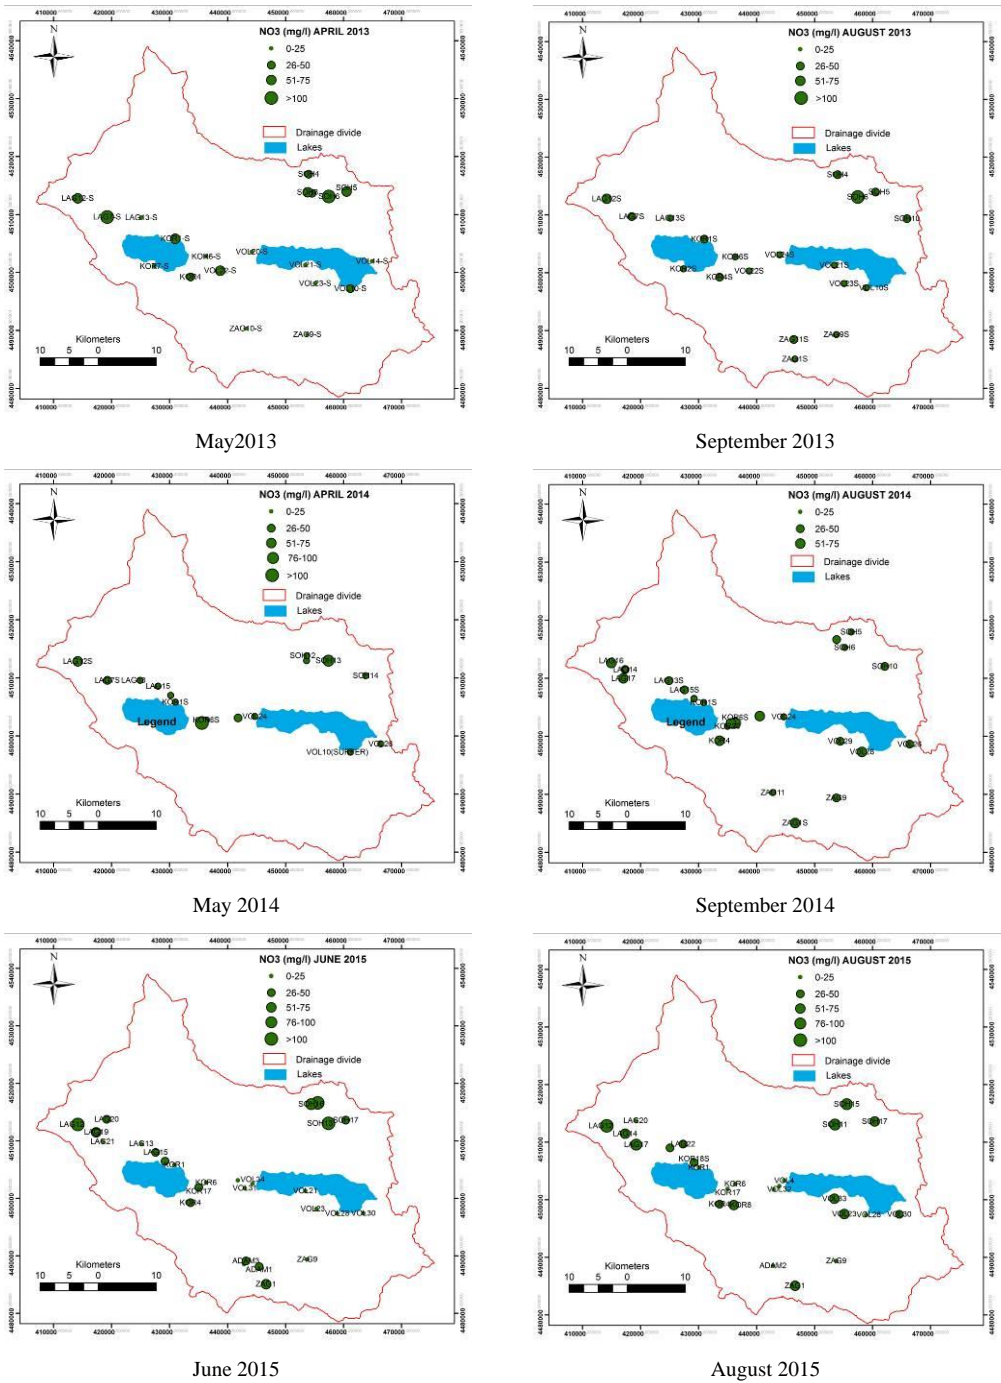
Figure 5 - Spatial distribution of the nitrate ions (mg/l) in the study area.

The results of the chemical analyses and the time period of the groundwater sampling are depicted in Table 1. The spatial distribution of the Electrical Conductivity, sodium and nitrates is depicted in the Figures 3, 4, 5. The aforementioned parameters were selected as the most indicative of water pollution for the area, but a brief description of all the measured is given in the text. Regarding the Electrical Conductivity there is no significant fluctuation for the different sampling periods in the values of this parameter. The highest values were measured in the west part of Lake Koronia at the village of Irakleio (values higher than $1200 \mu\text{S}/\text{cm}$) and are attributed to human activities. According to testimonies of the residents an industry in the sector of textile dyeing operated in the area for many years. The wastes were disposed in a surface channel. Pollution of the aquifers due to the interaction with the waste is possible. In the southern part of the area close to the village Adam high values of electrical conductivity were observed due to the geological formations of the area. *The magnesium values remained constant during the water sampling periods. High concentrations of*
