COASTAL CLIFF INSTABILITY, A CASE STUDY FROM THE UK

Saroglou C.¹ and Alexandrou D.²

The present paper presents the conceptual ground model for coastal cliff retreat and instability. Cliff instability has been intensified due to climate change in the last years, especially by sea level change and high windstorms. A case study of cliff instability in the SW coast in the UK is presented. The stability of the cliffs is primarily controlled by the presence of tensile cracks parallel to the cliff face and intersecting fractures as well as undercutting of cliff base due to wave action. The cliff instability mechanisms were identified for different locations along the shoreline and the cliffs were classified according to the cliff behaviour unit approach.

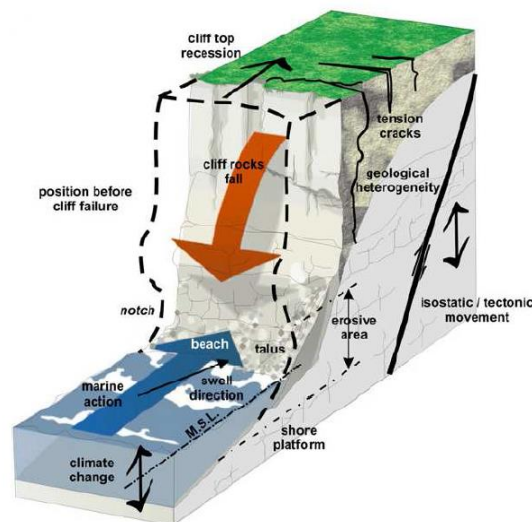
Figure 1 - Conceptual ground model of coastal cliff unit, representing geomorphological and erosive processes.

The conceptual ground model should describe the range of processes that can modify the geotechnical properties of the initial rock type (weathering, tectonic activity, erosion, solution, sea level changes, etc) and the effects on the geotechnical parameters. A conceptual ground model for the description of the cliff erosion processes is illustrated in Figure 1 (Castedo *et al.*, 2012).

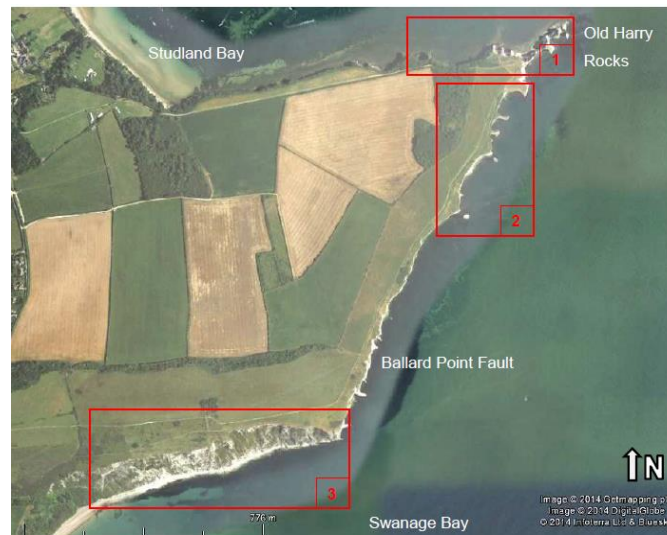
Figure 3 - Study area divided in 3 sections based on the Cliff Behaviour Unit approach.

The study area was divided in three sections based on the type of cliff failure and the cliff behaviour unit approach, as shown in Figure 3. The first section is facing north and located in the Studland Bay. The rates of erosion in this area are lower because the cliffs are not susceptible to great wave energy due to their orientation. Moreover, the existence of shore platform in front of the cliffs is reducing the wave energy. Also, the wave energy had produced, in some cases, under-cutting or over-steepening of the cliffs' toe.

The second section is facing east, towards the Isle of Wight. In this area, the rates of erosion are expected to be greater. In various cases, the existence of notch as well as structurally controlled failures has been observed. The third section is facing south and located in the Swanage Bay. A completely different type of failure is taking place in this area, mainly due to different bedding orientation (vertical) and the lower quality of the rock mass. The instability conditions of sections 1 and 3 are presented in the next paragraphs.

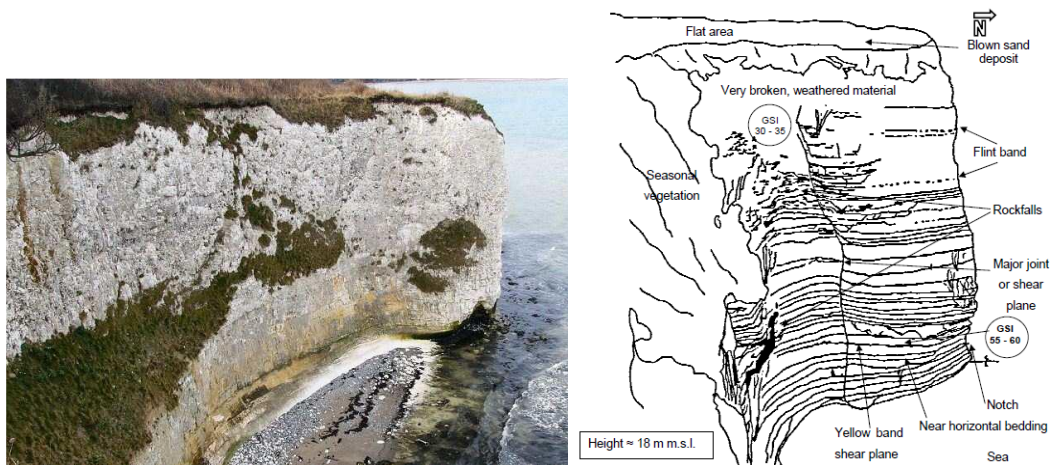
Figure 4 - Section 1, a) photo b) cliff stability block chart.

The bedding in section 1 is near-horizontal (8°) and dips towards North. The height of the cliffs has a range between 15 m and 20 m. The chalk can be possibly divided in two subunits.

The border line between these units is most of the times a yellow band parallel to the bedding. The pattern of the fractures in the upper part is very dense and creates blocks of a rectangular or even triangular shape. The bedding is thinner than the bedding in the lower part. The lower part has not only thicker bedding, but the rock mass is also less fractured. Furthermore, the yellow band was used in almost all cases as a reference bed. The conditions are summarised as follows:

- The shore platform and the orientation of the Studland Bay reduce the wave energy.
- Fronting beach is protecting the cliffs.
- Clear evidence of notch formation on the right side of the photo. The rate of notch formation cannot be calculated.
- Very weathered upper part of chalk. Thinner bedded.
- Minor instabilities in the upper part of the Chalk. Joint controlled failures.
- Generally stable. Phase 1 of the recession cycle.
- Increase of vegetation height and surface area, shows stable conditions.

In terms of CBU, this section is characterised as “simplified cliff – topples and falls”. In specific sites, it was observed that the failures follow a characteristic and repeatable type of failure. In order to determine the retreat rates of the section, a longer observation period was necessary as whole cycles of recession need to be observed.

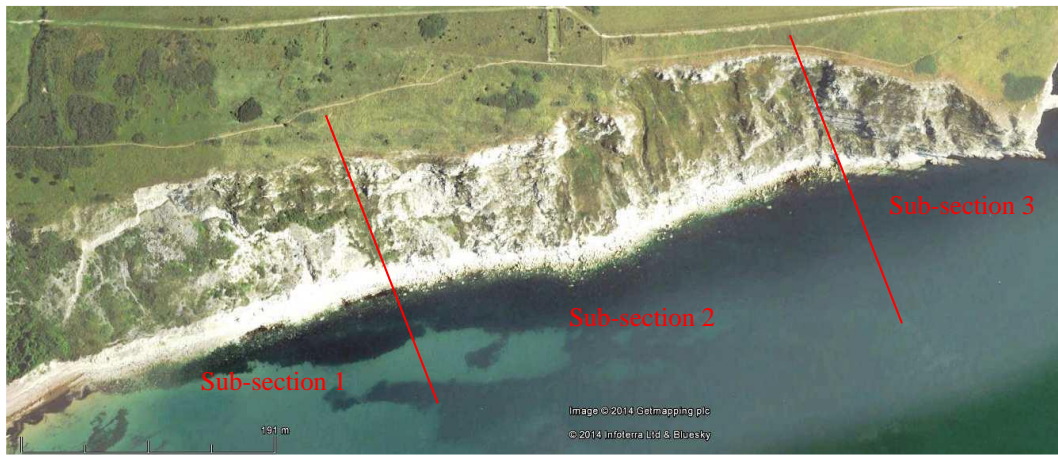
Figure 5 - Section 3, a) photo b) cliff stability ground model (block chart).

A general ground model of section 3 is presented in Figure 5, illustrating the various geomorphological features, the mechanisms and types of cliff instability in this area.

The conditions in characteristic points (1 to 4 in Figure 5) along the cliff are described. In point 1 they are summarised as follows:

- High rates of retreat. Significant changes in 5 years.
- No protection from wave energy. Generally unstable.
- Phase 1 of the recession cycle on the left: Under – cutting.
- Phase 4 of the recession cycle on the right: Debris removal
- Structurally controlled instabilities
- Height from the sea level \approx 90 m
- Seasonal vegetation shows only temporary stability

- High rates of retreat. No protection from wave energy.
- Rotational landslide. Unstable due to constant toe undercutting.
- Constant instabilities. Rock falls and under-cutting of the failed mass.
- Phase 4 of the recession cycle on the right: Debris removal.
- Structural controlled instabilities in the upper part of the slope.
- Height from the sea level \approx 100 m.
- Seasonal vegetation shows only temporary stability.

Section 3 was divided in three sub-sections (Figure 5) according to the type of failure that has been observed. The first sub-section is located in the western part and consists of a large rotational landslide. Close to the toe of the landslide, some remaining features of an older and smaller landslide can be identified. This area is slowly eroded by wave action and can be characterised as an earlier stage of the sub-section 2 (middle part). The main triggering factors are the under-cutting of the toe of the landslide due to wave erosion, the freeze-thaw action and the wind erosion. In terms of recession cycle it can be identified that the sub-section 1 is at the last stage (debris removal).

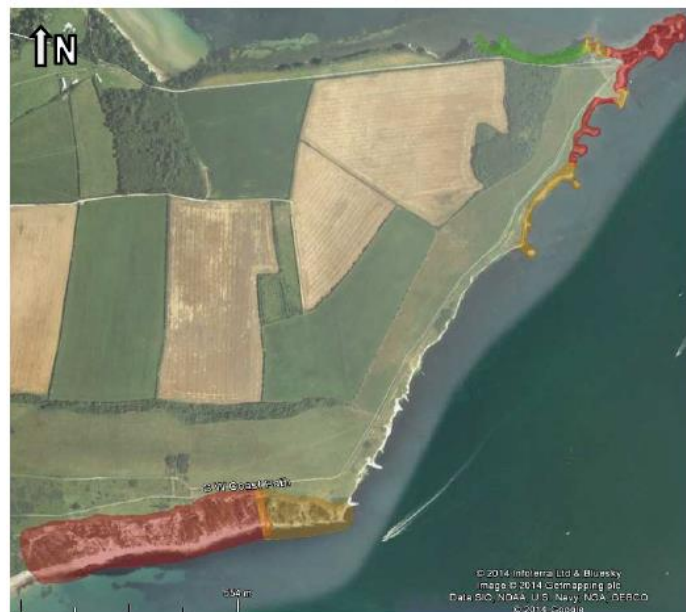
Figure 6 - Coastal cliff instability map.

It was found difficult to calculate accurately the rate of cliff retreat in the study areas. The rates have been calculated from historical. The need of accuracy in the calculation requires the use of good quality aerial photos. A preliminary assessment of cliff instability was performed and presented in Figure 6. The unstable areas are identified in red, while the stable areas in green colour. The areas that seemed stable during the site investigation but are categorised as areas of potential higher instability denoted in orange.
