TECHNOGENIC CHANGE OF THE GEOLOGICAL ENVIRONMENT OF URBAN AREAS (BY THE EXAMPLE OF IRKUTSK TOWN)

Abstract

The paper discusses engineering-geological problems of urban areas, among which are geohazards like flooding, suffosion subsidence, erosion, and gravitation. It is the concern of the research to do both natural and industrial effect analyses. A detailed historical-geological evaluation has been made of urban spatial development as one of the main geological environment modification factors.

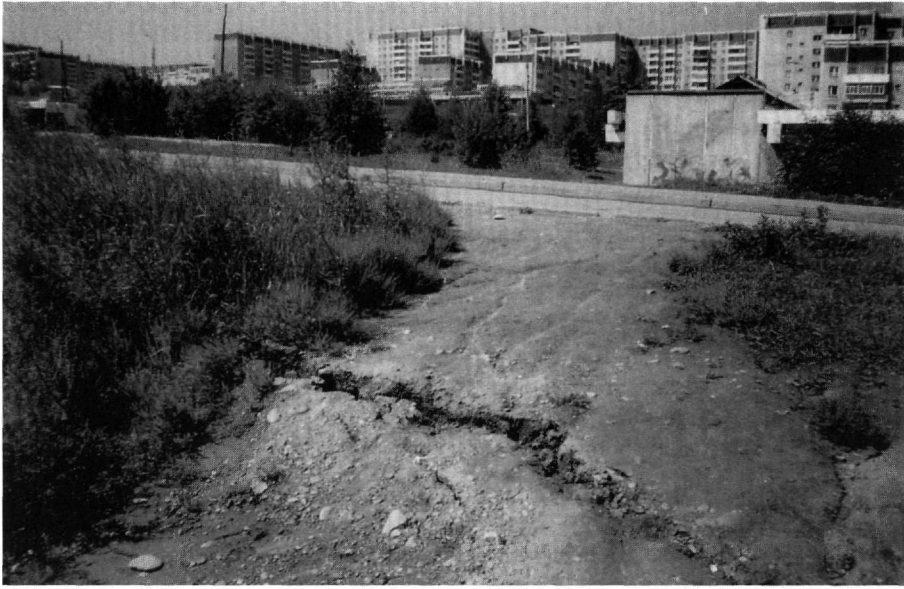
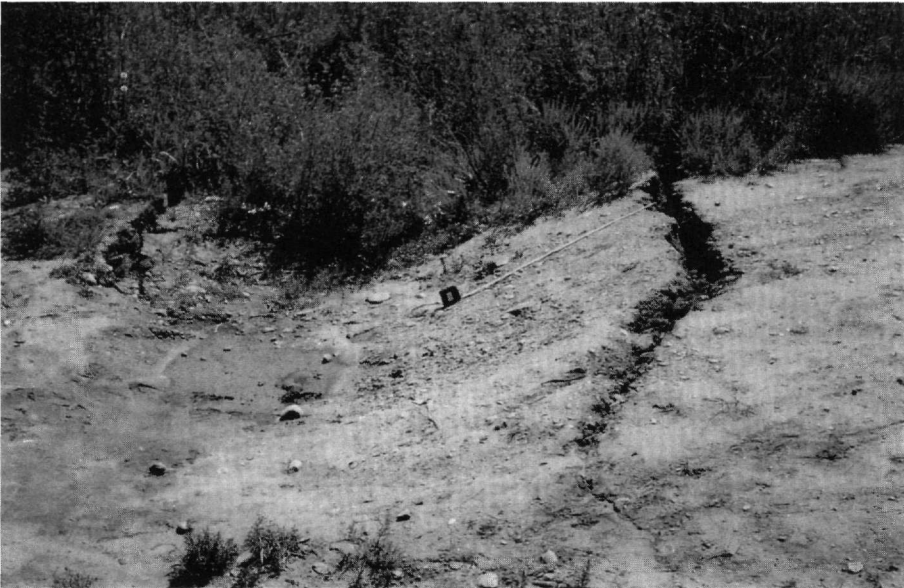
Figure 1 – The suffosion-subsidence processes above the underground sewer systems

As of now, most of the area of Irkutsk is covered by underground water-bearing pipeline network. Underconsolidation of soils after the backfill results with time in soil shrinkage and its surface or internal erosion. The formation of underground cavities and leaking are responsible for suffosion along the pipelines. The observed suffosion subsidence processes are confined just to the area of influence of the underground water-bearing pipeline systems. In response to the rupture of 200-m long pipeline section in Universitetsky housing complex 10 large suffosion forms up to 2.8 m wide and 1.0 m deep occurred in one spring month (Fig. 1). Sinkholes and subsidence showed up there in loessal loams, for which a skeletal-aggregate microstructure (26.9 %) and a low free fine-clay fraction index (15.4 %) have been determined. The loams are carbonaceous, plastic (7.1 %),

middle-density (1.72 g/cm^3), and have a reduced strength in the water-saturated conditions (cohesion is 0.25 kg/cm^2 , internal friction angle is 31°).

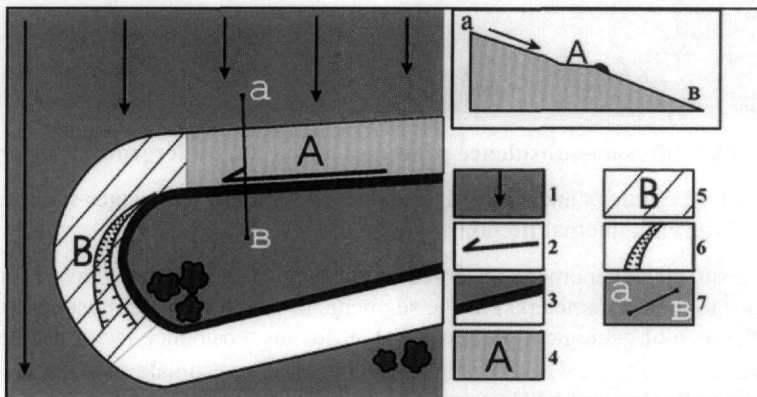
Figure 2 – Pattern of the formation of technogenic ravine (district Universitetskiy)

1 – the direction of the surface drain of the water; 2 – direction of the road incline; 3 – the roadside ground wall, which impedes the flow of the water; 4 – the zone of the concentration of the surface drain; 5 – the zone of the maximum speed of the aqueous flow; 6 – the ravine; 7 – the profile

In the spring-summer period of 2001 a gully to 1.5 m deep, 4 m wide and 15 m long was induced on the slope of the third terrace above flood plain (Universitetsky housing complex). Most of it is occupied by grassland vegetation with some grouped trees. The entire area was at one time a recreation zone unaffected by erosion. But the autodrome construction associated with scalping and land formation gave rise to erosion conditions. The deciding factor contributing to the formation of the gully was the surface runoff concentration on the slope-crossing trace, the side fence of which in its turn interfered with the downslope runoff. Because of this, the water flow down the road speeding up at the curve and acquiring a high destructive power that is responsible for the gully (Fig. 2).

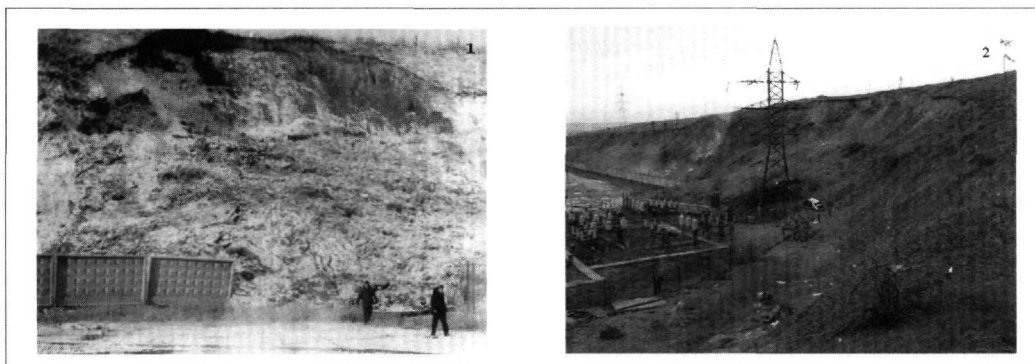
Figure 3 – Landslide on the slope of the quarry (in the area of the brick plant in the district of Novolenino) (1 – 1985 year; 2 – 2004 year)

The slide of another type is that in the wall of the brickworks quarry in Novo-Lenino (Fig. 3). In the middle 1980s the loess-like loams and sandy loames with interlayered clays and sands slid along the watered clayey horizon as a result of surface water concentration above the clayey level due to the water encroachment with the garbage dumping upwards the slope (Fig. 4). The debris accumulation slowed down the soil evaporation. The slid masses moved right up to some of the brickworks facilities and affected the high-voltage network support.

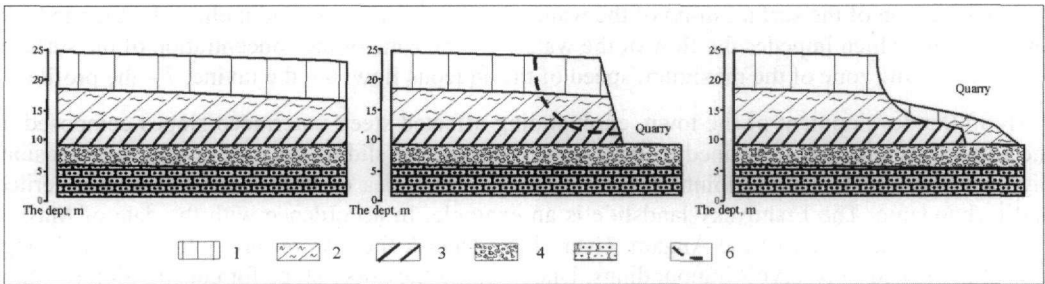
Figure 4 – The scheme of the landslide development (in the area of the brick plant in the district of Novolenino)

1 – loessial loams (horizon II); 2 - loams and sand dust with the interlayers of clays and sand (horizon I); 3 - clays and the loams of the floodland facies; 4 - gravel and pebbles with the sand; 5 – sandstones; 6 - boundary of the slip surface of the landslide
