## LANDSLIDE HAZARD ANALYSIS – A CASE STUDY IN KERASIA VILLAGE (PREFECTURE OF KARDITSA)

Matziaris V.<sup>1</sup>, Ferentinou M.<sup>1</sup>, Angelopoulou O.<sup>1</sup>, Karanasiou S.<sup>1</sup>, and Sakellariou M.<sup>1</sup>

<sup>1</sup> National Technical University of Athens, Faculty of Rural and Surveying Engineering, Department of Infrastructure and Rural Development Laboratory of Structural Mechanics and Engineering Structures, vmatziar@mail.ntua.gr, mferen@mail.ntua.gr, mgsakel@mail.ntua.gr

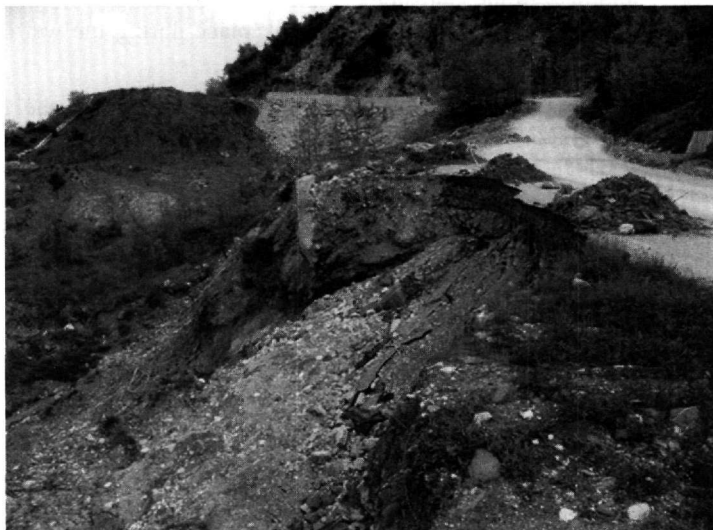
**Figure 3 - Landslide No1 (cross-section AA')**

For the purposes of the current research, site investigation in the study area took place in order to examine the site specific engineering geological conditions and locate recent landslides. Two active landslides were identified (Figs 3, 4).

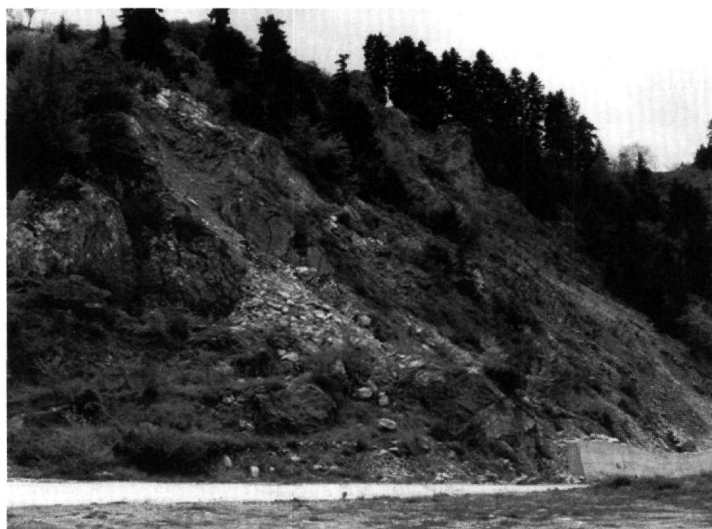
**Figure 4 - Landslide No2 (cross-section BB')**
