LANDSLIDE HAZARD ANALYSIS – A CASE STUDY IN KERASIA VILLAGE (PREFECTURE OF KARDITSA)

Matziaris V.¹, Ferentinou M.¹, Angelopoulou O.¹, Karanasiou S.¹, and
Sakellariou M.¹

¹ National Technical University of Athens, Faculty of Rural and Surveying Engineering,
Department of Infrastructure and Rural Development Laboratory of Structural Mechanics and
Engineering Structures, vmatziar@mail.ntua.gr, mferen@mail.ntua.gr, mgsakel@mail.ntua.gr

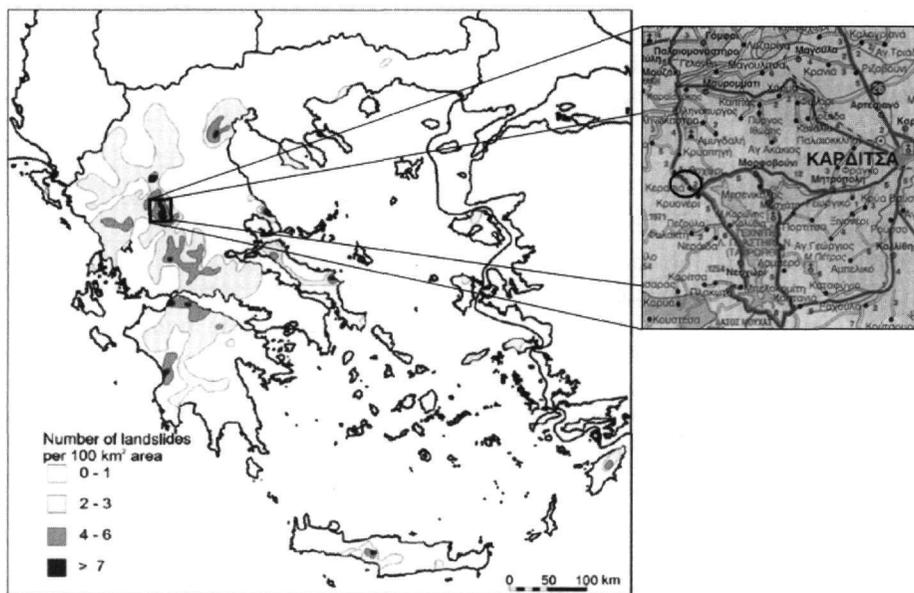
Figure 1 - Landslide hazard zonation map of Greece (Koukis et al., 2005). The study area is located in central Greece (prefecture of Karditsa) and has been indicated by the black box

In Greece there is a great number of registered but also unregistered landslides. According to Koukis (1992), landslides are fairly common in Greece, but most of them are quite small or shallow. However, a large number of villages have been relocated due to landslide events in the last 30 years. There are, also, considerable damages to roads and other constructions caused by landslide events. Over 80 % of landslides occur in the western and central parts of Greece, because of the combination of relief, rainfall and geological conditions (Koukis *et al.* 2005) (Fig. 1).

The results from the landslide hazard map, in Figure 8, come in deal with the map in Figure 1, which shows that the area is susceptible in landslide phenomena. A review of the landslide phenomena in the particular area was given in chapter 3.1, showing the great problem that exists there concerning slope stability. Our analysis confirms that this area faces serious instability problems, as there are slopes which are characterized unstable. The specific sites where instability problems exist are focused in the landslide hazard map and can be easily recognized. In these cases, remedial works are important in order to prevent landslide phenomena.

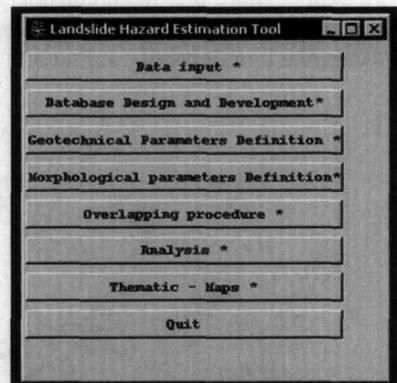
Figure 2 - The main menu of the tool "Landslide hazard estimation Tool".

In the current paper we used Landslide Hazard Analysis Tool developed in the Laboratory of Structural Mechanics in order to create a landslide hazard assessment map for a study area seriously suffering from landslide events. This tool was developed in ArcGIS environment (Arc/Info Workstation, ArcMap, AcScene) by (Ferentinou 2004, Charalambous, 2006) (Fig. 2). On the following sections the capabilities of the implemented computational tools used in examining the problem of slope stability will be described.

The methods of slope stability analysis are based on the hypothesis of a certain failure mode. The slope under study could fail under various failure mechanisms. Soil slopes, or highly weathered rock slopes usually fail under a circular failure mode while rock slopes usually fail under planar or wedge failure mode. In the current tool we have integrated planar, circular and wedge failure criteria, in order to estimate landslide hazard in an entire study area.

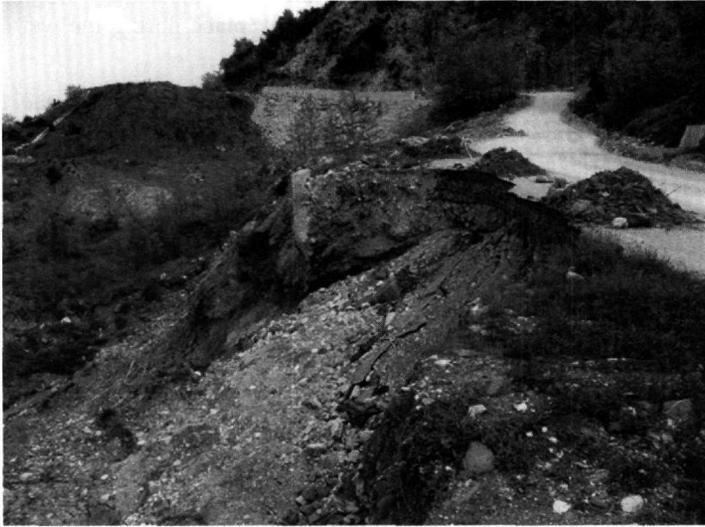
Figure 3 - Landslide No1 (cross-section AA')

For the purposes of the current research, site investigation in the study area took place in order to examine the site specific engineering geological conditions and locate recent landslides. Two active landslides were identified (Figs 3, 4).

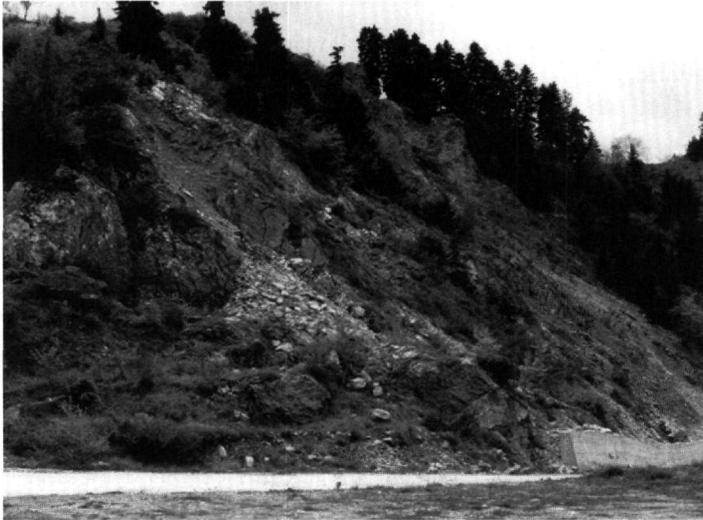
Figure 4 - Landslide No2 (cross-section BB')

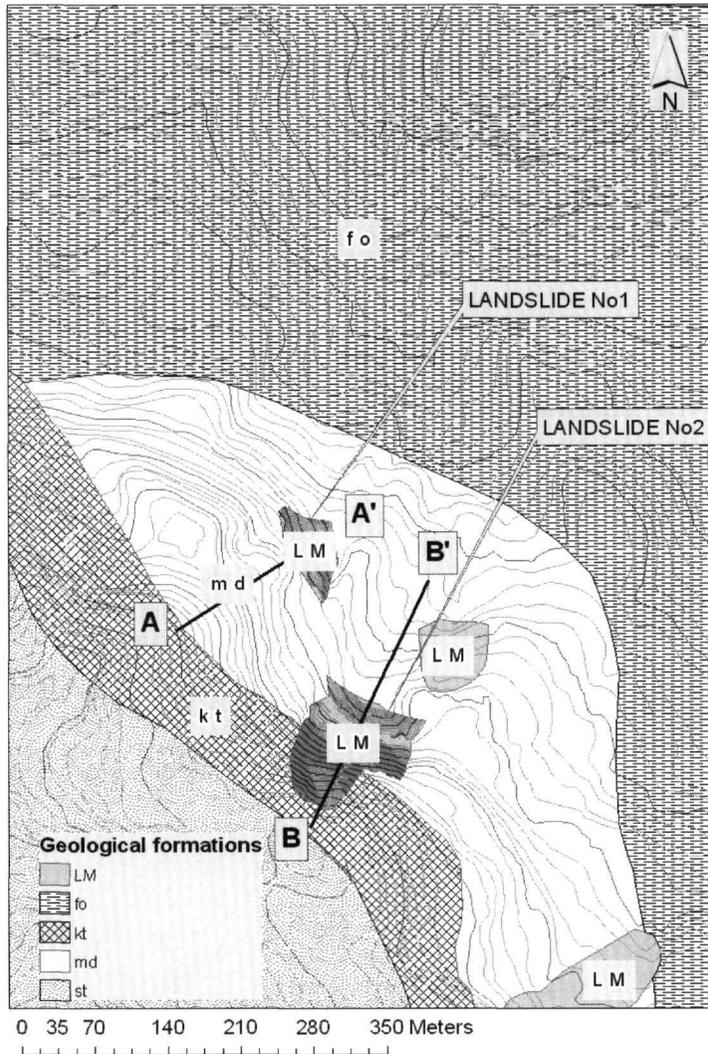
Figure 5 - Geological map of the study area. The identified landslides are indicated with the dark grey color. Also, the two cross-sections AA' and BB' are indicated

A survey of the two landslides (Fig. 5) was conducted using the Topcon pulse total station GPT - 7003 of 10 cc precision. Two stations were established on the wider area and the nearest points were aimed using a prism, while the inaccessible ones with a laser beam within a range of 250 m. The coordinates of the stations and consequently of all other points were computed in the Greek Geodetic Reference System 87 (GGRS 87).

The geology of the study area constitutes of the following formations (Fig. 5) from the most recent to the older formations:

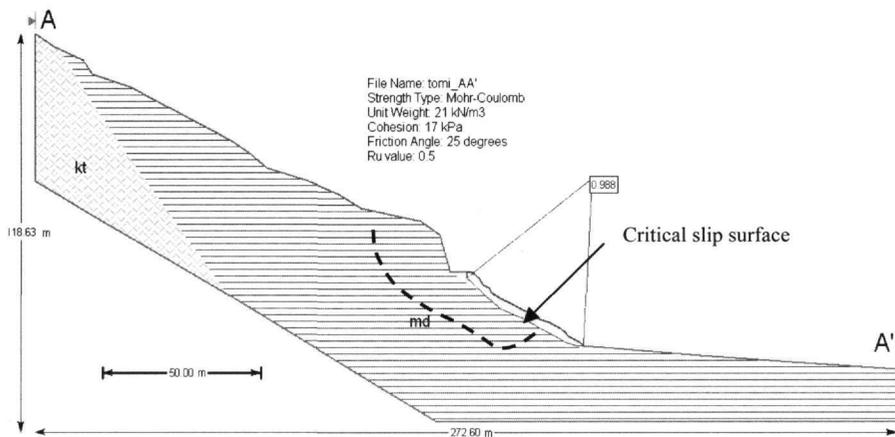
Figure 6 - Cross-section AA'

Prior to GIS analysis, a back analysis took place in order to get an estimation of the geotechnical properties of the formations in the area. For this reason, a limit equilibrium slope stability software was used, Slide v.5.0 provided by Rocscience Ltd. The two selected cross-sections are illustrated in Figures 6 and 7.

The selection of the geotechnical properties is based on the consideration that these two slopes were at limited condition at the time of failure, something which means that the factor of safety at this time was equal or near 1. Also, the pore pressure ratio r_u was used in the analysis, in order to simulate rainfall conditions. The value of r_u was selected to be 0.5, signifying saturated conditions after rainfall events.

In cross-section AA', a tension crack was taken into account, which was mapped during the site investigation. Again, this tension crack was considered to be filled with water, showing in this way critical conditions.

Slope stability analysis was performed, using Janbu method and in both cases, results can be characterized realistic. The failure surfaces actually follow the topography and also the surface

between the weathered material and the bedrock. Moreover, the type and morphology of the failures coincide with surveyed landslide boundaries. The determined values of the geotechnical properties of the LM formation are presented in Table 2.

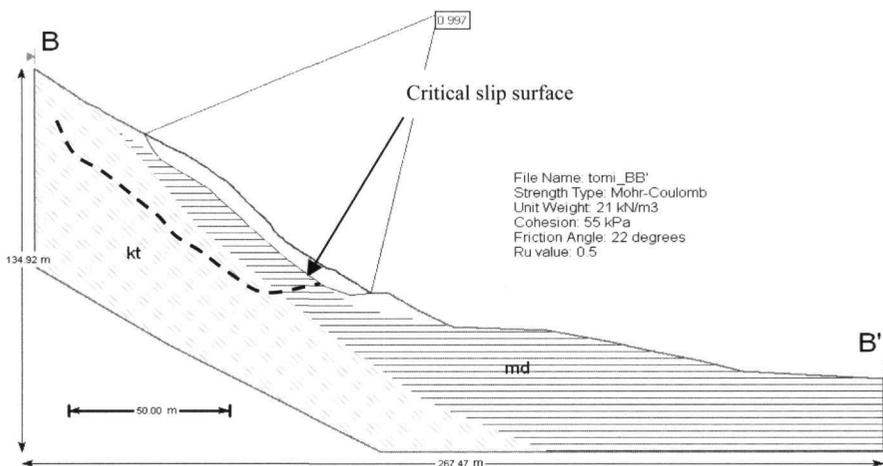
Figure 7 - Cross-section BB'

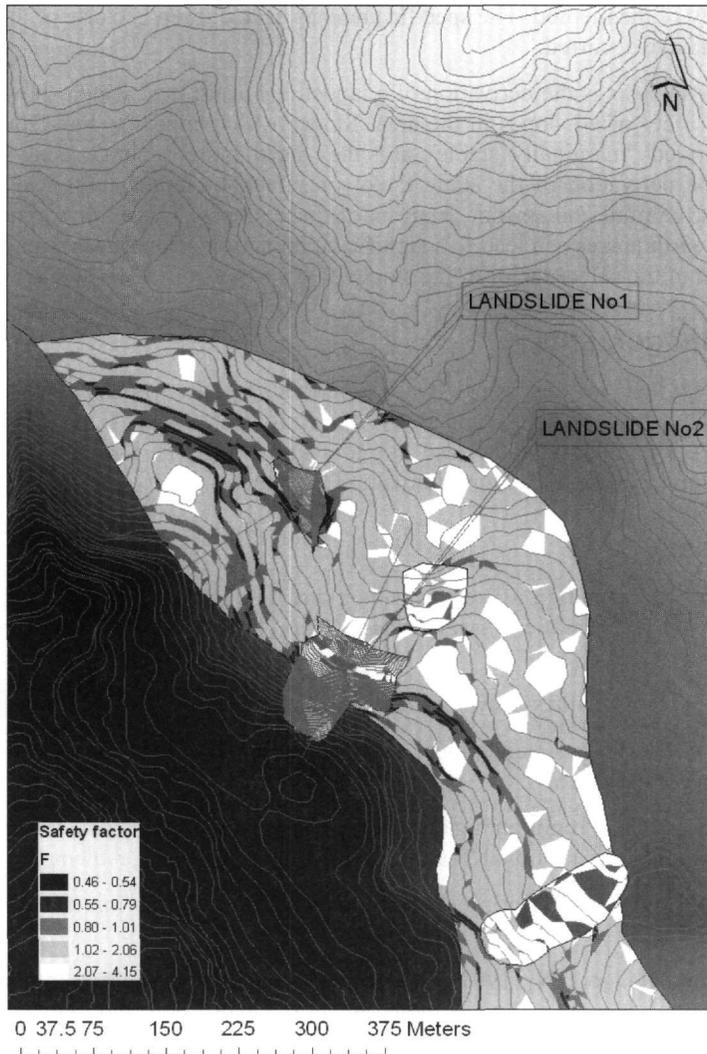
Figure 8 - “Landslide hazard map”

From the analysis with LHA, the landslide hazard map presented in Figure 8 was developed. This map illustrates the distribution of safety factor of slopes in the examined area. There have been determined five groups of FS values, from 0.46 up to 4.15. However, it is more important to consider three groups, i.e. slopes which have FS less than 1, these with FS between 1 and 2 and finally the slopes with FS greater than 2. Slopes which belong to the first group exhibit significant low shear strength and they are prior to instability. The area which includes these slopes is characterized as the “dangerous area”, where remedial measures have to be taken in order to prevent landslide phenomena. As can be seen in the landslide hazard map, the identified landslides in the area have been indicated with grey color, showing that the factor of safety for these slopes is below or near 1. For this group of slopes, a more extended and accurate analysis is needed in order to determine the exact value of FS and to define how other factors, like rainfall and earthquake, can affect their stability.

The second group includes slopes with factor of safety between 1 and 2. These slopes are characterized as marginally stable. For these slopes, and especially those which have FS greater than 1.4, there is no significant danger for failure and so they can be excluded from a more accurate analysis. However, if the FS is between 1 and 1.4, the impact of rainfall and earthquake in the stability of these slopes has to be determined because these factors can lead to a significant decrease of the shear strength of the soil. So, even when there seems to be safe enough, a slope can fail after an intense rainfall event or even after an earthquake. Also, it is important to determine the impact of unsaturated soil conditions, in addition to a rainfall event, as in this case there seems to be an important decrease in the shear strength of the soil, something which effects its stability (Matziaris *et al.* 2005).
