CHARACTERIZATION AND CAUSES OF BUILDING STONE DECAY AT THE ARTEMIS TEMPLE, BRAURON, E. ATTICA, GREECE

Tsipoura-Vlachou M.¹, and Michopoulos K.¹

Abstract

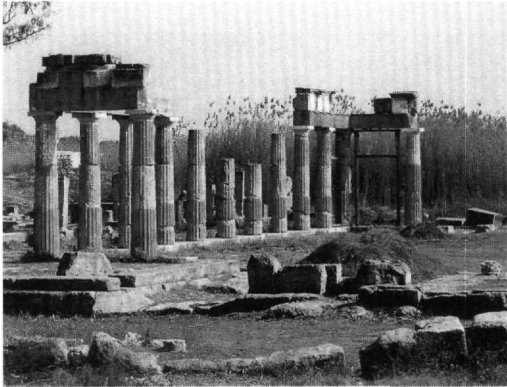
Figure 1 - View of the monument remains

2. Strong colour alteration- calcareous crust formation: observed in many column pieces having deep grey colour, instead of whitish-grey to beige colour of the new column pieces, used at the restoration, (Figs 1, 3, 14)

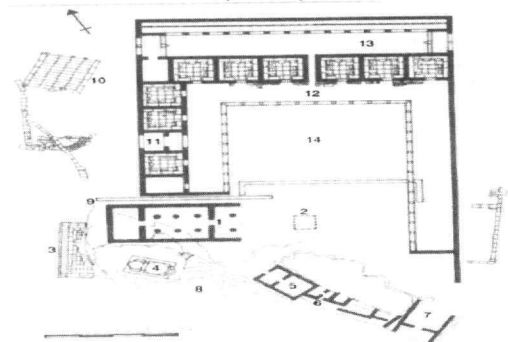
Figure 4 - Plan of Artemis Temple area. 1. Temple, 5. Iphigeneia heroon, 6. Iphigeneia tomb, 7. Sacred house, 12. Stoa 14. Courtyard

- From the building stones used for the construction of a. the II shaped Portico b. the connected rooms and c. the sacred house, the alter and the tomb of Iphigeneia, (Fig. 4).
- From the sandstone layers of the above-mentioned upper-Miocene formation where the ancient quarries were (figure 4). They are located in a near by hill 500m away from the temple, at northeast and the quarry traces are well preserved, (Buras 1967)

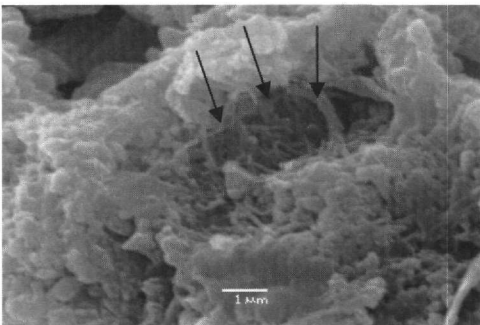
Figure 8 - Micromorphology development in pores

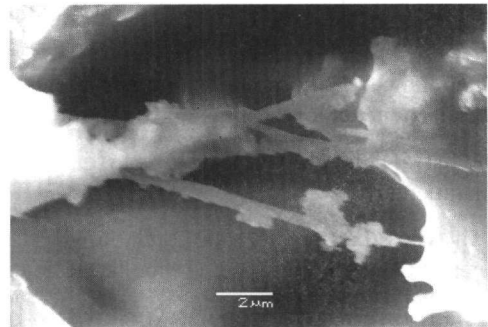
Figure 9 - Tiny crystals of halite

SEM analysis: Initial coarse calcite cement crystals are locally dissolute and secondary recrystallized calcite is formed. The locally presence of germs was observed. They have developed between the grains where the cement is dissolute (Fig. 8) and are bound to the grains. Tiny salt (NaCl) are developed in voids and pores creating bridges between grains (Fig. 9). Zircon also was found as isolated grains or constituent in rock fragments.

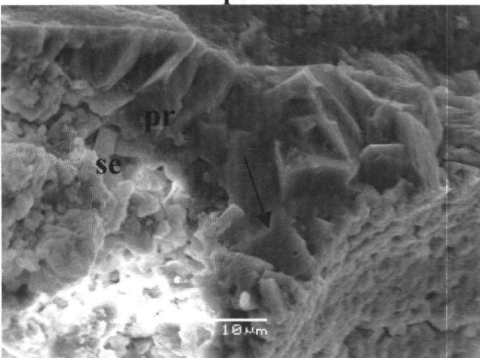
Figure 10 - Secondary calcite cement crystals (se), displaying coarser crystals than the primary calcite cement (pr), with dissolution pits (arrow)

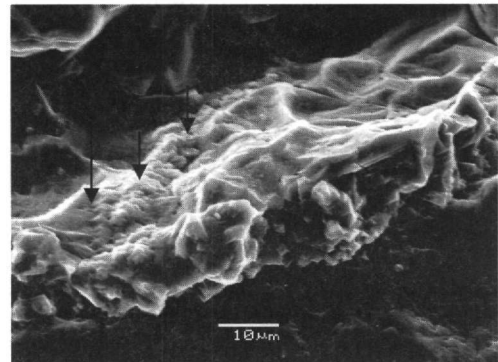
Figure 11 - Dissolution patterns and pits (arrow) on calcite cement, due to solution attack

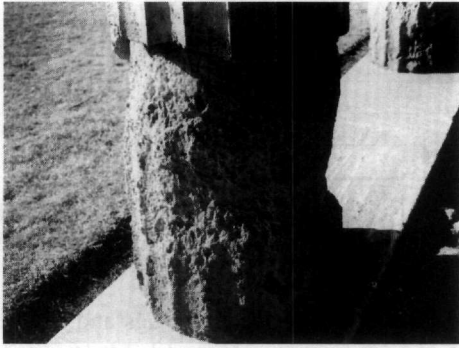
Figure 12 - Honeycomb decay of bottom column piece of type I sandstone, and shape alteration

1. Pitting corrosion to cavitation erosion of graduated degree: the presence of vugs and cavities, large enough, approximately of 1-4 cm mean diameter, is very extensive, (Figs 12, 13, 16, 17, 18, 19). These vugs that were observed on many different pieces of the columns, seem to have diminished not only the durability, but also the good appearance of the monument, (Figs 13, 14, 15). When the cavities are getting enlarged they are connected by “bridges” (narrow areas of rock), (figure 13). Eventually bigger pieces are loosening and the result is a complete alteration of the original grooves and progressively of the shape of the column pieces (Figs 12, 13).

A close inspection of the building stones indicates that in the restored monument pieces of stone found in situ and other new pieces display different degree of decay. For example in figure 12, the lower part of the column, characterized by great material loose was found in situ, whereas the upper part is a new piece. The different stage of deterioration between the weathered source rock and the decayed building stone is quite obvious in figures 22, 23, 24 and 25. In the pair of figures 22-23 and 24-25 under the same magnification, rock samples from the quarries and samples of the building stones that correspond to the same lithotype, I and III, are compared. The degree of decay of the building stones is obvious. The calcareous cement is been partly dissolute. Pits, pores and vugs have developed. Progressive dissolution of cement leads to the formation of bigger pores and cavities. These cavities may be connected by narrow areas as “bridges” (Fig. 13), which progressively will be diminished. That gradually results to grain loose and material removal. The concave surfaces occupied previously by grains are obvious (Fig. 25).

The three sandstone lithotypes are cemented by calcite. This is a feeble characteristic since acid water attack results easily to calcite dissolution, (Fig. 20). Vulnerability of stone to certain decay forms, as soluble minerals, is highly controlled by microstructural and mechanical characteristics of the stone (Leith, *et al.* 1996). When the cementing material is loose through solution, the mechanical properties of the stone are diminished. That results in rapid disintegration of the clasts. The consequence is the development of honeycomb forms, which is a usual decay form of sandstones, (Fig. 12).

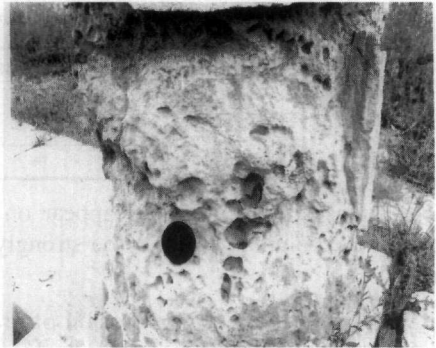
Figure 13 - Severe decay of bottom column piece constructed of type III sandstone and shape alteration

Calcareous crust was also observed on the column pieces, which were in contact to the capital, constructed of white Penteli marble, (Figs 13, 14).

Rock properties controlling the effects of acid rainwater or/and pore water include mineralogical composition and permeability. The later is again controlled by porosity, more particularly by pore size distribution. The three sandstone types display mean to high porosity. On this basis they are considered of poor quality for building material. The role of pore size distribution is clearly indicated in the decay patterns of sandstone type III, which displays the most intense decay problems compared to the other two types, while its mineralogical composition is similar to that of type I. With increasing porosity the attacking solution waters are able to penetrate deep into the rock. During dry periods of evaporation the salt solution are drawn by capillary action toward the surface, where precipitation may cause the development of a resistant crust over the deteriorated interior, (Figs 13, 15, 16).

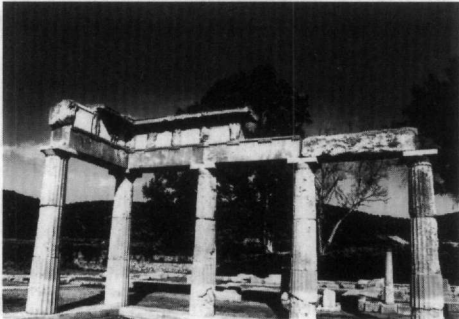
Figure 14 - Different degree of decay on capitals and Calcareous crust development

a whitish-grey sandstone found in situ and b: beige (light brown) sandstone cut from the nearby quarry. These two stone materials show different degree of corrosion. The former (Figs 14, 16) displays strong cavity corrosion and colour alteration (calcareous crust), while the latter displays pit and cavity corrosion of a lower degree (Figs 14, 17).

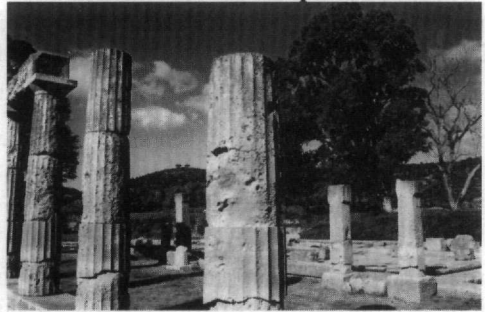
Figure 15 - Different degree of decay on column pieces

The more intense decay problems appear on the portico columns, (Figs 12, 13, 14, 15). The sandstone of the columns seems to be strongly deteriorated. The different types of decay can be summarized

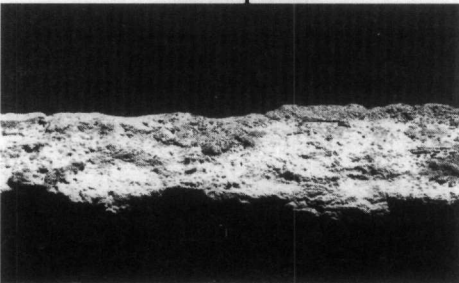
Figure 16 - Capital constructed by lithotype I illustrating high vuggy decay, shape alteration- material loss and crust development

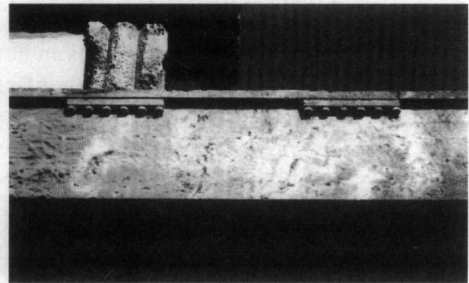
Figure 17 - capital constructed by lithotype II illustrating vuggy decay and color alteration

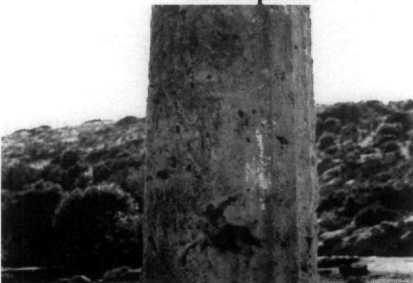
Figure 18 - Intence decay form on sandstone type III

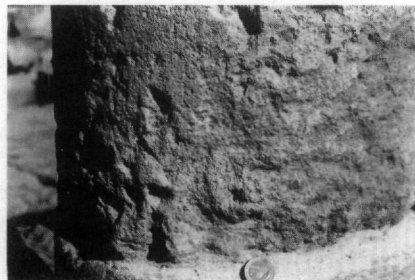
Figure 19 - decay form on sandstone type I

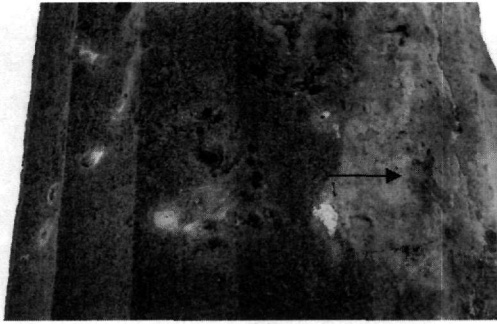
Figure 20 - Cavities and calcareous crust on column piece (arrow)

well as along cracks, (Webley *et al.* 1963, Winnkler 1966). Since the stones have been covered by mud for a substantial period of time and are still influenced by the periodical presence of the water, the development of communities is expected (Michopoulos 2005), (Figs 20, 21) and has considerable impact on stone decay.

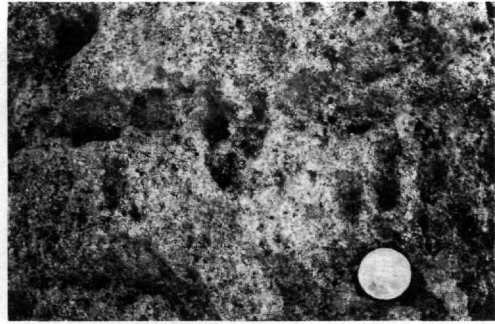
Figure 21 - Development of calcareous crust (white areas)

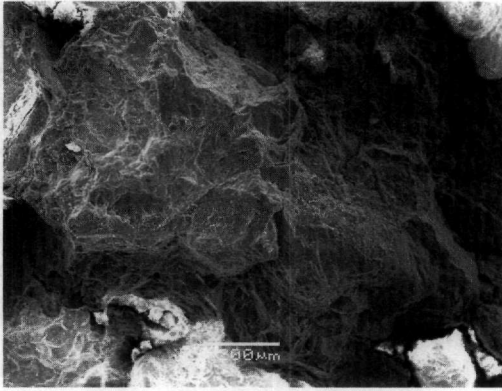
Figure 22 - lithotype I-quarry

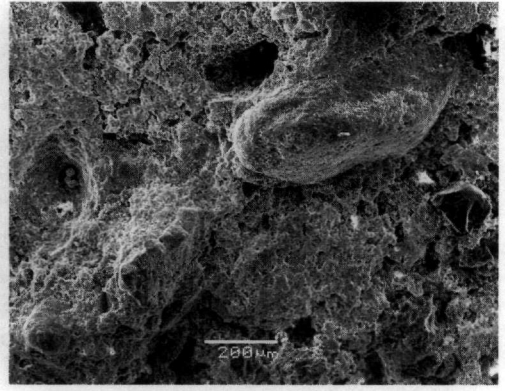
Figure 23 - lithotype type I-monument

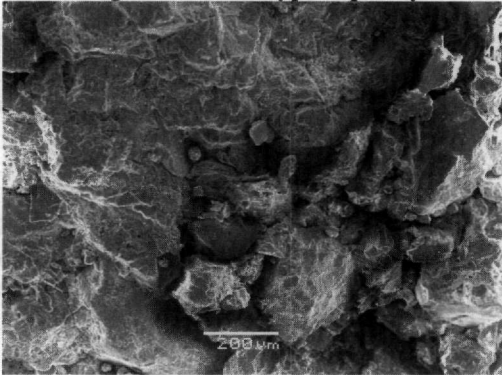
Figure 24 - lithotype III-quarry

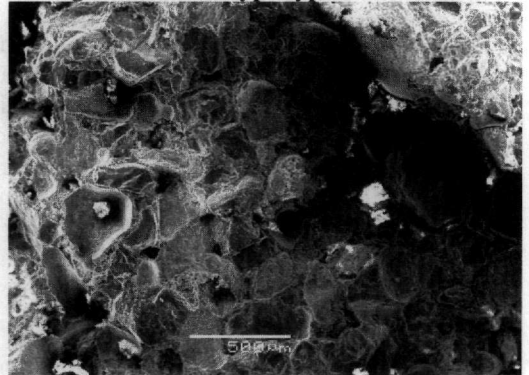
Figure 25 - Litho type III-monument

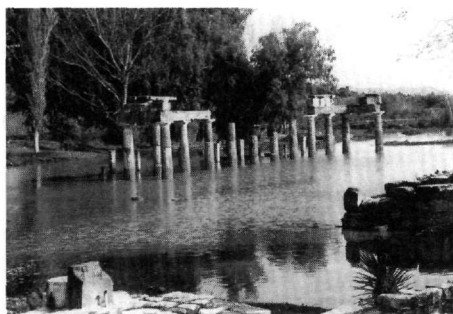
Figure 27 - Brauron monument (26/11/2005) Erasinos flooded after strong rainfalls

Although Erasinos is a small river, it is flooding after strong and intense rainfalls. (Figs 26, 27). Then the waters caring along mineral materials as bed load or in suspension, cover all the area of the monument, (Fig. 16), for considerable period, until the waters withdraw. The water drainage area of Erasinos is large enough including locations as Attica Road, Venizelos airport, Marcopoulo city. Rainwaters and Municipal wastewater treatment from the above areas are driven into the bedload of Erasinos. This might be a possible pollution source for the river waters that reinforce the ion and bio content. Running water picks up ions on its way downstream or loses ions by absorption to clay particles. The flow through stone pores and narrow channels gives the water enough time to reach near equilibrium condition quickly in the presence of calcium carbonate in the stones. The ion content of groundwater is subject to extreme variation depending on both the source rock and the length of travel; groundwater is generally high in Ca, Mg, SO₄, Cl, and Fe. Saline groundwater that usually indicates invasion of corrosive marine water cannot be excluded even in the present since distance from the shore is short and wetlands partly and periodically exist. Soluble salts are considered to be the key-deteriorating factor of building materials in the case of monuments and historic buildings (Arnold 1989). During salt crystallization pressure crystallization occurs within the pores of rocks, and degree of weathering is depends on the degree of salt saturation of the solution and the pore size (Benavente *et al.* 1999).
