## PARAMETERS OF INTENSITY DISTRIBUTION IN THE IZMIT AND DUZCE (TURKEY) EARTHQUAKES

E. L. LEKKAS<sup>1</sup>

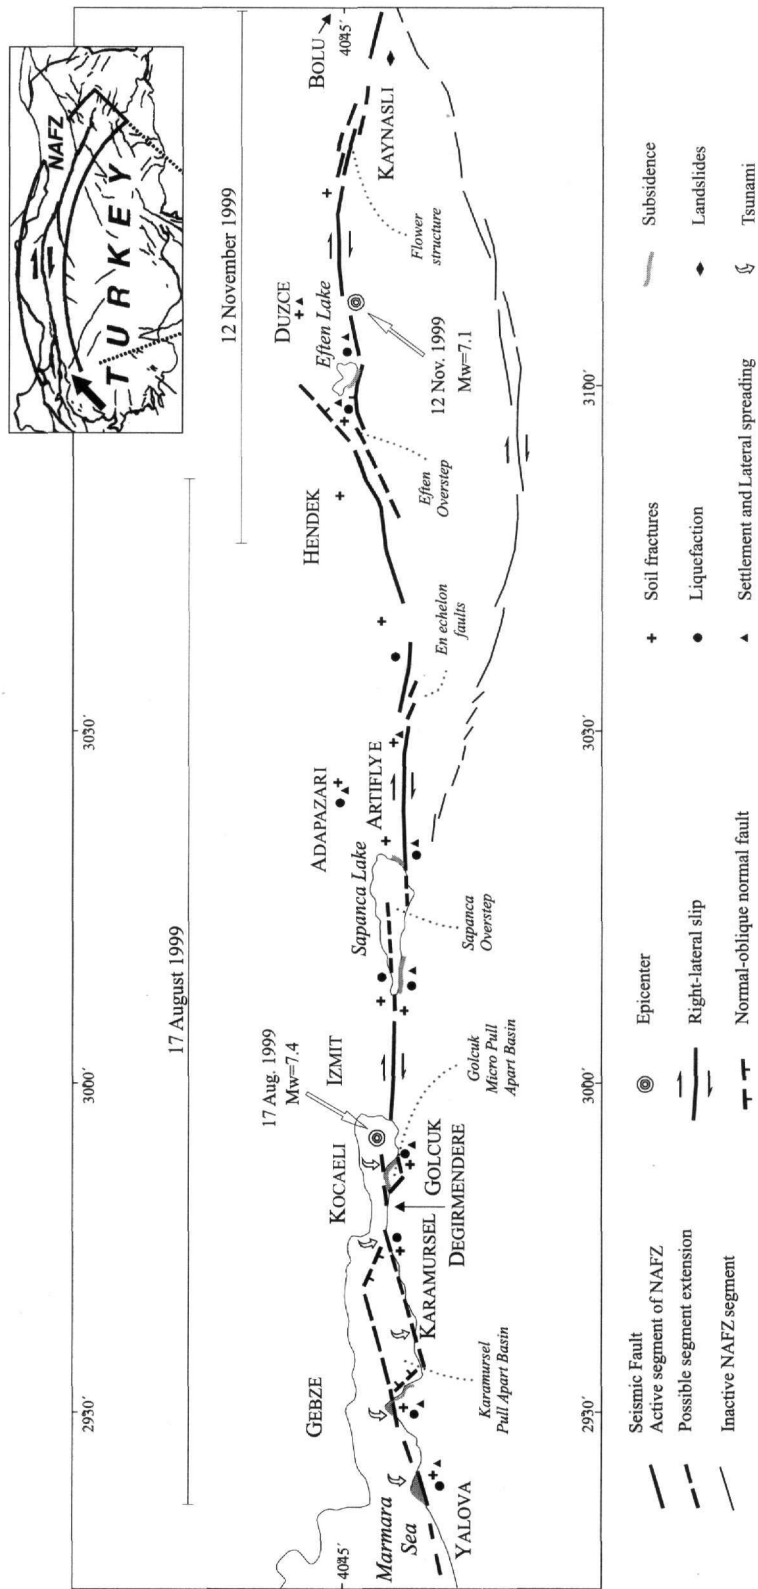
Fig. 1 Map depicting the segments of the North Anatolian Fault Zone reactivated during the earthquakes of 17<sup>th</sup> August and 12<sup>th</sup> November 1999, and the concomitant geodynamic phenomena that took place.

Field observations show that the surficial rupture was more than 90 km long (LEKKAS et al., 1999), vertical with right-lateral displacement in excess of 5 meters, in good agreement with the instrumental data (Figure 1). This seismic fault extends into the submarine area of Marmara bay and west of Gólcók.

The 12<sup>th</sup> November 1999 earthquake, the epicenter of which was south of Dózcce, occurred at the eastern end of the previously activated segment of the NAFZ (Figure 1). Also, this section remained dormant in other

During the earthquakes of 17<sup>th</sup> August and 12<sup>th</sup> November 1999 a number of geodynamic phenomena (LEKKAS et al., 1999) took place in the broader epicentral area (Figure 1). These phenomena are not only of academic interest, as they aggravated the impact, amplified the intensities, and contributed to intensity differentiation from place to place either in the meizoseismal area or at longer distances. These effects are briefly described below:

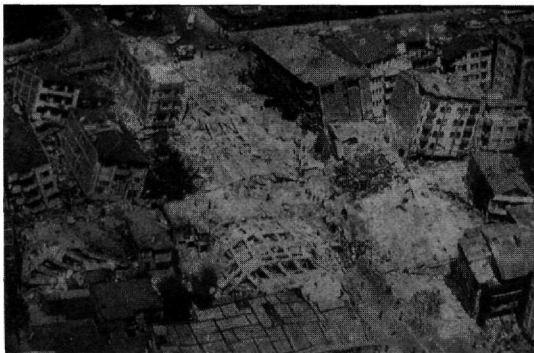
**Fig. 3 Representative view of a portion of Adapazari that suffered total damage ( $I_{EMS-98} = XII$ ) after the 17<sup>th</sup> August earthquake.**

- The maximum intensities exceeded  $I_{EMS98} = XI$  and locally reached XII (Figure 3) for both seismic events of 17<sup>th</sup> August and 12<sup>th</sup> November 1999. During the first earthquake, maximum intensities occurred in the coastal area of Gölcök, in Degirmendere, in Yalova and in Adapazari (Figs. 4, 5). Particularly, total collapse of the constructions occurred in the coastal area of Gölcök, due to the submergence of the region into the Marmara sea. Constructions were not only affected by seismic loading but also by subsidence, tsunamis, lateral spreading and liquefaction. A similar picture was present in the coastal region of Degirmendere. On the other hand, the situation was better in parts of Yalova, because only liquefaction, soil fissures and lateral spreading took place. Parts of Adapazari town were devastated and all buildings collapsed. These sites were dominated by soil fissures, liquefaction, effects of “sedimentary basin” and “basin edge” effects and so on (Kawase 1996, Lekkas 2000b), which played a significant part in intensity distribution. In Adapazari, tens of buildings sank into the ground, toppled, were partially overturned or collapsed because the soil beneath them liquefied and weakened the foundations (Figure 3). On the contrary, damage was lighter in areas of the town where none of the above phenomena occurred. Intensities that exceeded  $I_{EMS98} = XI$  degree were recorded after the 12<sup>th</sup> November 1999 earthquake in a portion of Kaynasli, which collapsed thoroughly due to the surface impact of a zone of seismic fissures in the form of a negative flower structure (Lade & Cole 1984, Harding 1985), and also due to settlement, lateral spreading and liquefaction.

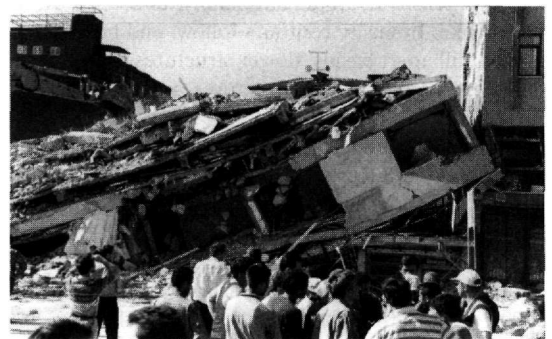
**Fig. 4 Reinforced concrete frame structure that collapsed in Gölcök town (damage degree 5).**

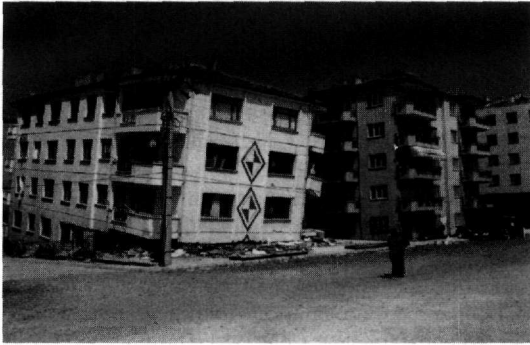
*Fig. 5 Reinforced concrete frame structure that sustained collapse of ground floor in the area of Gölçök -Degirmendere (damage degree 5).*

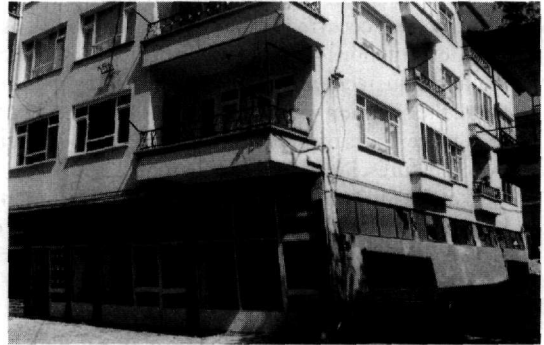
*Fig. 6 Reinforced concrete frame structure in Yalova that displayed first story column-hinge deformation, but did not collapse (damage degree 4).*

- $I_{EMS-98} = X$  intensities were present in a wider area that formed two elongated zones in both seismic events. Specifically after the 17<sup>th</sup> August earthquake, X intensities occurred in an E-W zone that began at Yalova (Figs. 6), was found again at Gölcök, passed through Izmit and stopped in Sapanca lake. The zone reappeared in Adapazari and terminated east of the town. The width of the zone ranged from 100m to 200m. After the 12<sup>th</sup> November 1999 earthquake,  $I_{EMS-98} = X$  contours were arranged in a similar E-W trending zone, which covered the areas of Hendek, Döğze, Kaynasli and was up to 800m wide at places. The exact estimation of the intensities that were attributed to the second earthquake was quite hard to make (12<sup>th</sup> November 1999) in the area between Adapazari-Döğze, because constructions had already been damaged by the earthquake of 17<sup>th</sup> August 1999. In this case, the cumulative effect of both earthquakes was estimated, incorporating the damage from both earthquakes. In Döğze, about 30% of the damage is attributed to the first earthquake (17<sup>th</sup> August) and 70% to the second earthquake (12<sup>th</sup> November). This estimate regards only the structural elements of reinforced concrete constructions. It was found that the first earthquake exhibited maximum intensities that reached  $I_{EMS98} = VIII$  in an E-W zone at Döğze area, while after the second earthquake intensities exceeded  $I_{EMS98} = X$  and locally approached XI. This may be attributed to the fact that the resistance of the constructions had already been weakened by the first earthquake.
