Angistalis Georgios, Dounias Georgios, Tsokas Grigorios, Zambas Costas (2018), The Walls of Eupalinos Aqueduct, Samos Island, Greece. Description, Pathology and Proposed Restoration Measures. Bulletin Geological Society of Greece, 53, 193-228.

THE WALLS OF EUPALINOS AQUEDUCT, SAMOS ISLAND, GREECE. DESCRIPTION, PATHOLOGY AND PROPOSED RESTORATION MEASURES

Abstract

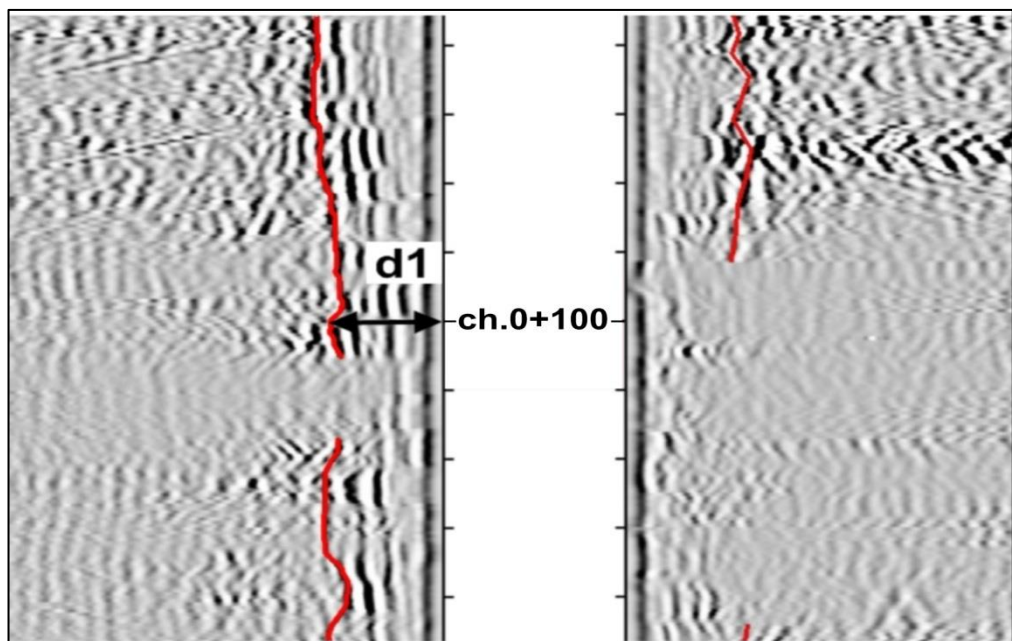
Fig. 6: Results of ground penetration at ch. 0+100.

The wall was investigated by means of ground penetration radar (GPR) and electrical resistivity tomography (ERT). The evaluation of the GPR results is shown in Figure 6. It is obvious that the GPR method predicts the wall – backfill interface or in other words the thickness “d1” of the wall’s hewn stones. The actual thickness of the wall “d1” is almost 25 cm (Figure 5). It is practically identical with the one derived from the interpretation of the GPR results, dimension “d1” at Figure 6.

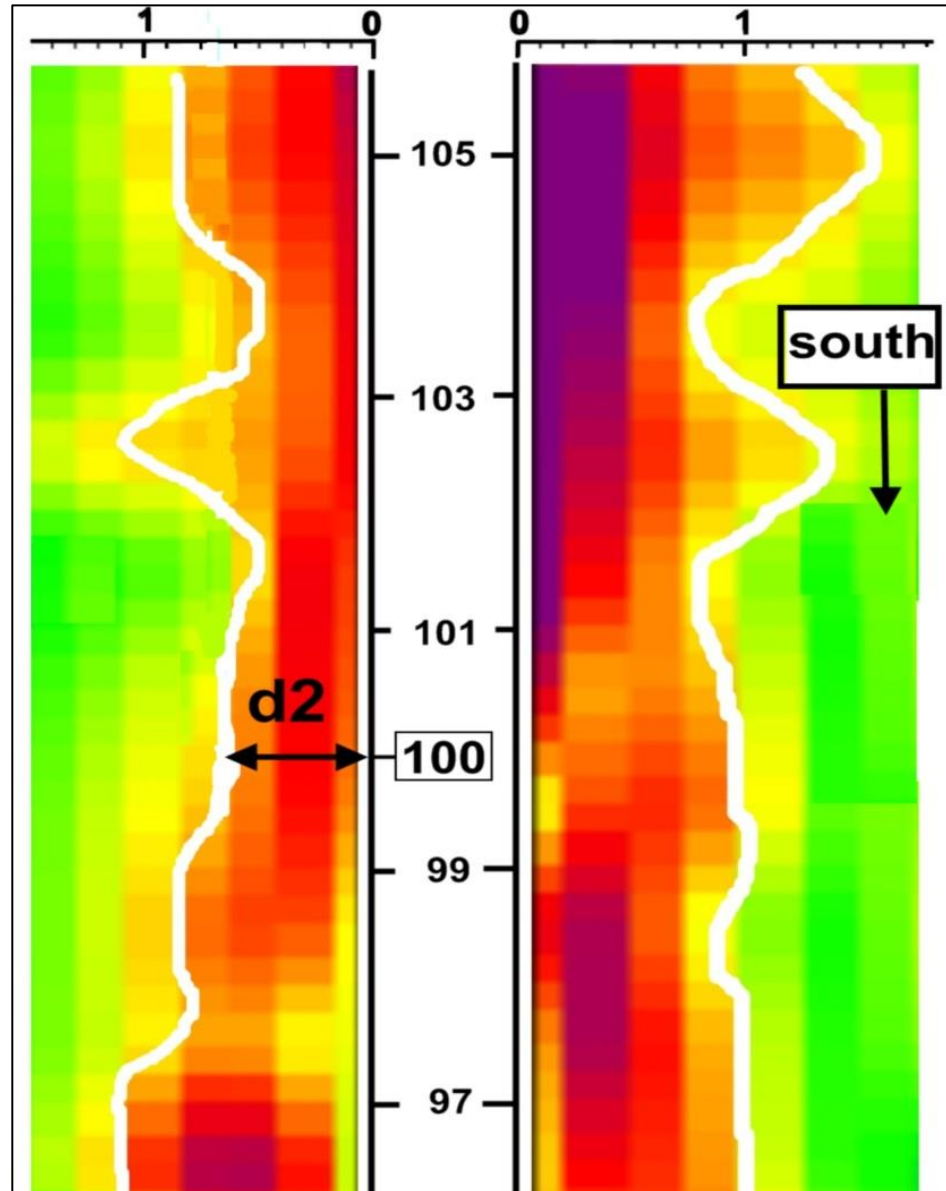
Fig. 7: Electrical resistivity results at ch. 0+100. High resistivity boundaries (white lines) match with the ground – backfill interface boundary.

On the other hand, the ERT method predicts (Figure 7) the ground – backfill interfaces or in other words the sum of the thickness of the wall’s hewn stones “d1” plus the thickness of the backfill material. The actual thickness “d2” is almost 60 cm (Figure 5). It is practically identical with the one derived from the interpretation of the ERT results, dimension “d2” at Figure 7. GPR signal loss (no rebound measured), at approximately **ch 0+100** is justified by the high-water content that is observed in this area.

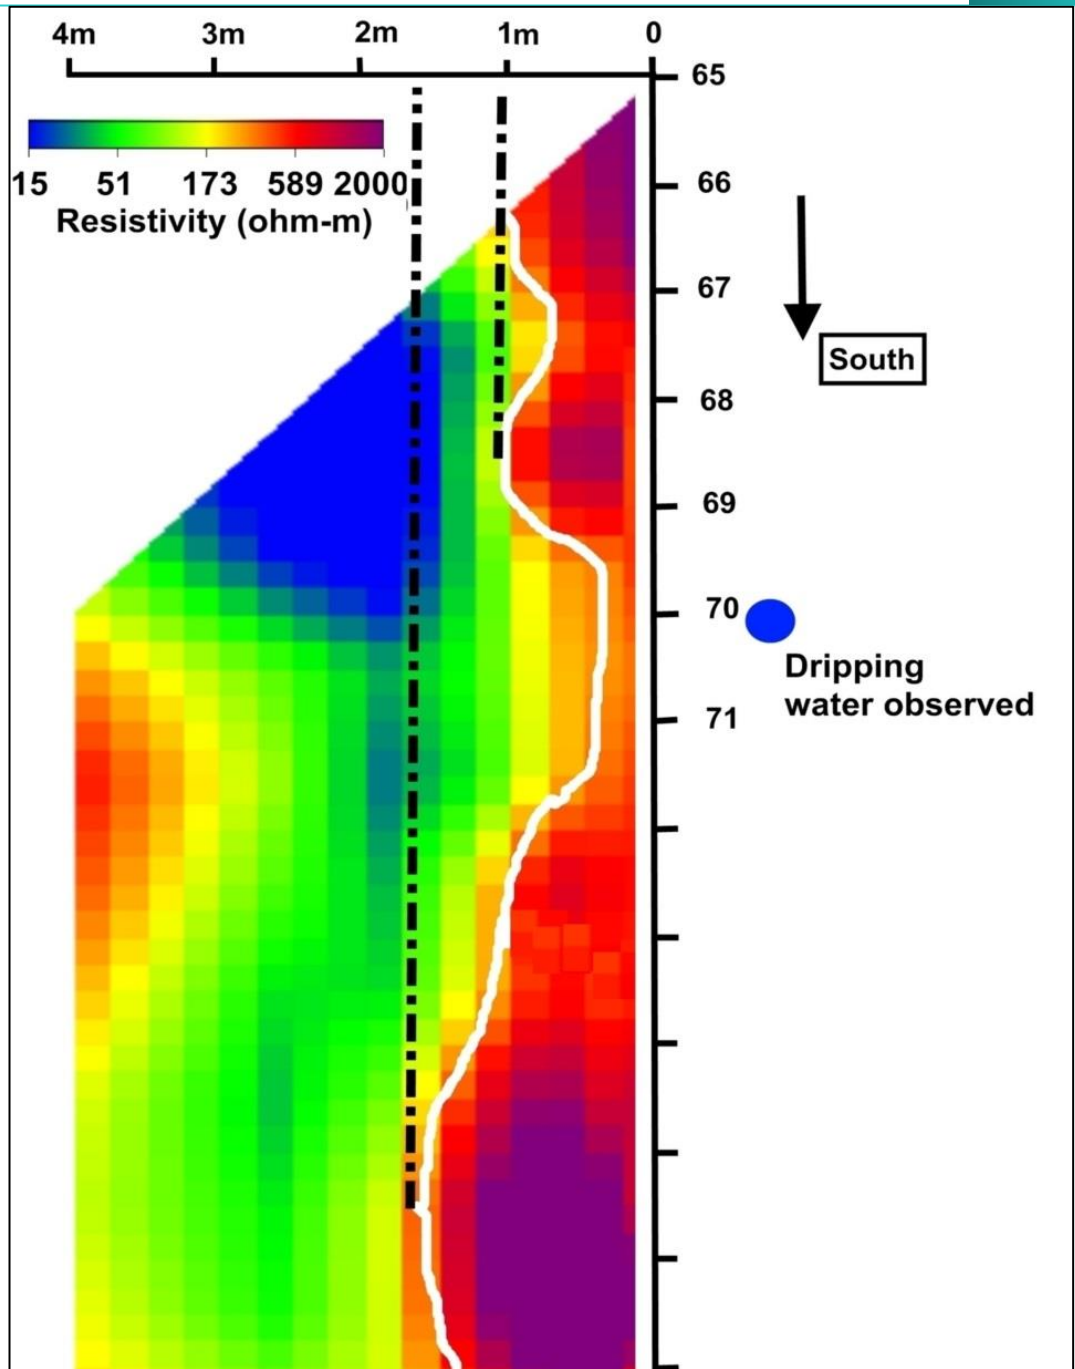
Fig. 12: Results of electrical resistivity tomography near ch 0+64 at the west sidewall of the lining. The white line represents the ground-backfill interface. The line that represents the interface is very uneven most likely due to the ground collapses that occurred during the tunnel drive.

Figures 10 and 11 show the results of the GPR. Figure 12 shows the ERT result at the west sidewall of the lining (at the level of the point). The comparison of the GPR results shows again that this method practically predicts the thickness of the solid hewn stones of the walls (backfill-wall interface).

The ERT method on the other hand estimates well the dimensions of the excavation profile (backfill-ground interface). An area with very low resistivity (blue area) at ch **0+070** has also been evaluated as an area with high water content. Dripping water is observed in this location.

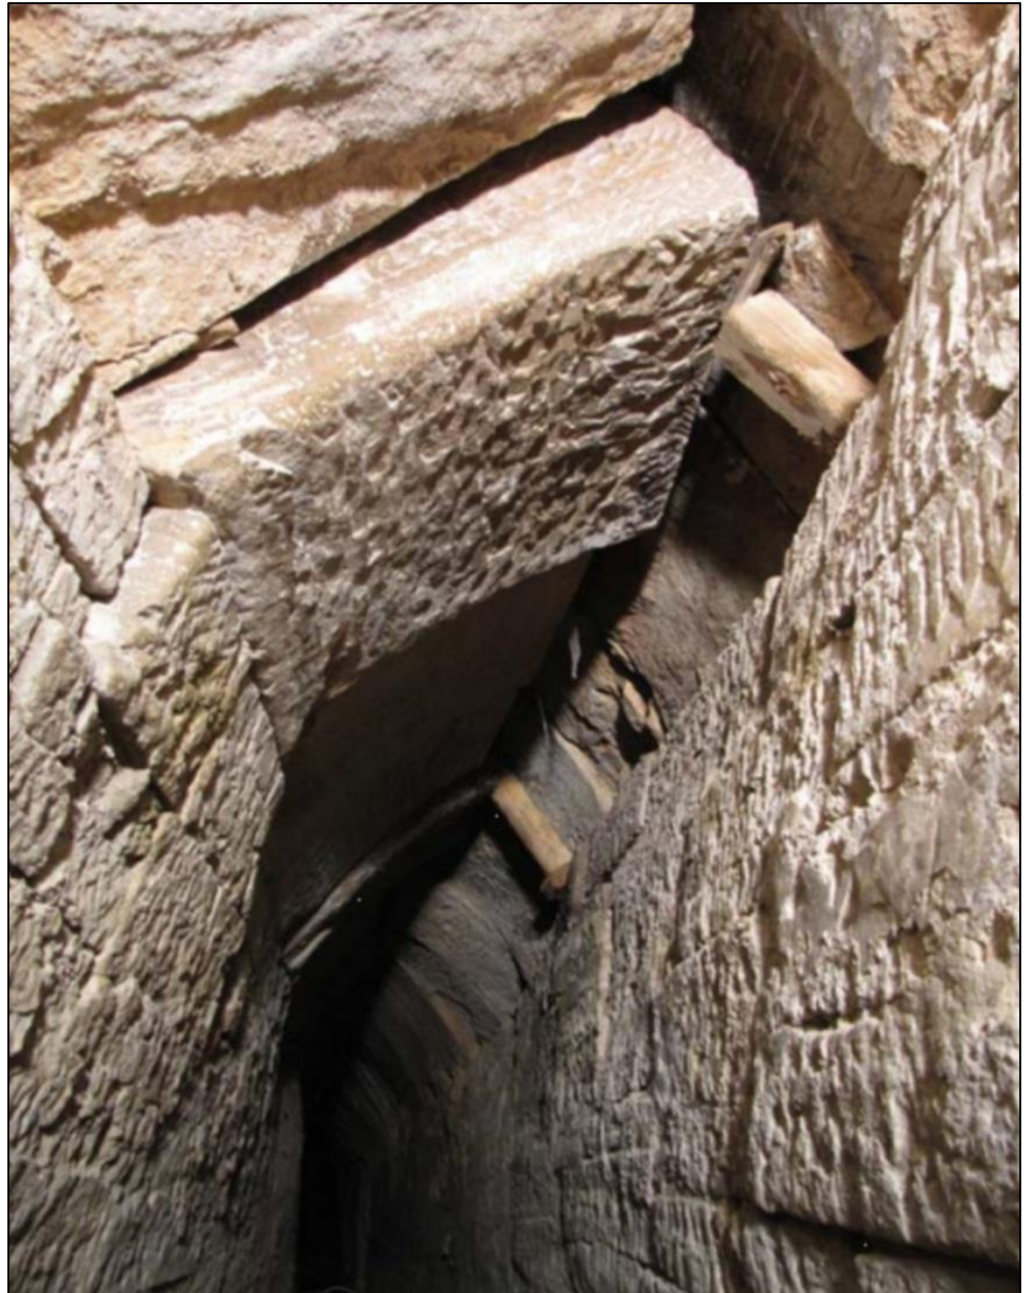
Fig. 13: The tunnel at ch. 0+130 with dislocated roof stones.

From **ch 0+130** to **ch 0+136** the wall is highly deformed and the arched stones of the roof are displaced and fractured (Figure 13).

A simplified finite element analysis was also carried out in order to understand the failure pattern of the wall's roof of chainage **0+130** (Figure 13). The west stone block is significantly dislocated and is temporarily supported by a wooden wedge. The ground is simulated as a homogenous material with low strength properties. The pattern of the calculated deformation is shown in Figure 25. The deformation magnitude is similar to both sides of the wall (the maximum measured deformation is 5 cm).

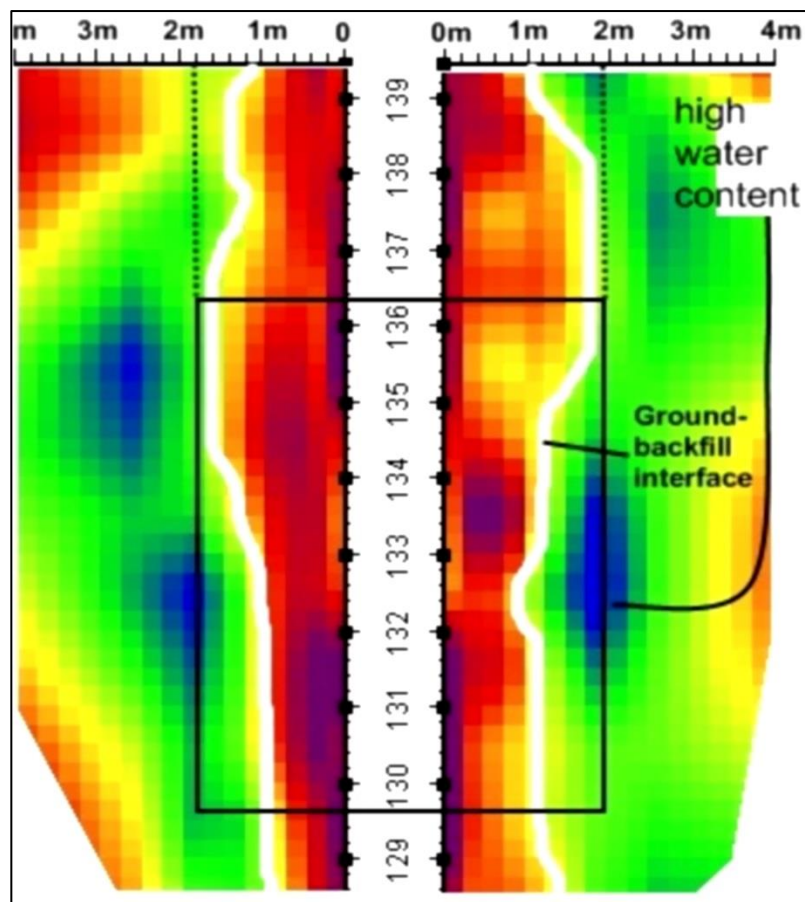
Fig. 15: Results of ERT 1,10 m above the walking level.

Figure 14 shows the GPR results and Figures 15 and 16 the ERT results. Electrical resistivity tomography has been used along four lines of the wall (two at either side). The lower ones were at 0,6 m from the walking level and the higher 1,10 m from the walking level.

The pattern of the wall here is the same as the one described previously. The maximum wall thickness (solid rock blocks) is 50 cm, observed at **ch 0+131** at the west side. The ERT results are very striking. At level 1,10 m the excavation width (white line) is the maximum identified. It reaches 2 m on either side. Interesting is the fact that at level 0,60 m the excavation width reduces down to less than 1m. This can be explained by the presence of a cave-in (ground collapse) that occurred during excavation and enlarged both sidewalls. Areas of high water content are present on either side of the tunnel.

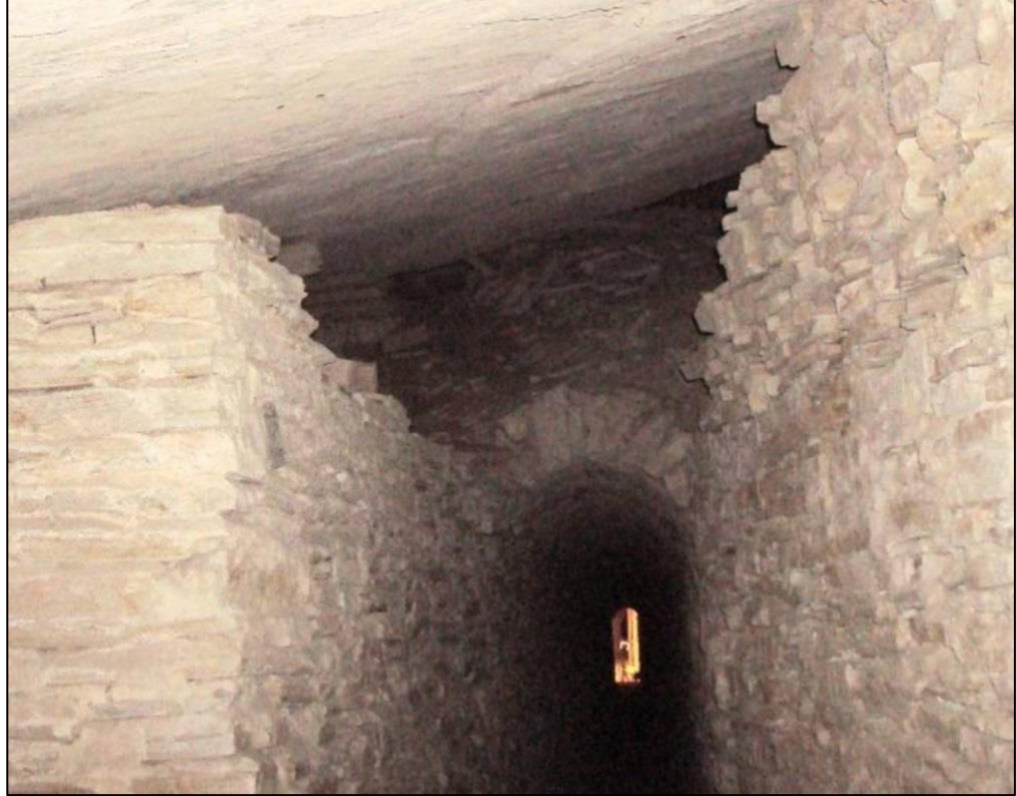
Fig. 17: Roman type wall of the north portal. The tunnel roof (geological bedding is subparallel to the tunnel axis) has collapsed on the arch of the wall. For a limited length the walls are vertical up to the tunnel roof.

This Roman type wall starts at **ch. 0+010**. It ends at **ch 0+050** (l=40 m). It is a mortared masonry wall of an arched shaped roof (Figure 17). The thickness of the mortared joints is 3 cm, the stone bricks are 3 to 15 cm thick and the roof arch is 25 to

The rock mass here consists of thinly bedded limestone with sub horizontal bedding. The excavation geometry above the lining is visible from **ch 0+011** (Figure 17). The tunnel roof has been gradually collapsing. Most likely this explains why this section was protected in the Roman era. Today, the arched roof is loaded with the weight of the debris that has fallen on it; when this weight became excessive the roof subsided and slipped (Figure 18).

For the Roman-type wall, the first measure proposed is the careful removal of the failed rock material accumulated above its arch. Where the height of the “cave-in” (ground collapse) is small, the space between the arch and the cave-in’s perimeter is proposed to fill with bags filled with lightweight material (Figure 28). The latter is proposed in order to avoid further rock falls from the tunnel roof.

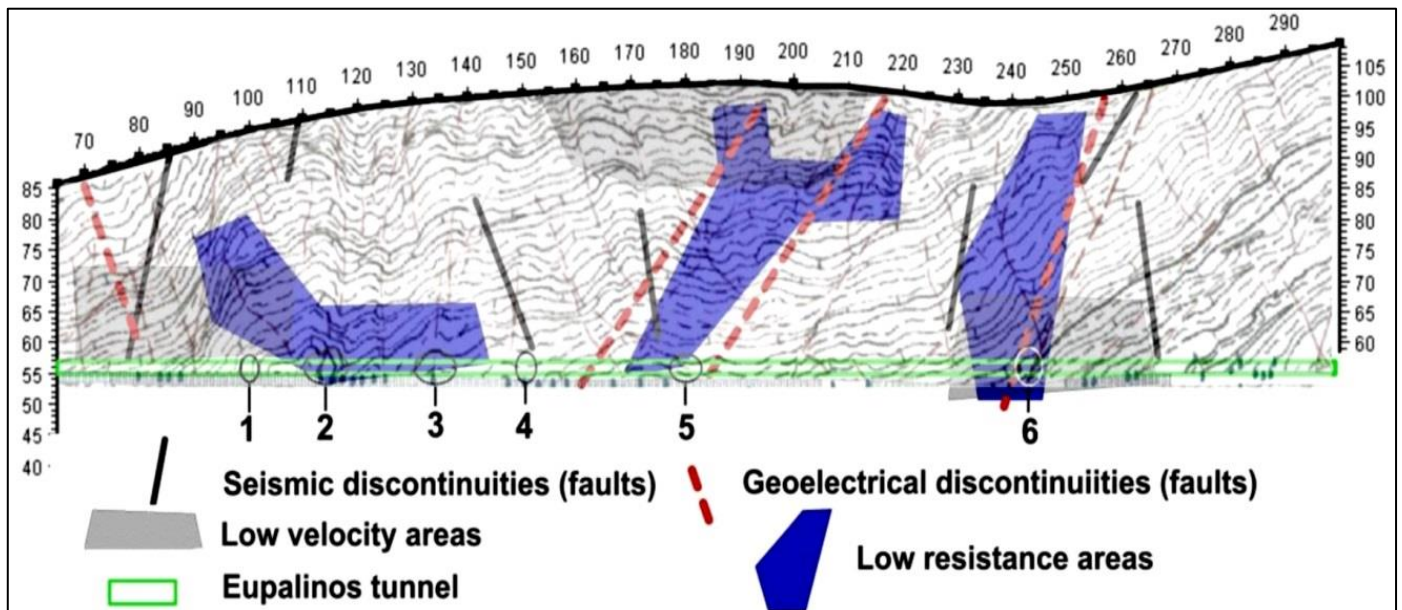
Fig. 19: Geophysical and geological longitudinal section along the lined (protected) tunnel section at the north bore (Tsokas et al, 2014). Damage on the wall: **1:0+100**, **2:0+110-0+117**, **3:0+130-0+136**, **4:0+149**, **5:0+178-0+184**, **6:0+245**.

The geophysical methods that have also been used along the walled tunnel section at the north bore involve surface to tunnel electrical resistivity tomography, seismic refraction, VLF (Very Low Frequency) and SP (Spontaneous Polarization) methods (Tsokas et al, 2014). The scope of these methods was to investigate the ground conditions of the tunnel's overburden. This is the ground between the tunnel crown and the surface. Figure 19 is a combined geological/geophysical longitudinal section along the north tunnel section that is protected by the dry masonry walls. The tunnel is shown by the green lines of the level +55. The locations where the wall has been damaged are marked by the black circles 1 to 6 on the tunnel. The black and the red lines are seismic and geoelectrical discontinuities respectively and have been recognized as fault zones. The grey and blue sections are areas of low velocity and resistance respectively and have been evaluated as areas of lower strength ground.

Along this tunnel section, surface geological mapping (Lyberis et al, 2013) has identified alternations of thinly bedded marls, green schistose clays and limestones. Many intersecting faults have been identified from **ch 0+090** to **ch 0+140**. Two major fault zones at **ch 0+220** and **ch 0+270** have been mapped as well.

The evaluated geophysical results are in good agreement with those of the geological mapping. The geophysical methods have identified the distribution of the major fault zones in the ground. They have also supplemented the geological mapping observations at the level of the tunnel, by recognizing, the areas of a poor/low strength ground adjacent to the faults. For example, the area of the intersecting faults from **ch 0+090** to **0+140** that was identified with the geological mapping at the surface was also identified (as a low resistance area) at the tunnel levels by the geophysical methods. It is of great interest that the damages identified at the tunnel masonry walls are located at the intersections of the tunnel with the fault zones mentioned earlier. Most of them occurred between **ch 0+090** to **0+140**. For example, a serious damage at the wall (Figure 20) at chainage **0+180** is located at the intersection with a major fault zone.

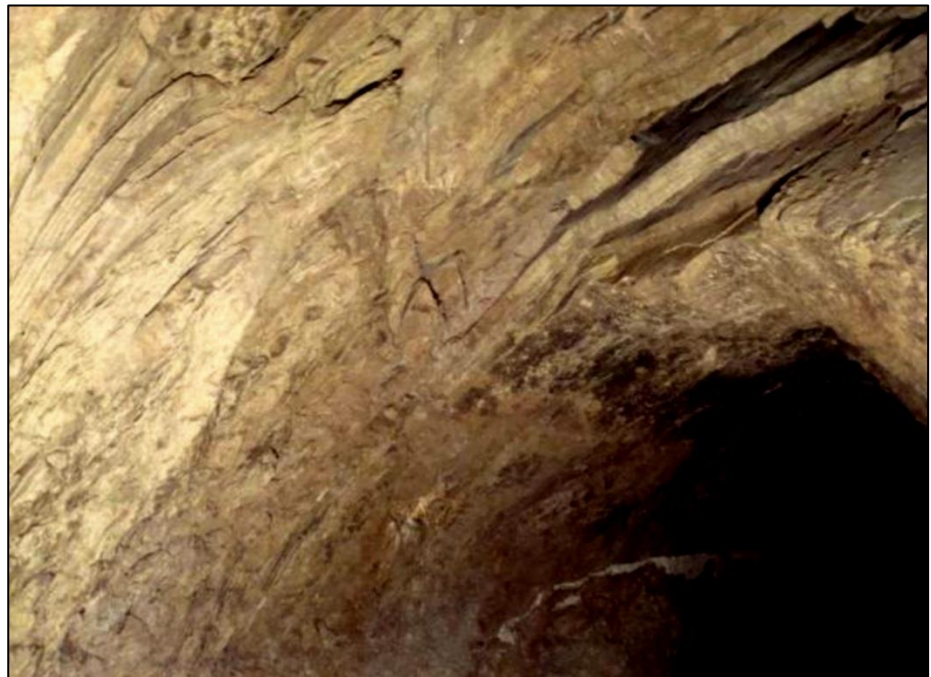
Fig. 21: Thinly bedded marls, green schistose clays (some slippage of rock material has occurred along a planar joint to the right).

As mentioned in the previous paragraph, the ground behind the walls comprises thinly bedded marls and green schistose clays. These (when sheared and faulted) form an amorphous soft clayey matrix with rock fragments (Figures 21 and 22).
