**Research Paper****THE MARCH 2021 THESSALY EARTHQUAKES AND THEIR IMPACT THROUGH THE PRISM OF A MULTI-HAZARD APPROACH IN DISASTER MANAGEMENT****Spyridon Mavroulis<sup>1,\*</sup>, Maria Mavrouli<sup>2</sup>, Panayotis Carydis<sup>3</sup>, Konstantinos Agorastos<sup>4</sup>, Efthymis Lekkas<sup>1</sup>**<sup>1</sup> Department of Dynamic Tectonic Applied Geology, Faculty of Geology and Geoenvironment, National and Kapodistrian University of Athens, 15784 Athens, Greece,[smavroulis@geol.uoa.gr](mailto:smavroulis@geol.uoa.gr)<sup>2</sup> Department of Microbiology, Medical School, National and Kapodistrian University of Athens, 11527 Athens, Greece, [mmavrouli@med.uoa.gr](mailto:mmavrouli@med.uoa.gr)<sup>3</sup> European Academy of Sciences and Arts, A-5020 Salzburg, Austria, [pkary@tee.gr](mailto:pkary@tee.gr)<sup>4</sup> Region of Thessaly, 41110 Larissa, Greece, [periferiarxis@thessaly.gov.gr](mailto:periferiarxis@thessaly.gov.gr)**Abstract**

Mavroulis S., Mavrouli M., Carydis P., Agorastos K. and Lekkas E. (2021), The March 2021 Thessaly Earthquakes and Their Impact Through the Prism of A Multi-Hazard Approach in Disaster Management. Bulletin Geological Society of Greece, 58, 1-36

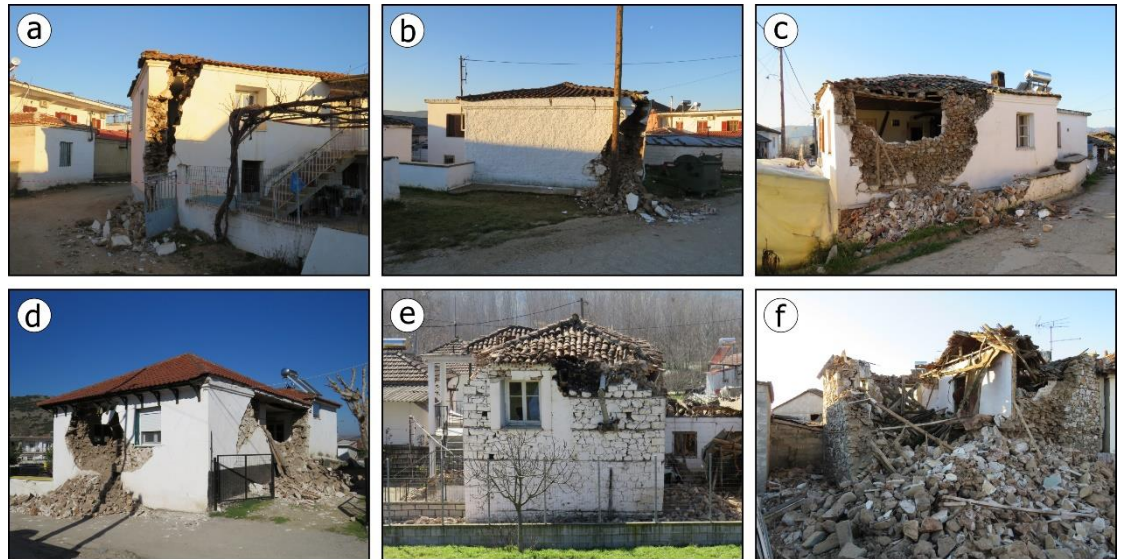
**Fig. 7:** (a, b) Vertical cracks and gaps were frequently formed and propagated along the height of the bearing wall intersections. This damage is attributed to the absence of horizontal banding means, which could provide structural integrity. Examples from Mesochori village. (c, d) Failures of the upper part of the walls were also attributed to the interaction of roof structure and perimeter walls. Examples from Mesochori (c) and Damassi (d) villages. (e, f) Damage were also attributed to poor mortar and poor workmanship resulting in partial or total collapse. Views from Mesochori village.

The worst affected building type is the old unreinforced buildings with load-bearing masonry walls (Figs 7, 8). These buildings suffered mainly heavy damage on their structural elements comprising vertical cracks at wall intersections due to the lack of horizontal band beams (Figs 7a-b), out-of-plane failures of the upper part of the walls attributed to the interaction between roof structure and perimeter walls and to lack of building integrity (Figs 7c-d) as well as partial or total collapse due to poor quality mortar and poor workmanship, resulting in disintegration of masonry units and loss of support to floors (Figs 7e-f).

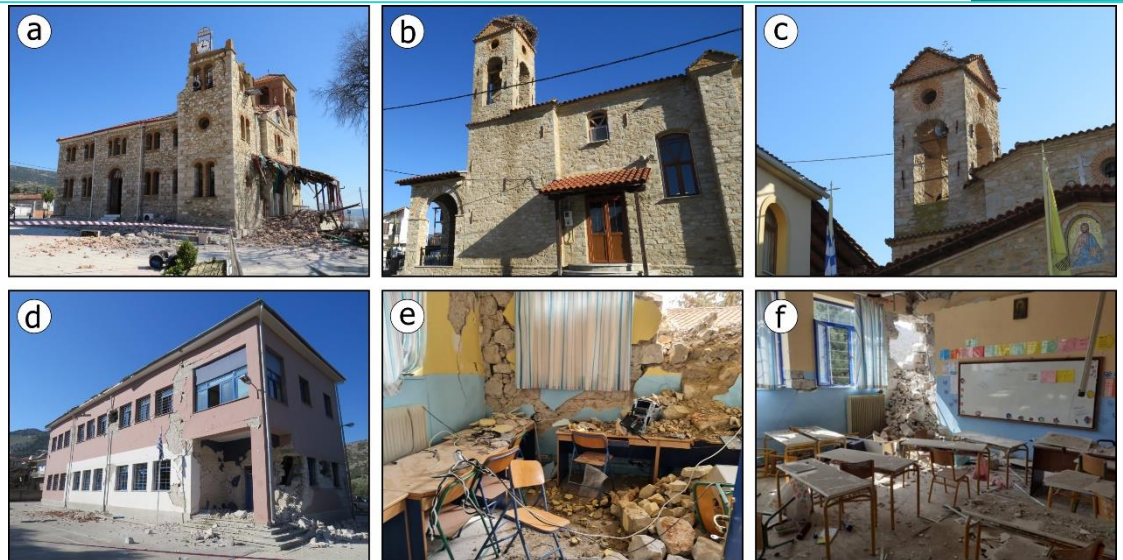
**Fig. 8:** (a) The Ayios Dimitrios church in Mesochori village, which has been founded on recent deposits, suffered damage to its walls and bell towers by the 3 March earthquake. The 4 March earthquake aggravated damage. (b, c) The Ayia Triada church in Vlachogianni village has been founded on alpine deposits and has been recently reinforced with steel ties in the bell tower and in the other parts of the construction. It remained intact by the early March earthquakes. (d, e, f) Damage to the old masonry elementary school of Damassi village. It suffered heavy structural damage including partial collapse of the walls.

Similar damage was generated in special structures, including schools, and monumental buildings, comprising churches (Fig. 8). Churches suffered damage to their load-bearing masonry walls, arches, roofs, plasters and their bell towers. Their seismic performance depended on their strengthening with longitudinal steel tie rods and on the soil foundation. A characteristic example comprises the churches in Mesochori and Vlachogianni villages located only 1.5 km away from each other. The Mesochori church founded on recent river deposits suffered partial collapse (Fig. 8a), while the Vlachogianni church founded on alpine formations and recently reinforced with steel tie rods remained intact by the earthquakes (Figs 8b-c).

mainshock comprising extensive cracking and partial collapse of its masonry walls (Figs 8d-f) and consequently was later demolished. It is significant to note that 63 students and 10 teachers were in the building when the earthquake struck the area. They immediately evacuated the buildings and were all safe.

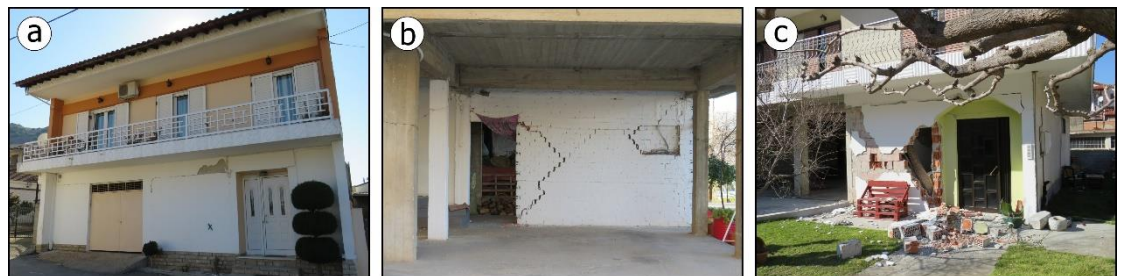
**Fig. 9.** Few earthquake-affected reinforced concrete buildings suffered non-structural damage varying from slight detachment of the infill walls from the surrounding reinforced concrete frame (a) and cracking in the infill walls (b) to partial collapse of the infill walls (c).

Regarding the recently constructed buildings with reinforced concrete frame and infill walls, they remained intact by the earthquake in general. They suffered damage on their non-structural elements comprising detachment of plasters from infill walls, detachment of infill walls from the surrounding reinforced concrete frame and detachment of tiles from roofs and of cladding from walls (Fig. 9a-b). However, limited cases of reinforced concrete buildings that suffered structural damage including damage to columns of the ground floor were also detected (Fig. 9c).
