### Massive fish mortality in Ismarida Lake, Greece: identification of drivers contributing to the fish kill event

E. KOUTRAKIS, G. EMFIETZIS, G. SYLAIOS, M. ZOIDOU, M. KATSIAPI, M. MOUSTAKA-GOUNI

## Fish kill in Ismarida lake, Greece: identification of drivers contributing to the event

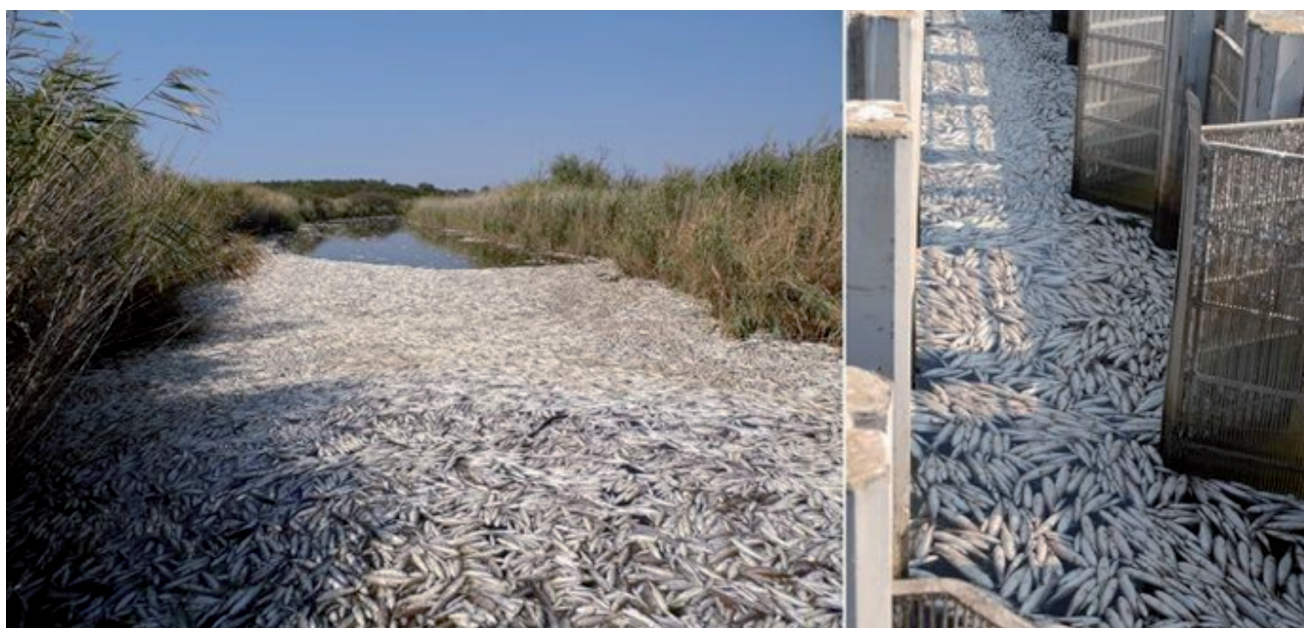
**Fig. 2:** Dead fish along the seaward entry channel and inside the permanent fishing devices.

In the morning of 29 August 2013, a thick layer of dead fish was observed at the littoral part of the lake (Gemitzi, pers. comm.) (Fig. 2). Air odor due to dead fish decay was inducing discomfort. At that time, dissolved oxygen levels in the lake water were approximately 4 mg/L (Gemitzi, pers. comm.) and conductivity ranged between 26 and 30 mS/cm. During the second half of August 2013 the water level of Ismarida Lake dropped to its lowest annual point (near 45 - 50 cm depth), probably due to the combined action of evaporation and the limited Vosvozis inflow (annual minimum was reached). This inflow comprised mostly of processed waste water from Komotini WWTP. Mean air temperature during the day of the event was measured as 26.6 °C at the closest weather station, Imeros, Rhodopi, 4.7 km southeast of the lake, and the most common wind direction during 25 – 29 August was SSW, SW and S. On 28 August, daily-
