### Massive fish mortality in Ismarida Lake, Greece: identification of drivers contributing to the fish kill event

## Fish kill in Ismarida lake, Greece: identification of drivers contributing to the event

During the end of August 2013, a massive fish mortality occurred in Ismarida Lake, a small and shallow system of northern Greece, where approximately 10-18 tons of euryhaline fish died. This study attempts to describe the fish kill that occurred in Ismarida Lake during the night of 28 August 2013, and to identify the possible drivers that may have triggered this event. Combined hydrographic, ichthyological and phytoplankton surveys were carried out with a toxicological analysis. The study proposes both short-term and long-term measures for the management of both quality and quantity of the water (ground and surface) resources in the broader basin of Ismarida Lake.

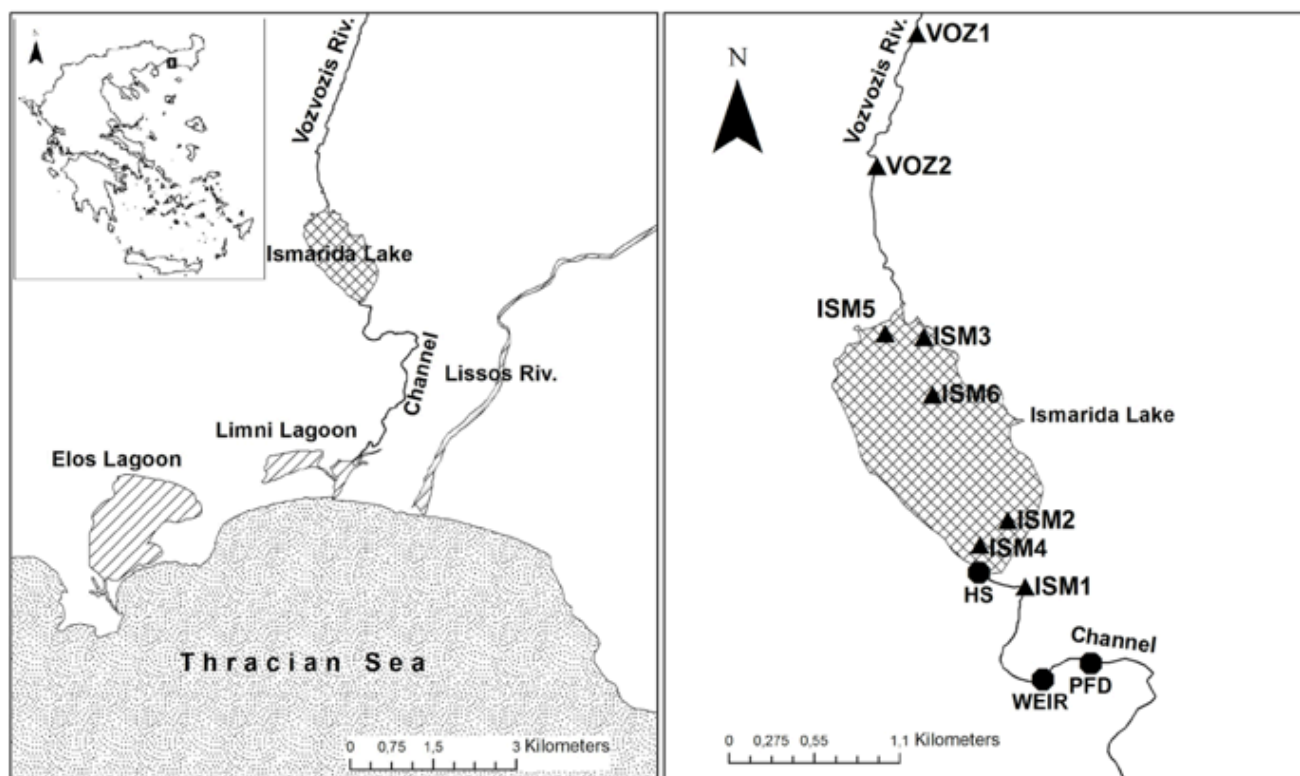
**Fig. 1:** Map of the study area. The fish fauna sampling stations are marked as triangles (see table 1 for a short description of each site), where the dot labeled as “WEIR” is its position, the one labeled “PFD” represents the position of the Permanent Fishing Devices, and the dot labeled “HS” shows the position of the hydrographic station.

lake, mainly during the dry season. Permanent fishing devices are located on a cross-section of the channel, 200 m downstream from the weir (Fig. 1).

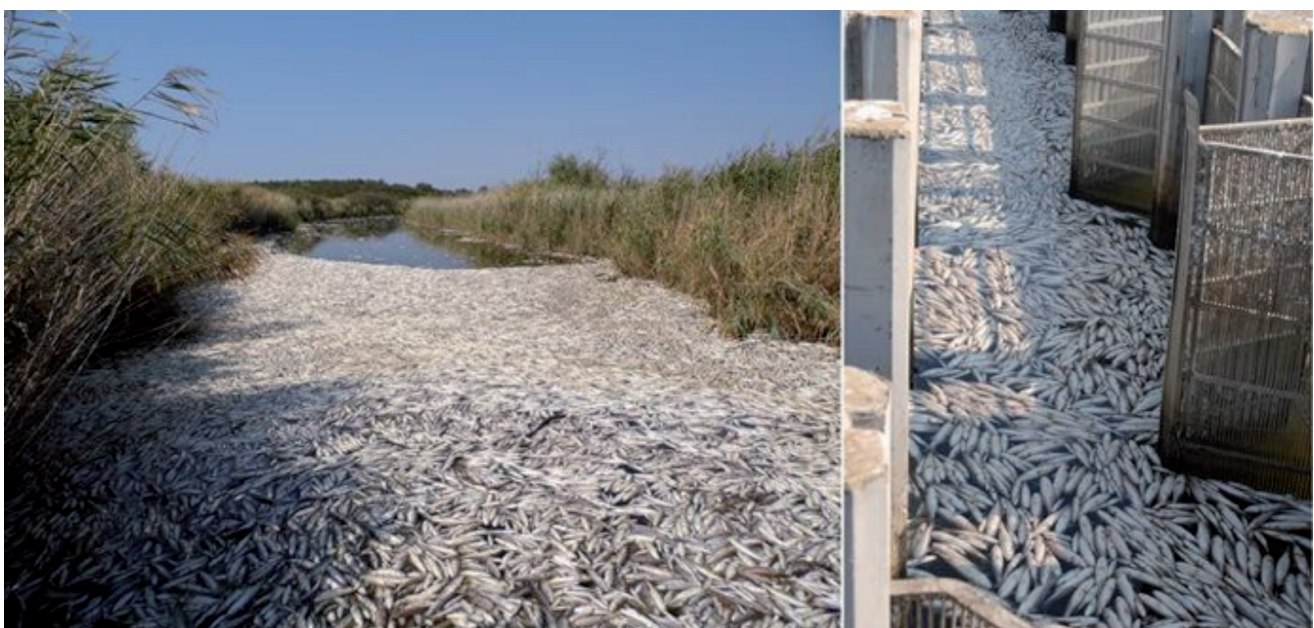
**Fig. 2:** Dead fish along the seaward entry channel and inside the permanent fishing devices.

In the morning of 29 August 2013, a thick layer of dead fish was observed at the littoral part of the lake (Gemitzi, pers. comm.) (Fig. 2). Air odor due to dead fish decay was inducing discomfort. At that time, dissolved oxygen levels in the lake water were approximately 4 mg/L (Gemitzi, pers. comm.) and conductivity ranged between 26 and 30 mS/cm. During the second half of August 2013 the water level of Ismarida Lake dropped to its lowest annual point (near 45 - 50 cm depth), probably due to the combined action of evaporation and the limited Vosvozis inflow (annual minimum was reached). This inflow comprised mostly of processed waste water from Komotini WWTP. Mean air temperature during the day of the event was measured as 26.6 °C at the closest weather station, Imeros, Rhodopi, 4.7 km southeast of the lake, and the most common wind direction during 25 – 29 August was SSW, SW and S. On 28 August, daily-

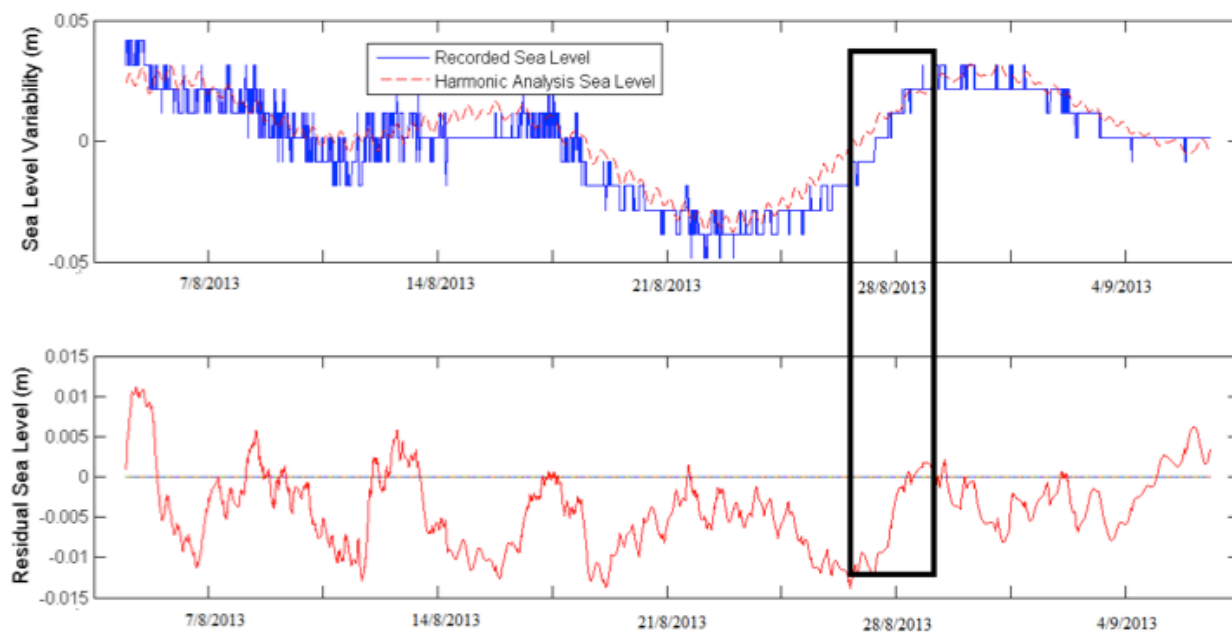
**Fig. 3:** a) Upper panel: Water level variability in Ismarida Lake, as recorded by the auto-recording hydrographic station (blue line) and water level reconstruction model, based on harmonic analysis results (red line); b) Lower panel: Residual (non-tidal) fluctuation of sea level variability in Ismarida Lake. Rectangle represents the period of the fish mortality event.

influence is limited in amplitude, as the length of the artificial entry canal dissipates the incoming tidal energy (Fig. 3). However, during the week prior to the event, the water level was reduced to a minimum value, probably due to summer evaporation and limited fresh and sea water inflow. From 23 August 2013 sea level displayed an increasing trend, associated with the sudden inflow of water in the system. Figure 4 illustrates the modeled and the recorded conductivity curves. Modeled conductivity appears in phase and closely follows the recorded series, with slight overestimation, especially at the beginning of the month. During the event, the model exhibits strong underestimation and fails to follow the recorded curve, which increases suddenly, explaining that the water level into the system increased due to an unexpected and violent sea water intrusion under normal conditions.

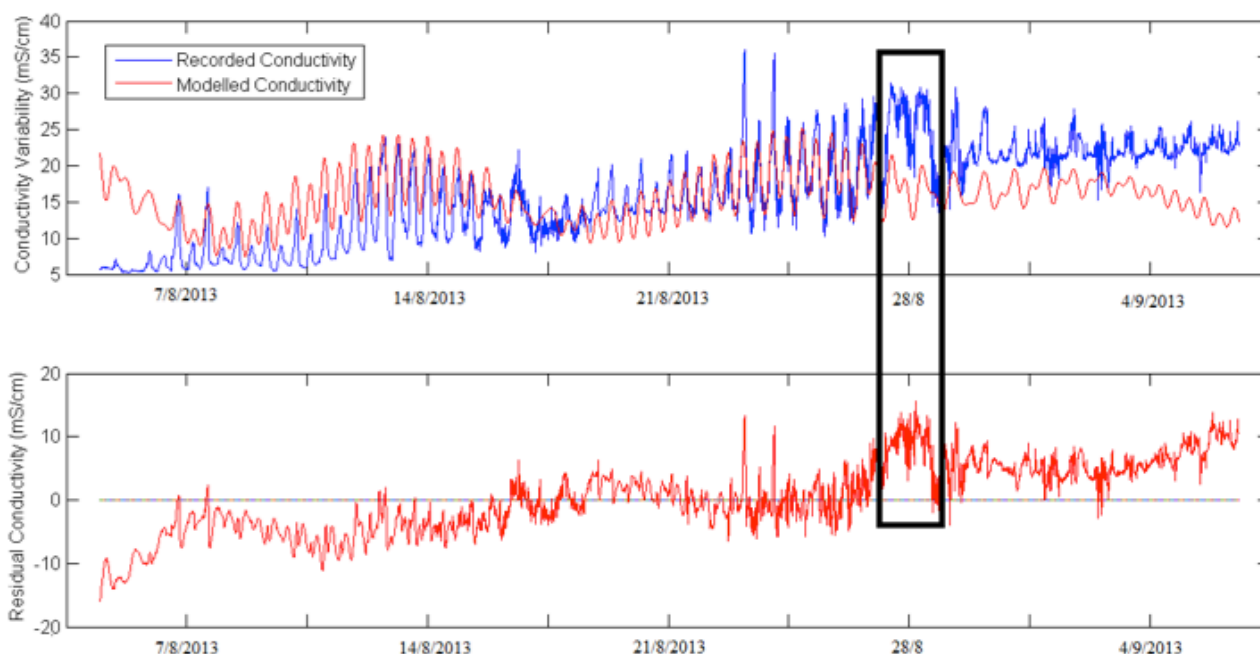
**Fig. 4:** a) Upper panel: Water conductivity in Ismarida Lake, as recorded by the auto-recording hydrographic station (blue line) and water conductivity reconstruction model, based on harmonic analysis results (red line); b) Lower panel: Residual (no-tidal) fluctuation of water conductivity variability in Ismarida Lake. Rectangle represents the period of the fish mortality event.

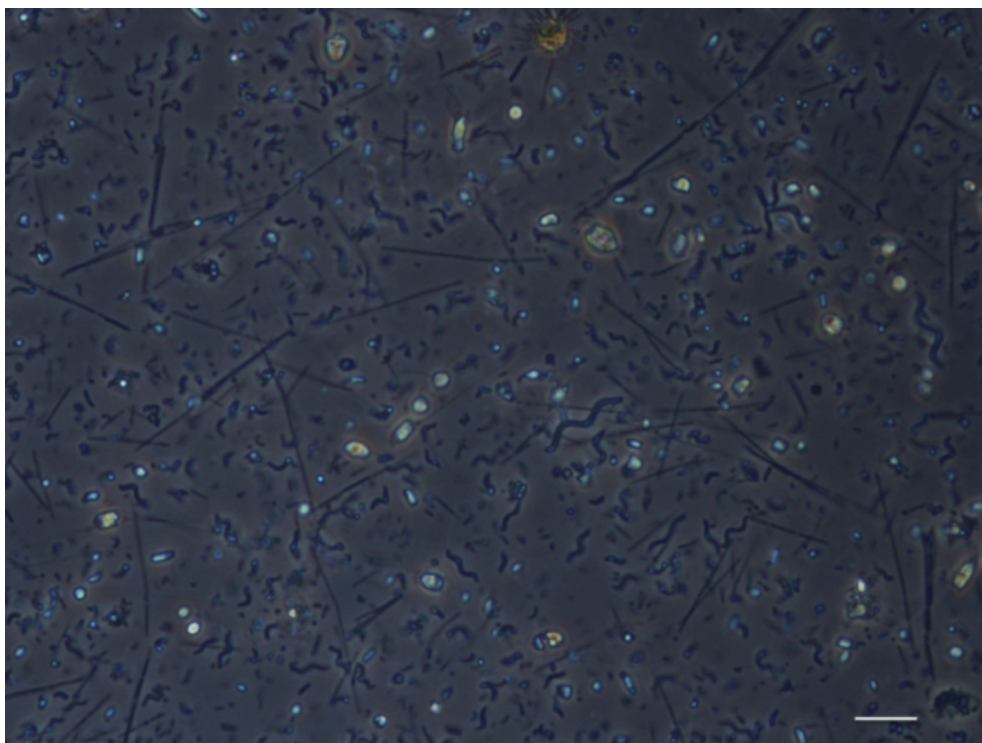
**Fig. 5:** Light micrograph (phase contrast) of a water sample containing predominantly large comma to spiral-shaped heterotrophic bacteria collected from Vosvozis River on 5 September 2013. Scale bar 10  $\mu$ m.

conspicuous ( $\sim 110 \times 10^6$  individuals/L) in phytoplankton samples collected from the Lake on 5 September 2013, exceeding  $1,000 \times 10^6$  individuals/L in the water samples collected from Vosvozis River (VOZ1) (Fig. 5).
