Vol 17, No 1 (2016)

### Massive fish mortality in Ismarida Lake, Greece: identification of drivers contributing to the fish kill event

## Fish kill in Ismarida lake, Greece: identification of drivers contributing to the event

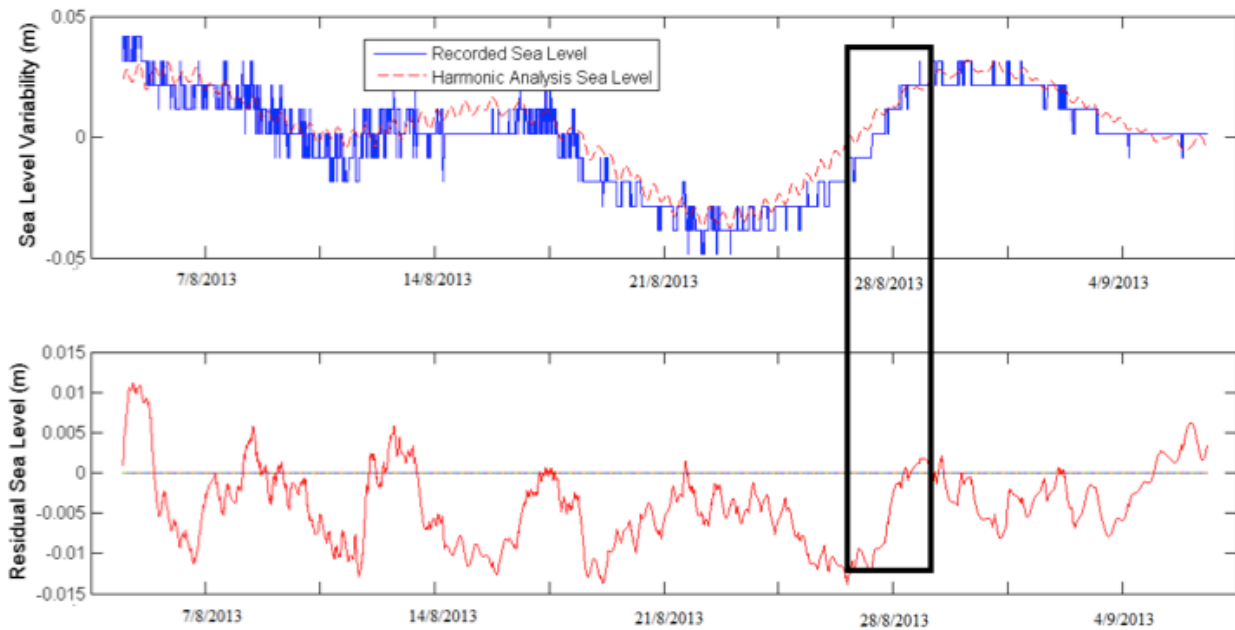
**Fig. 3:** a) Upper panel: Water level variability in Ismarida Lake, as recorded by the auto-recording hydrographic station (blue line) and water level reconstruction model, based on harmonic analysis results (red line); b) Lower panel: Residual (non-tidal) fluctuation of sea level variability in Ismarida Lake. Rectangle represents the period of the fish mortality event.

influence is limited in amplitude, as the length of the artificial entry canal dissipates the incoming tidal energy (Fig. 3). However, during the week prior to the event, the water level was reduced to a minimum value, probably due to summer evaporation and limited fresh and sea water inflow. From 23 August 2013 sea level displayed an increasing trend, associated with the sudden inflow of water in the system. Figure 4 illustrates the modeled and the recorded conductivity curves. Modeled conductivity appears in phase and closely follows the recorded series, with slight overestimation, especially at the beginning of the month. During the event, the model exhibits strong underestimation and fails to follow the recorded curve, which increases suddenly, explaining that the water level into the system increased due to an unexpected and violent sea water intrusion under normal conditions.
