A pointed falsework or a false decentering: Restoration and consolidation of Tsipiani bridge

Angelos Papageorgiou¹, Lampros Lolos²

Abstract. Tsipiani bridge (1875) is located at the East Zagori region in Epirus Greece, near the village of Miliotades. It is a peculiar single-arched bridge, the arch of which appears pointed, with an opening of 26 m. Traditional stone bridges have no wedge-shaped voussoirs, and the final round shape is formed by variable mortar amount amongst the flat sandstones of the area. The current stake is the salvation of the bridge. In the institutional framework of protection, the exact wording of the question is «whether or not» the study is approved. Bridges do not stand by democratic procedures but by the decisive intervention of the engineer corresponding to that of the master builder who in this case seems to have carried out a false decentering. In this case our proposal was the method of “stitching” which is used to reinforce existing structures made of stone or brick to increase the resistance of the masonry against compressive, shear and tensile forces and to connect loose parts in the body of the masonry.

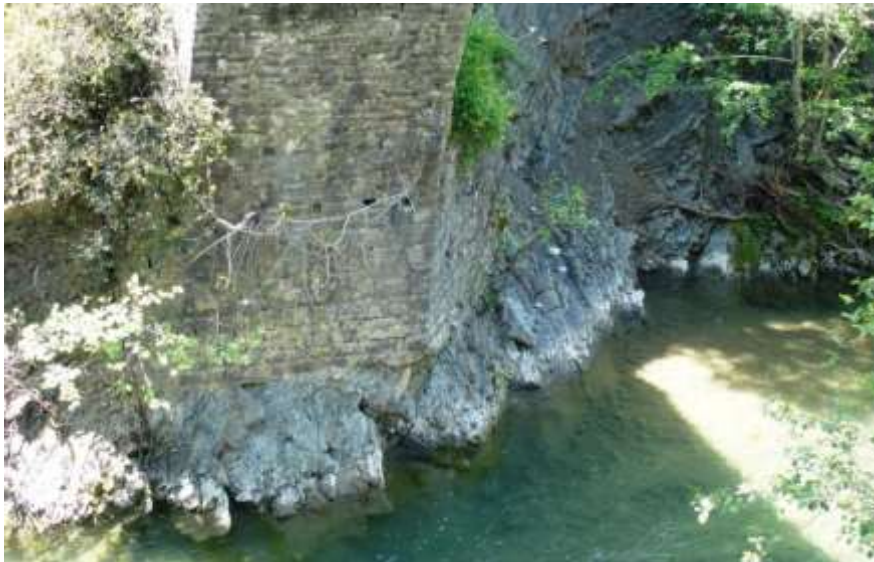
- iv. The revelation of the foundation to the right (downstream) of the bridge body with the simultaneous revelation of the rock on which it is founded can also be seen in (Fig. 5).

Fig. 5. Revelation of the foundation

The revelation of the foundation (iv) does not currently raise the issue of the stability of the bridge, without this ruling out a future problem due to its possible under excavation.

(iv) Construction of a stone wall around the revealed foundation if an excavation problem arises in the future. This wall, if the need for its construction is judged, will be founded at the level where the rocky ground will be found.

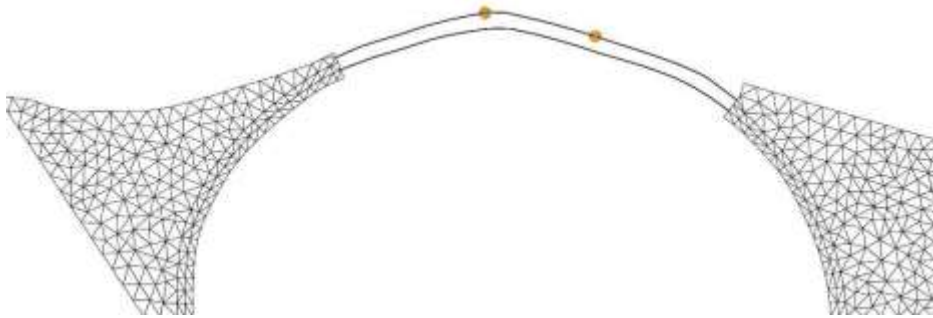
The arch of said bridge even if we ignore its loading history (which is essentially unknown), due to 2 (ii) & 2 (iii), has at least two estimated plastic joints in the upper ring (upper arch tread) as can be seen in (Fig. 8), generative cause of which is the failure in geometry and the self-weight loading.

Fig. 8. The two estimated plastic joints in the upper ring

The two above joints have turned the upper foot into a mechanism and the fact that it does not collapse is due solely to the frictional forces acting between the stone blocks. Meanwhile, the distribution of the self weight principal tensile stresses σ_1 can be seen in the (Fig. 9).

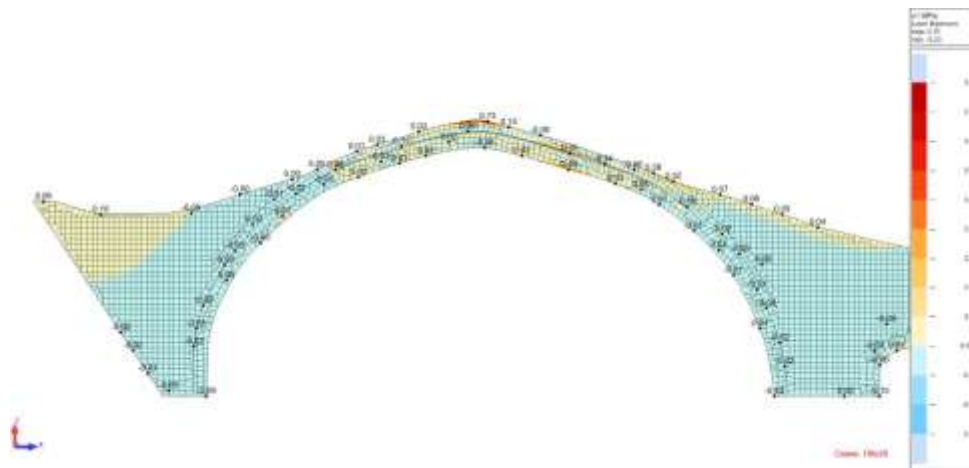
The results of principal tensile stresses σ_1 due to Self-weight load before and after the application of reinforcement are shown in (Figures 11 and 12) respectively.

Fig. 11. Results before reinforcement: Self weight load. Principal tensile stresses σ_1 (MPa)

Fig. 12. Results after reinforcement: Self weight load. Principal tensile stresses σ_1 (MPa)
