A pointed falsework or a false decentering: Restoration and consolidation of Tsipiani bridge

Abstract. Tsipiani bridge (1875) is located at the East Zagori region in Epirus Greece, near the village of Miliotades. It is a peculiar single-arched bridge, the arch of which appears pointed, with an opening of 26 m. Traditional stone bridges have no wedge-shaped voussoirs, and the final round shape is formed by variable mortar amount amongst the flat sandstones of the area. The current stake is the salvation of the bridge. In the institutional framework of protection, the exact wording of the question is «whether or not» the study is approved. Bridges do not stand by democratic procedures but by the decisive intervention of the engineer corresponding to that of the master builder who in this case seems to have carried out a false decentering. In this case our proposal was the method of "stitching" which is used to reinforce existing structures made of stone or brick to increase the resistance of the masonry against compressive, shear and tensile forces and to connect loose parts in the body of the masonry.

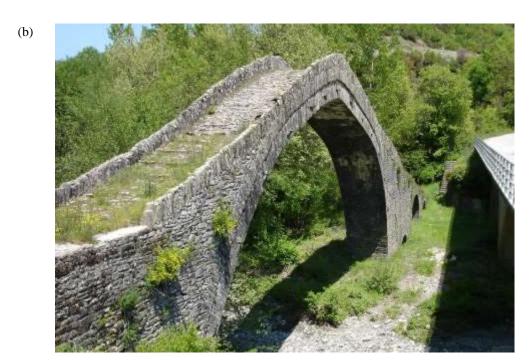
Fig. 1. Tsipiani bridge (a) Schematic representation, (b) side photo of the structure

Tsipiani bridge (1875) is located at the East Zagori region in Epirus Greece, near the village of Miliotades. It is a peculiar single-arched bridge, the arch of which appears pointed, with an opening of 26 m and a height of intrados 12,20 m as can be shown in Fig.1 (a and b). Traditional stone bridges have no wedge-shaped elements, known as voussoirs, and the final round shape is formed by variable mortar amount between the flat sandstones of the area. The average thickness of mortar is 1 cm while the sandstones are 6 cm thin. According to a 90's approach of the civil engineer Stathis Papavranousis the pointed shape of the arch is due to the compression of the mortar of the central area during an early decentering and not at the intention of the master build-

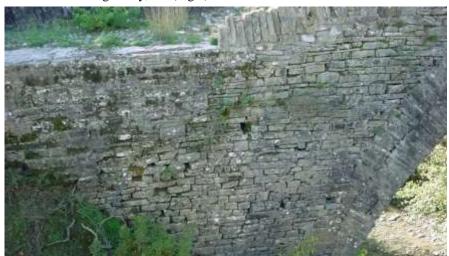
i. Extensive loss of sandstone bonding mortar all over the outer surface of

the bridge body, see (Fig.2)

Fig. 2. Extensive loss of sandstone bonding mortar

Due to (i) the initial mechanical operation of the "stone-mortar" system has been reduced to an unknown degree.

- (i) The replacement of the remaining and the lost external bonding mortar of the stones. The joints are expected to have a penetration depth in the body of the bridge 3-5cm. Of course, the final depth of the joints depends on the condition of the individual parts of the bridge body, but deep joints are not appropriate because they can lead to loosening of the coherence [2].

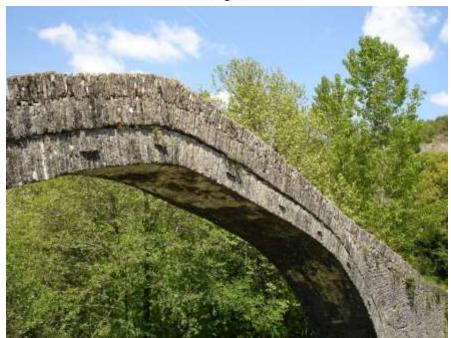
ii. The failure in the geometry of the arch in its upper left (downstream) part which occurred during its construction. The arch section tends towards its chord as can be seen in the (Fig.3).

Fig. 3. The arch section tends towards its chord

Because of (ii) and (iii), as shown by the static solutions, the eccentricity of the thrust line in the larger upper part of the arch exceeds in both rings ½ of their cross section. Specifically, for the upper ring we have a stability problem for the permanent actions (Same Weight) and for the design earthquake, while for the lower ring only for the design earthquake. The above results in the creation of internal joints [1], [2], [3], even-tually turning the larger upper part of the arch into a mechanism.

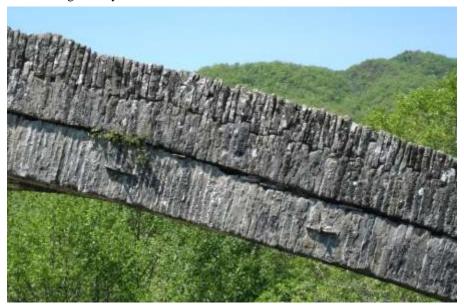
iii. The loss of contact between the two rings throughout the upper part of the arch due to the above-mentioned failure can be seen in (Fig. 4). The con-

sequence of this is that the loads of the deck are transferred exclusively from the upper ring, subjecting it to intensive sizes disproportionate to its geometry.

Fig. 4. Loss of contact between the two rings

- (ii) The connection of the two rings of the arch with reinforcing bars, which will have blades at their ends. The new agglomerate that will emerge aims to achieve the static function that a (single) ring 107cm thick (average thickness) would have. At the same time, the gap created between them will be filled with mortar.

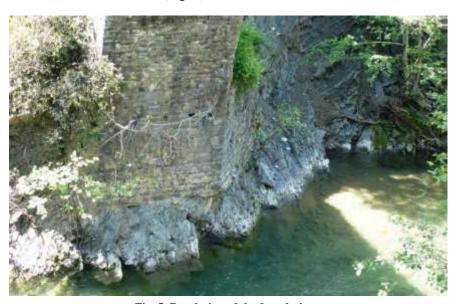
iv. The revelation of the foundation to the right (downstream) of the bridge body with the simultaneous revelation of the rock on which it is founded can also be seen in (Fig. 5).

Fig. 5. Revelation of the foundation

The revelation of the foundation (iv) does not currently raise the issue of the stability of the bridge, without this ruling out a future problem due to its possible under excavation.

- (iv) Construction of a stone wall around the revealed foundation if an excavation problem arises in the future. This wall, if the need for its construction is judged, will be founded at the level where the rocky ground will be found.

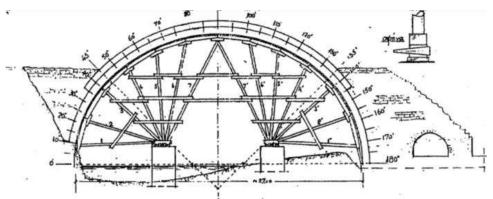
A schematic representation of Papavranousis 1996 [11] static model approach can be seen in (Fig. 6).

Fig. 6. A schematic representation of Papavranousis [13] approach

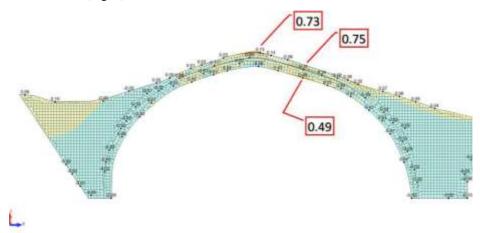
The two above joints have turned the upper foot into a mechanism and the fact that it does not collapse is due solely to the frictional forces acting between the stone blocks. Meanwhile, the distribution of the self weight principal tensile stresses σ_1 can be seen in the (Fig. 9).

Fig. 9. Self-weight principal tensile stresses $\sigma 1$ (MPa)

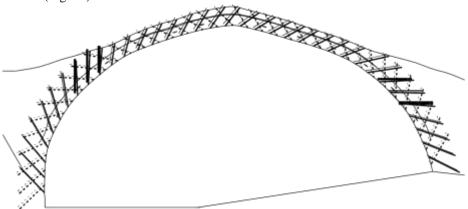
A side schematic representation of the reinforcement bars and anchor blades can be seen in (Fig. 10).

Fig. 10. A side schematic representation of the reinforcement

Metal rods Φ 12 / B500C of different lengths and metal anchor blades 100x100x20mm / Fe 360 are installed. Measurement of total length of metal bars 216 rods with an estimated total length of 420m Total number of blades 100x100x20 327 pieces

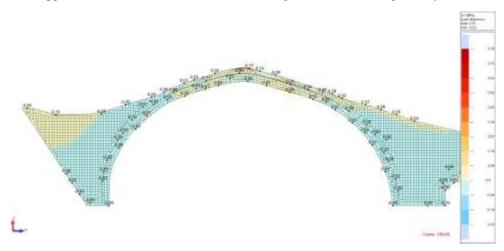
The results of principal tensile stresses $\sigma 1$ due to Self-weight load before and after the application of reinforcement are shown in (Figures 11 and 12) respectively.

Fig. 11. Results before reinforcement: Self weight load. Principal tensile stresses $\sigma 1$ (MPa)

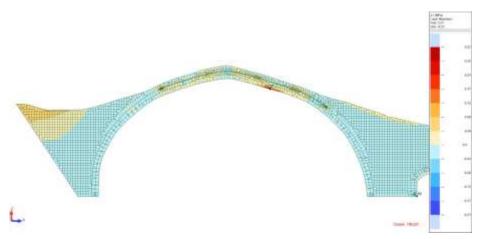
Fig. 12. Results after reinforcement: Self weight load. Principal tensile stresses $\sigma 1$ (MPa)

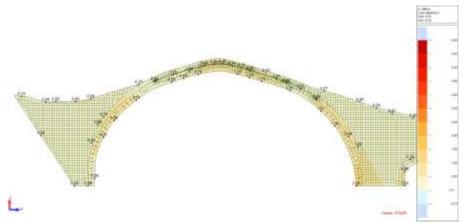
Fig. 14. Results after reinforcement: Seismic design load. Principal tensile stresses $\sigma 1$ stresses $\sigma 1$ (MPa)
