## **A pointed falsework or a false decentering: Restoration and consolidation of Tsipiani bridge**

**Abstract.** Tsipiani bridge (1875) is located at the East Zagori region in Epirus Greece, near the village of Miliotades. It is a peculiar single-arched bridge, the arch of which appears pointed, with an opening of 26 m. Traditional stone bridges have no wedge-shaped voussoirs, and the final round shape is formed by variable mortar amount amongst the flat sandstones of the area. The current stake is the salvation of the bridge. In the institutional framework of protection, the exact wording of the question is «whether or not» the study is approved. Bridges do not stand by democratic procedures but by the decisive intervention of the engineer corresponding to that of the master builder who in this case seems to have carried out a false decentering. In this case our proposal was the method of “stitching” which is used to reinforce existing structures made of stone or brick to increase the resistance of the masonry against compressive, shear and tensile forces and to connect loose parts in the body of the masonry.

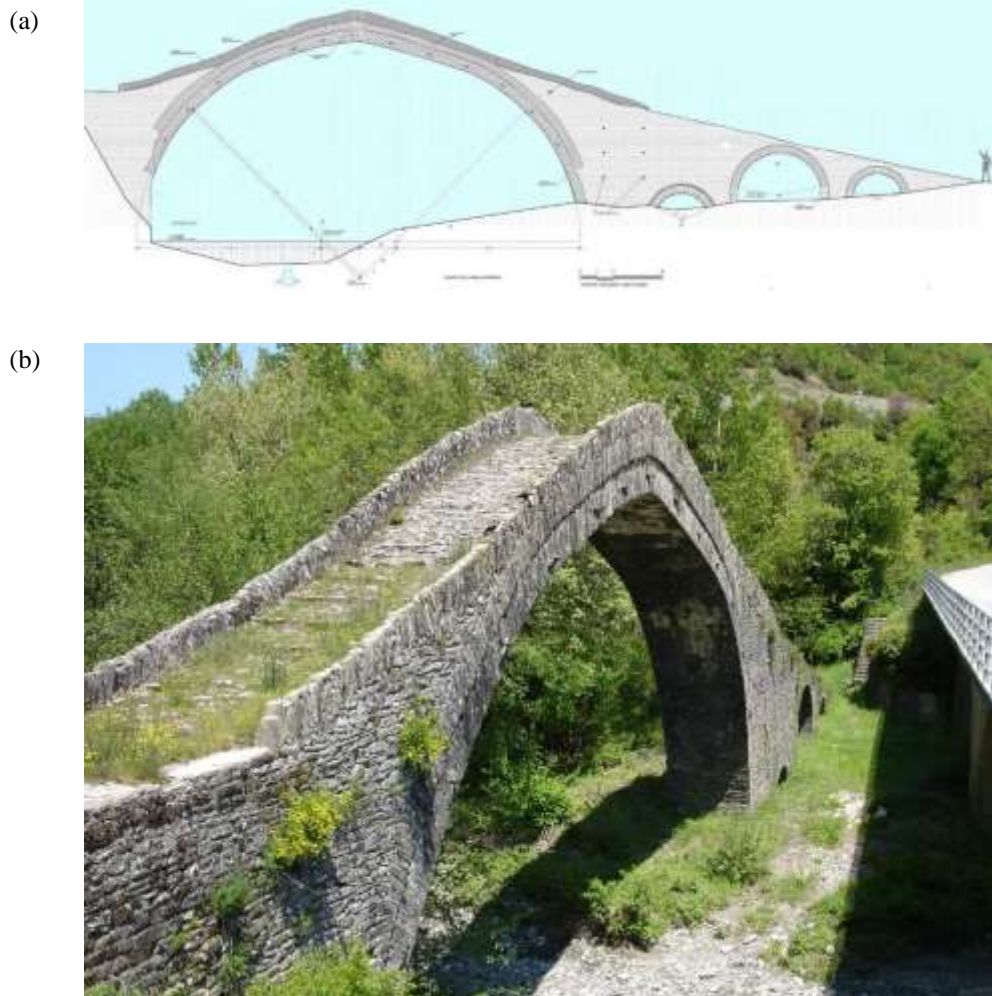
**Fig. 1.** Tsipiani bridge (a) Schematic representation, (b) side photo of the structure

Tsipiani bridge (1875) is located at the East Zagori region in Epirus Greece, near the village of Miliotades. It is a peculiar single-arched bridge, the arch of which appears pointed, with an opening of 26 m and a height of intrados 12,20 m as can be shown in Fig.1 (a and b). Traditional stone bridges have no wedge-shaped elements, known as voussoirs, and the final round shape is formed by variable mortar amount between the flat sandstones of the area. The average thickness of mortar is 1 cm while the sandstones are 6 cm thin. According to a 90's approach of the civil engineer Stathis Papavranousis the pointed shape of the arch is due to the compression of the mortar of the central area during an early decentering and not at the intention of the master build-

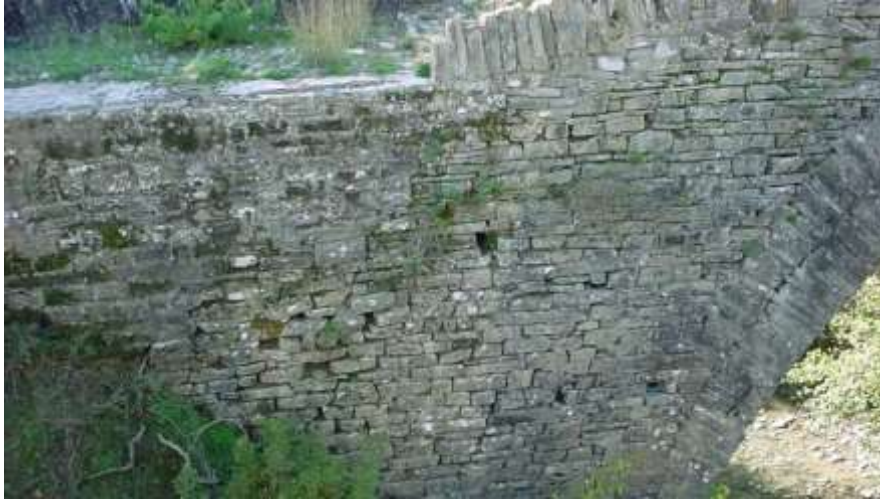
- i. Extensive loss of sandstone bonding mortar all over the outer surface of

**Fig. 2.** Extensive loss of sandstone bonding mortar

Due to (i) the initial mechanical operation of the "stone-mortar" system has been reduced to an unknown degree.

(i) The replacement of the remaining and the lost external bonding mortar of the stones. The joints are expected to have a penetration depth in the body of the bridge 3-5cm. Of course, the final depth of the joints depends on the condition of the individual parts of the bridge body, but deep joints are not appropriate because they can lead to loosening of the coherence [2].

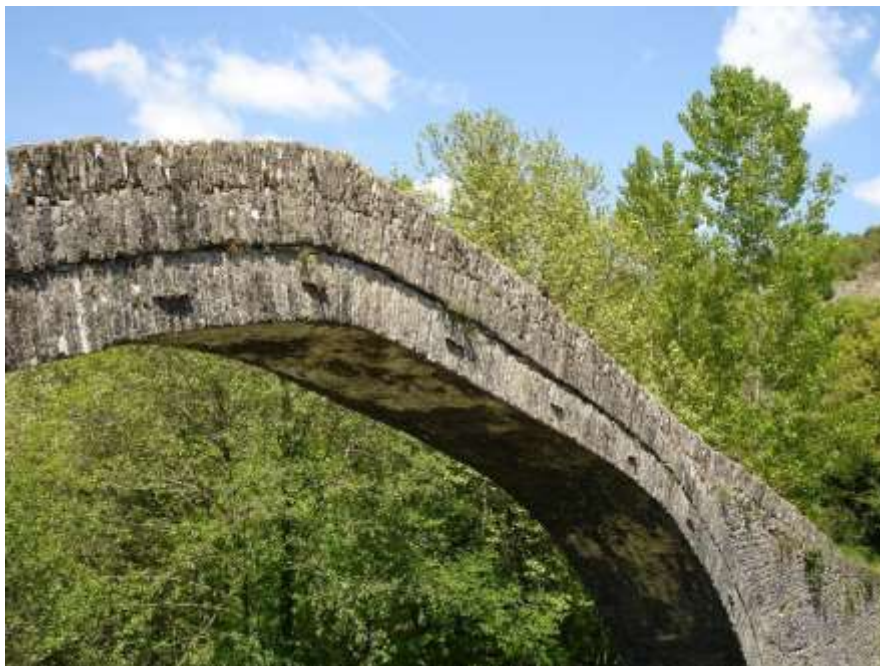
- ii. The failure in the geometry of the arch in its upper left (downstream) part which occurred during its construction. The arch section tends towards its chord as can be seen in the (Fig.3).

**Fig. 3.** The arch section tends towards its chord

Because of (ii) and (iii), as shown by the static solutions, the eccentricity of the thrust line in the larger upper part of the arch exceeds in both rings  $\frac{1}{2}$  of their cross section. Specifically, for the upper ring we have a stability problem for the permanent actions (Same Weight) and for the design earthquake, while for the lower ring only for the design earthquake. The above results in the creation of internal joints [1], [2], [3], eventually turning the larger upper part of the arch into a mechanism.

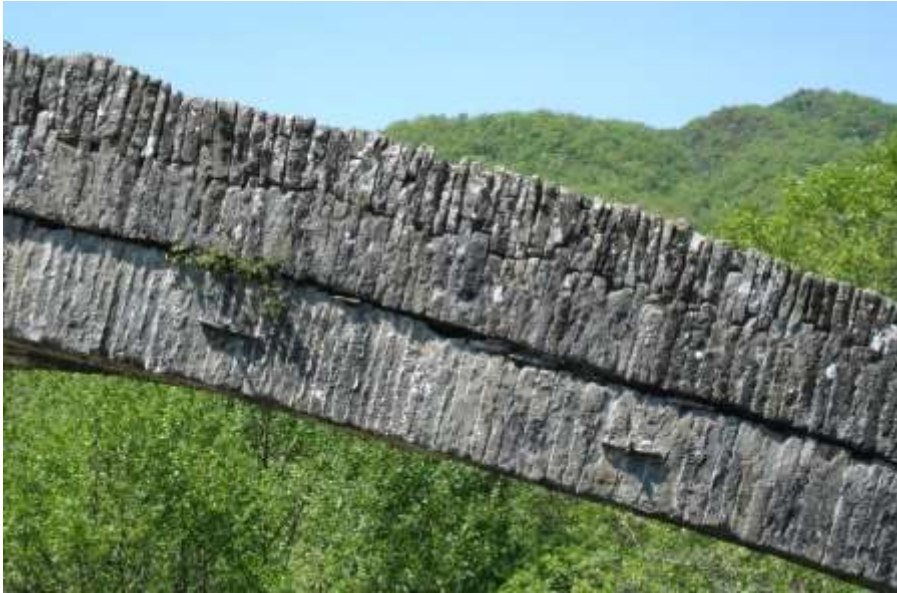
- iii. The loss of contact between the two rings throughout the upper part of the arch due to the above-mentioned failure can be seen in (Fig. 4). The con-

sequence of this is that the loads of the deck are transferred exclusively from the upper ring, subjecting it to intensive sizes disproportionate to its geometry.

**Fig. 4.** Loss of contact between the two rings

(ii) The connection of the two rings of the arch with reinforcing bars, which will have blades at their ends. The new agglomerate that will emerge aims to achieve the static function that a (single) ring 107cm thick (average thickness) would have. At the same time, the gap created between them will be filled with mortar.

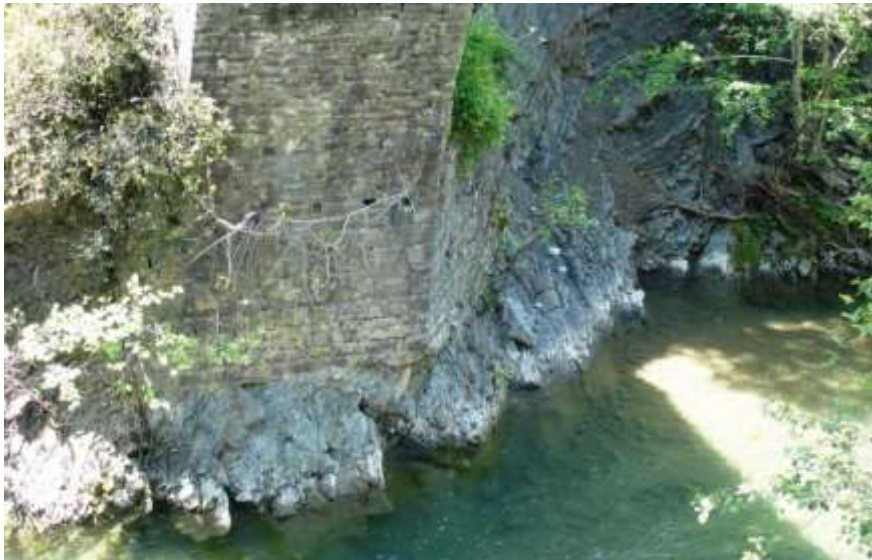
- iv. The revelation of the foundation to the right (downstream) of the bridge body with the simultaneous revelation of the rock on which it is founded can also be seen in (Fig. 5).

**Fig. 5.** Revelation of the foundation

The revelation of the foundation (iv) does not currently raise the issue of the stability of the bridge, without this ruling out a future problem due to its possible under excavation.

(iv) Construction of a stone wall around the revealed foundation if an excavation problem arises in the future. This wall, if the need for its construction is judged, will be founded at the level where the rocky ground will be found.

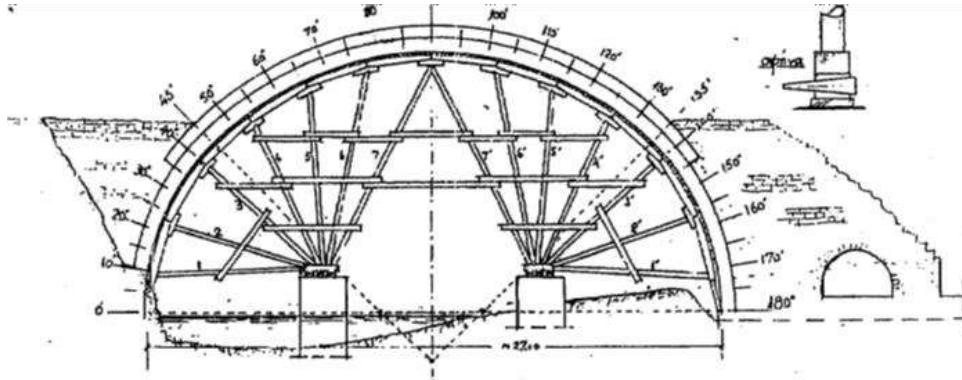
A schematic representation of Papavranousis 1996 [11] static model approach can be seen in (Fig. 6).

**Fig. 6.** A schematic representation of Papavranousis [13] approach

According to [11] the binder was created from river sand and lime in a large proportion. This allows us to estimate its relatively low strength. The following composition is proposed for the new mortar: 1 part Portland cement, 3 parts lime and 9 parts sand, ie M2.5 quality mortar ([2]).

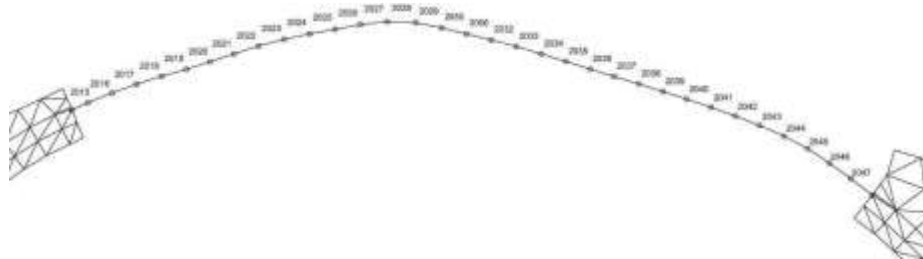
The Position of checking points of critical sections of the arch after restoration can be seen in (Fig. 7).

**Fig. 7.** Position of checking points of critical sections of the arch after restoration

As revealed by the above calculations, the mean of the approximately straight section which resulted from the failure of the arch geometry (upper right section), is the most critical cross section.

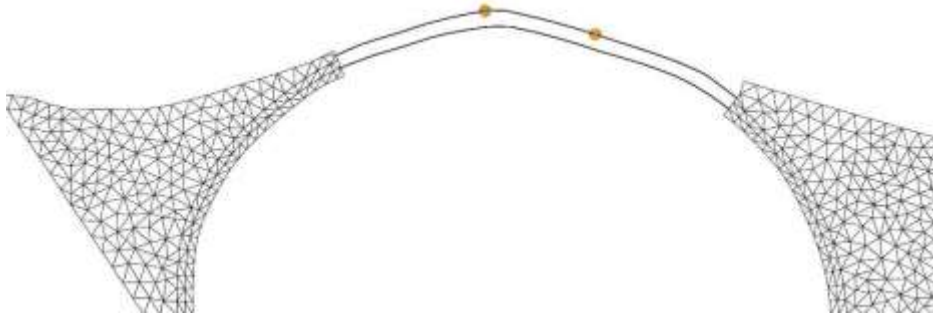
The arch of said bridge even if we ignore its loading history (which is essentially unknown), due to 2 (ii) & 2 (iii), has at least two estimated plastic joints in the upper ring (upper arch tread) as can be seen in (Fig. 8), generative cause of which is the failure in geometry and the self-weight loading.

**Fig. 8.** The two estimated plastic joints in the upper ring

The two above joints have turned the upper foot into a mechanism and the fact that it does not collapse is due solely to the frictional forces acting between the stone blocks. Meanwhile, the distribution of the self weight principal tensile stresses  $\sigma_1$  can be seen in the (Fig. 9).

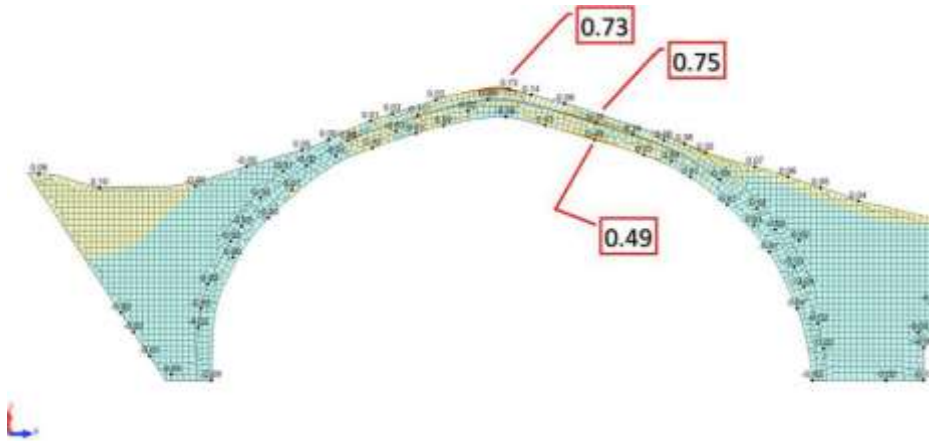
**Fig. 9.** Self-weight principal tensile stresses  $\sigma_1$  (MPa)

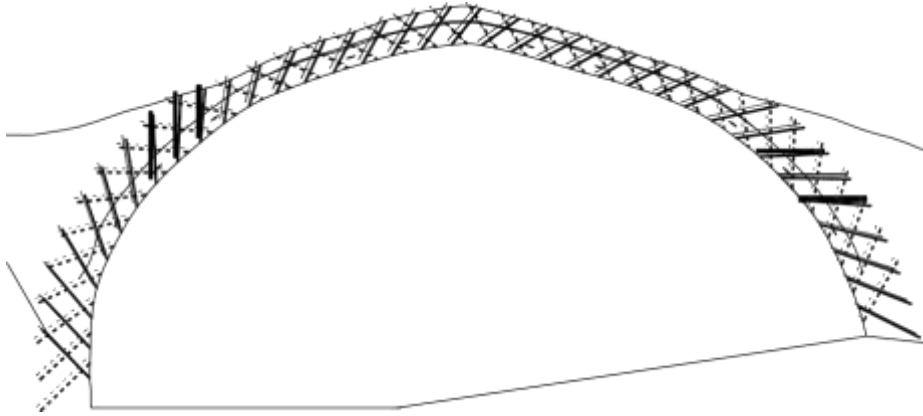
A side schematic representation of the reinforcement bars and anchor blades can be seen in (Fig. 10).

**Fig. 10.** A side schematic representation of the reinforcement

Metal rods  $\Phi 12$  / B500C of different lengths and metal anchor blades  
100x100x20mm  
/ Fe 360 are installed.

In the upper part of the arch are placed bars generally 4Φ12 / m<sup>2</sup>, B500C [2], [3], which at each end have blades measuring 100x100x20mm. In the rest of the arch where it is not possible to place blades on both sides, 4Φ12 / m<sup>2</sup> bars, S500s with a length of 2.30m are placed, on which a dimension blade is placed at their free end.

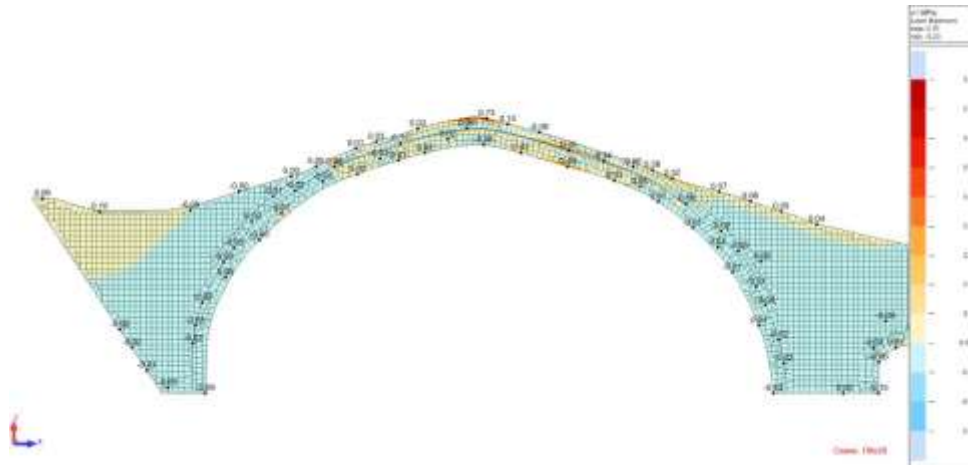
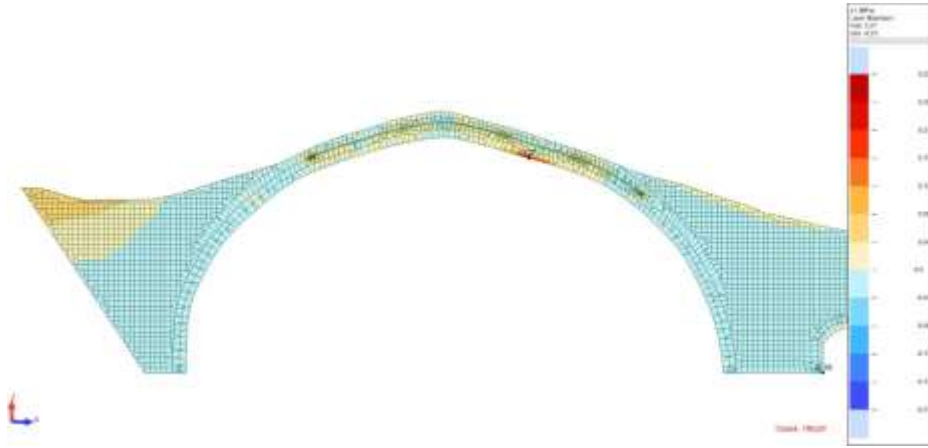
The results of principal tensile stresses  $\sigma_1$  due to Self-weight load before and after the application of reinforcement are shown in (Figures 11 and 12) respectively.

**Fig. 11.** Results before reinforcement: Self weight load. Principal tensile stresses  $\sigma_1$  (MPa)

**Fig. 12.** Results after reinforcement: Self weight load. Principal tensile stresses  $\sigma_1$  (MPa)

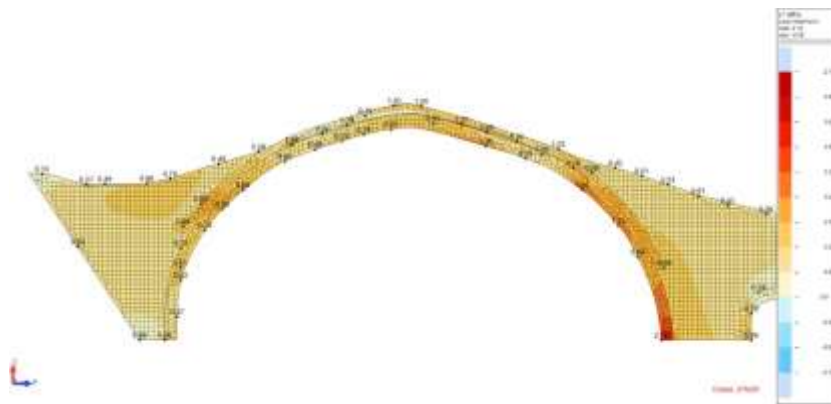
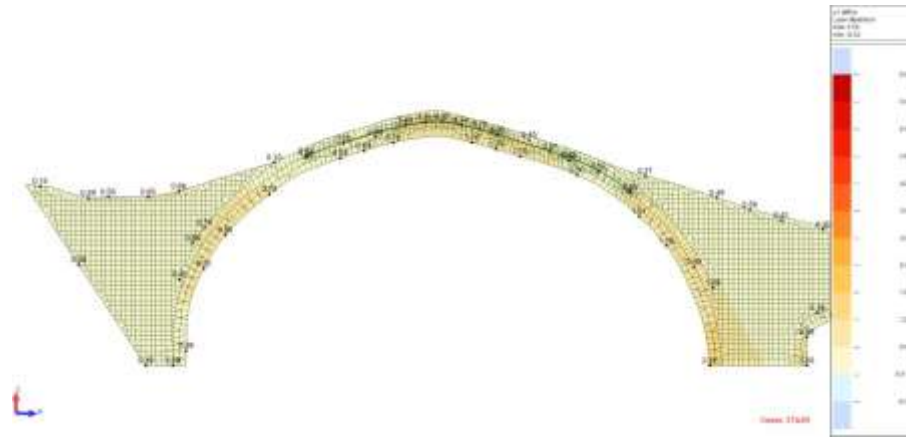
The results of principal tensile stresses  $\sigma_1$  due to Seismic design load before and after the application of reinforcement are shown in (Figures 13 and 14) respectively.

**Fig. 13.** Results before reinforcement: Seismic design load. Principal tensile stresses  $\sigma_1$  (MPa)

**Fig. 14.** Results after reinforcement: Seismic design load. Principal tensile stresses  $\sigma_1$  stresses  $\sigma_1$  (MPa)
