A pointed falsework or a false decentering: Restoration and consolidation of Tsipiani bridge

Angelos Papageorgiou¹, Lampros Lolos²

Abstract. Tsipiani bridge (1875) is located at the East Zagori region in Epirus Greece, near the village of Miliotades. It is a peculiar single-arched bridge, the arch of which appears pointed, with an opening of 26 m. Traditional stone bridges have no wedge-shaped voussoirs, and the final round shape is formed by variable mortar amount amongst the flat sandstones of the area. The current stake is the salvation of the bridge. In the institutional framework of protection, the exact wording of the question is «whether or not» the study is approved. Bridges do not stand by democratic procedures but by the decisive intervention of the engineer corresponding to that of the master builder who in this case seems to have carried out a false decentering. In this case our proposal was the method of “stitching” which is used to reinforce existing structures made of stone or brick to increase the resistance of the masonry against compressive, shear and tensile forces and to connect loose parts in the body of the masonry.

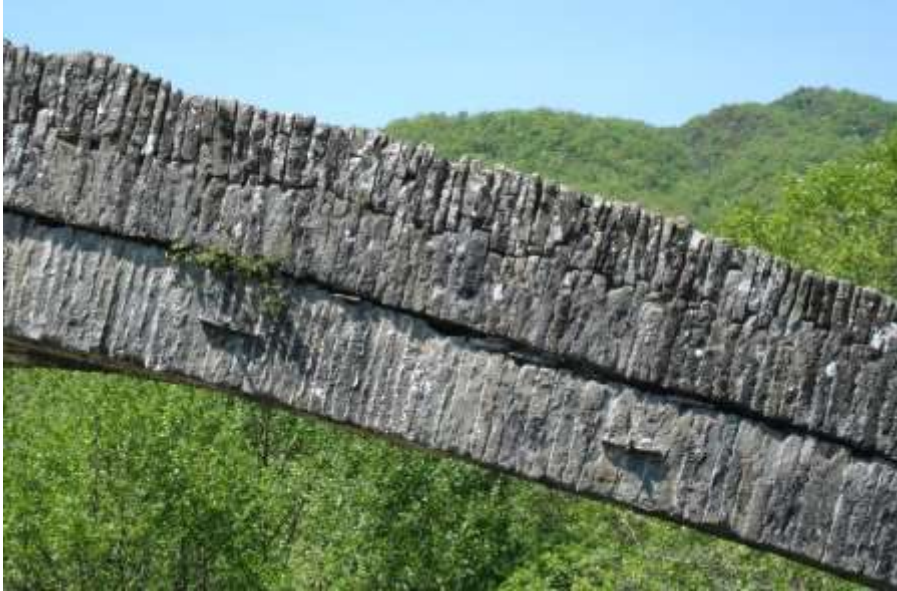
- iii. The loss of contact between the two rings throughout the upper part of the arch due to the above-mentioned failure can be seen in (Fig. 4). The con-

sequence of this is that the loads of the deck are transferred exclusively from the upper ring, subjecting it to intensive sizes disproportionate to its geometry.

Fig. 4. Loss of contact between the two rings

Because of (ii) and (iii), as shown by the static solutions, the eccentricity of the thrust line in the larger upper part of the arch exceeds in both rings $\frac{1}{2}$ of their cross section. Specifically, for the upper ring we have a stability problem for the permanent actions (Same Weight) and for the design earthquake, while for the lower ring only for the design earthquake. The above results in the creation of internal joints [1], [2], [3], eventually turning the larger upper part of the arch into a mechanism.

(ii) The connection of the two rings of the arch with reinforcing bars, which will have blades at their ends. The new agglomerate that will emerge aims to achieve the static function that a (single) ring 107cm thick (average thickness) would have. At the same time, the gap created between them will be filled with mortar.

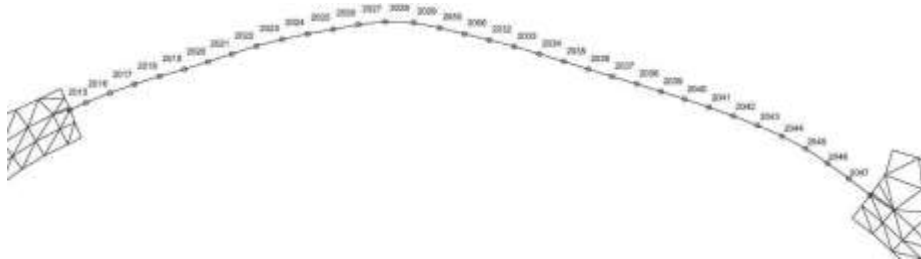
The Position of checking points of critical sections of the arch after restoration can be seen in (Fig. 7).

Fig. 7. Position of checking points of critical sections of the arch after restoration

As revealed by the above calculations, the mean of the approximately straight section which resulted from the failure of the arch geometry (upper right section), is the most critical cross section.

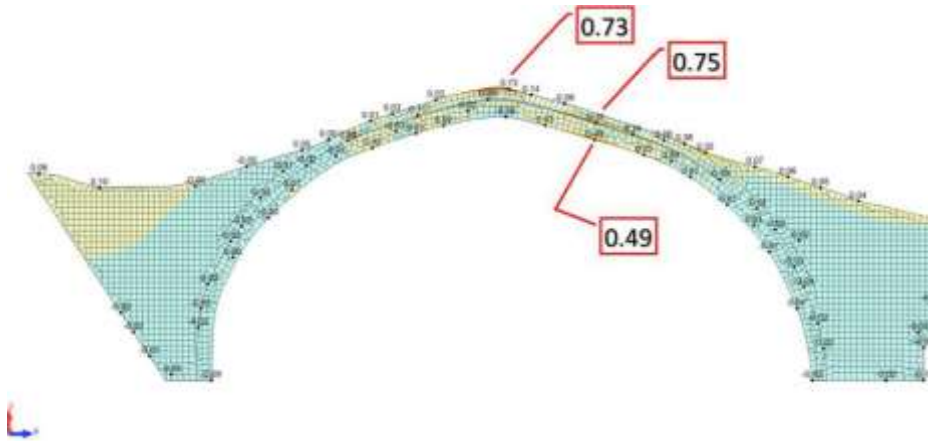
The two above joints have turned the upper foot into a mechanism and the fact that it does not collapse is due solely to the frictional forces acting between the stone blocks. Meanwhile, the distribution of the self weight principal tensile stresses σ_1 can be seen in the (Fig. 9).

Fig. 9. Self-weight principal tensile stresses σ_1 (MPa)

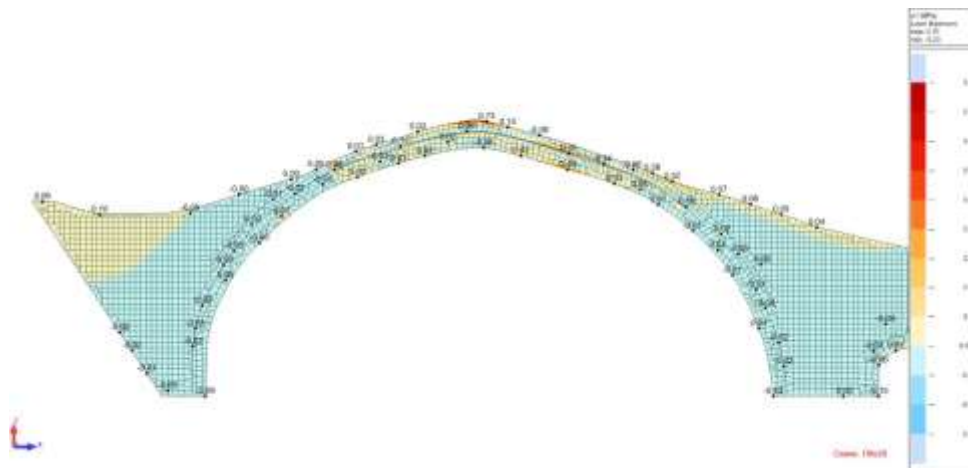
The results of principal tensile stresses σ_1 due to Self-weight load before and after the application of reinforcement are shown in (Figures 11 and 12) respectively.

Fig. 11. Results before reinforcement: Self weight load. Principal tensile stresses σ_1 (MPa)

Fig. 12. Results after reinforcement: Self weight load. Principal tensile stresses σ_1 (MPa)
