A pointed falsework or a false decentering: Restoration and consolidation of Tsipiani bridge

Abstract. Tsipiani bridge (1875) is located at the East Zagori region in Epirus Greece, near the village of Miliotades. It is a peculiar single-arched bridge, the arch of which appears pointed, with an opening of 26 m. Traditional stone bridges have no wedge-shaped voussoirs, and the final round shape is formed by variable mortar amount amongst the flat sandstones of the area. The current stake is the salvation of the bridge. In the institutional framework of protection, the exact wording of the question is «whether or not» the study is approved. Bridges do not stand by democratic procedures but by the decisive intervention of the engineer corresponding to that of the master builder who in this case seems to have carried out a false decentering. In this case our proposal was the method of “stitching” which is used to reinforce existing structures made of stone or brick to increase the resistance of the masonry against compressive, shear and tensile forces and to connect loose parts in the body of the masonry.

Keywords: Stone Bridge, voussoir, decentering, stitching.

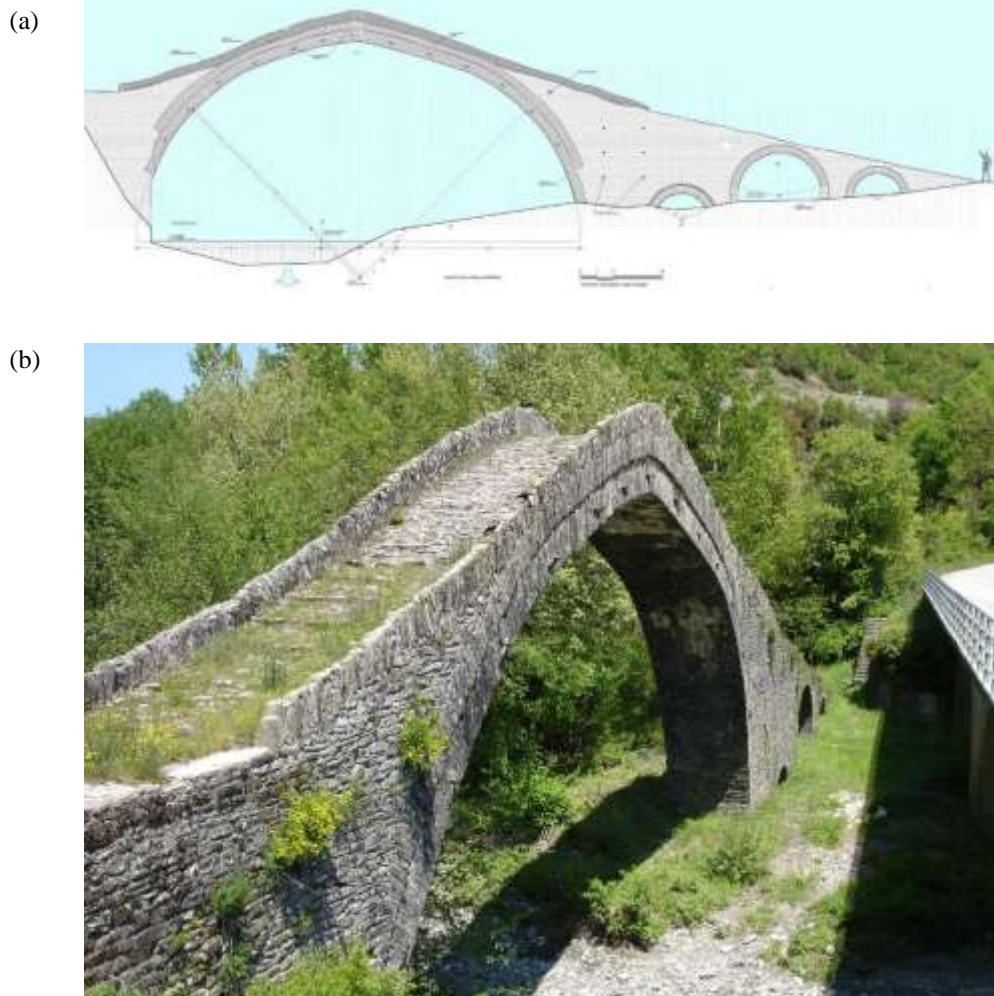
Tsipiani bridge (1875) is located at the East Zagori region in Epirus Greece, near the village of Miliotades. It is a peculiar single-arched bridge, the arch of which appears pointed, with an opening of 26 m and a height of intrados 12,20 m as can be shown in Fig.1 (a and b). Traditional stone bridges have no wedge-shaped elements, known as voussoirs, and the final round shape is formed by variable mortar amount between the flat sandstones of the area. The average thickness of mortar is 1 cm while the sandstones are 6 cm thin. According to a 90's approach of the civil engineer Stathis Papavranousis the pointed shape of the arch is due to the compression of the mortar of the central area during an early decentering and not at the intention of the master build-

Fig. 1. Tsipiani bridge (a) Schematic representation, (b) side photo of the structure

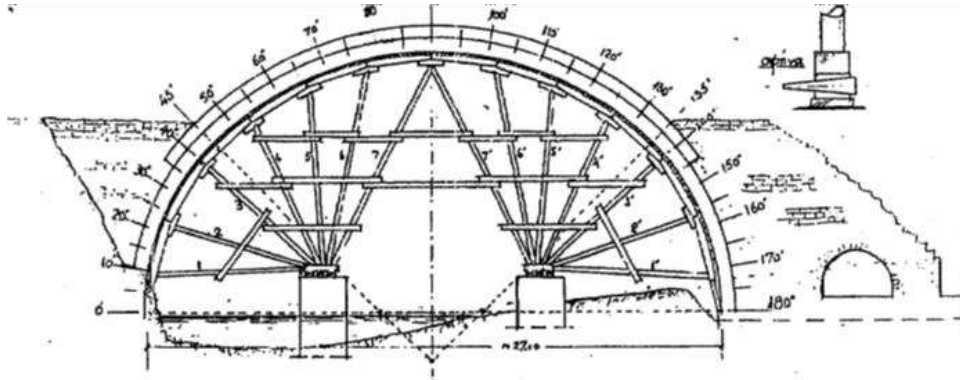
A schematic representation of Papavranousis 1996 [11] static model approach can be seen in (Fig. 6).

Fig. 6. A schematic representation of Papavranousis [13] approach

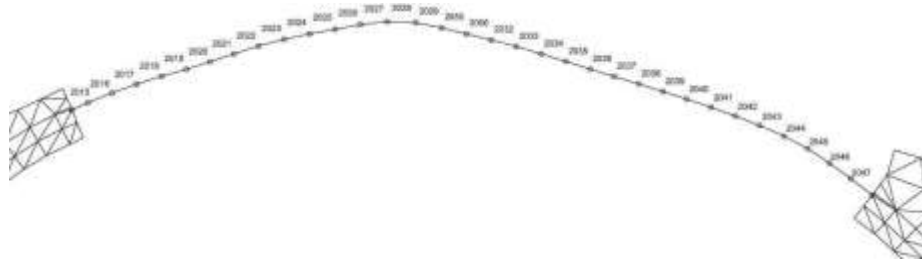
The Position of checking points of critical sections of the arch after restoration can be seen in (Fig. 7).

Fig. 7. Position of checking points of critical sections of the arch after restoration

As revealed by the above calculations, the mean of the approximately straight section which resulted from the failure of the arch geometry (upper right section), is the most critical cross section.
