Seismic investigation and upgrading of disused industrial buildings a case study

Seismic investigation and upgrading of disused industrial buildings: a case study

Abstract. In this paper, the evaluation of the seismic behaviour and the consolidation plan of a former industrial building are described.

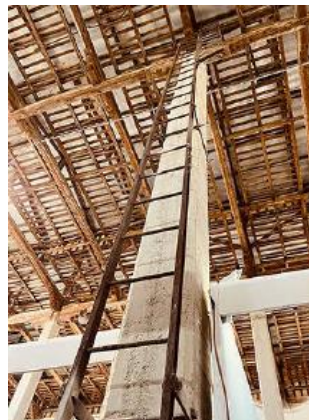
Its structure is of mixed type, composed of masonry and reinforced concrete (**Fig. 7**), the external masonry is realized with solid bricks, and it is interrupted by reinforced concrete pillars, placed at about 6 m each other, which develop from the ground to the building top (**Fig. 8**).

Fig. 8. Reinforced concrete pillar

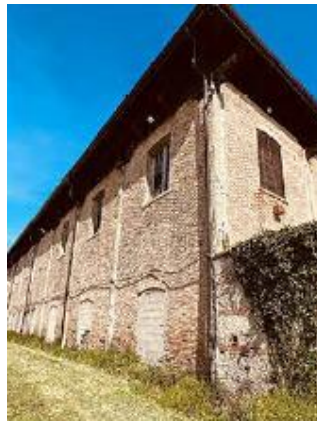
Fig. 10. Closure of the opening at ground floor

Since the design idea includes the elimination of masonry brick walls used for the closure of openings after the abandonment of the structure, in order to restore the resistance and the stiffness of the structure, steel frames are hypothesized to be inserted around openings. They are made up of two steel columns per side and two beams of HEB type.
