Seismic investigation and upgrading of disused industrial buildings: a case study

Abstract. In this paper, the evaluation of the seismic behaviour and the consolidation plan of a former industrial building are described.

Keywords: Industrial buildings, Tobacco factory, Pushover analyses, Retrofitting operation, Seismic upgrading.

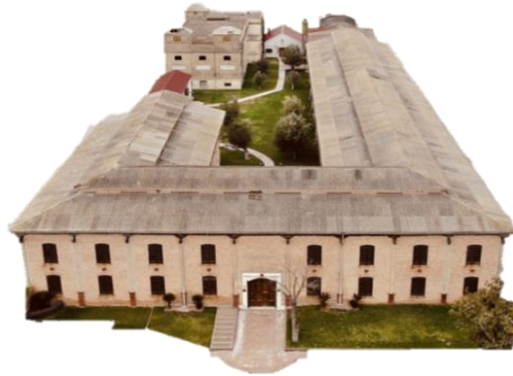
Fig. 5. A three-dimensional view of the building

The building under study, which within the large area examined is the one intended to the dryers' function when it was active. The drying phase in the processing of tobacco consisted in hanging the leaves on wooden structures, generally the gratings placed under the covers, to allow them to dry before the next production stages. **Fig. 5** shows a three-dimensional view of the edifice.
