### Seismic investigation and upgrading of disused industrial buildings a case study

# Seismic investigation and upgrading of disused industrial buildings: a case study

**Abstract.** In this paper, the evaluation of the seismic behaviour and the consolidation plan of a former industrial building are described.

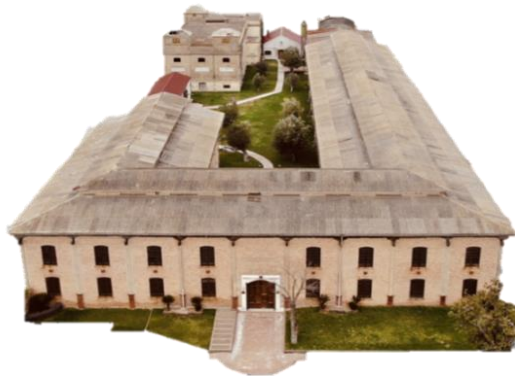
**Fig. 5.** A three-dimensional view of the building

The building under study, which within the large area examined is the one intended to the dryers' function when it was active. The drying phase in the processing of tobacco consisted in hanging the leaves on wooden structures, generally the gratings placed under the covers, to allow them to dry before the next production stages. **Fig. 5** shows a three-dimensional view of the edifice.

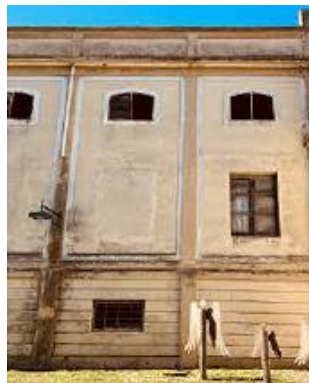
**Fig. 7.** Alternation of masonry walls and pillars on the façade

Its structure is of mixed type, composed of masonry and reinforced concrete (**Fig. 7**), the external masonry is realized with solid bricks, and it is interrupted by reinforced concrete pillars, placed at about 6 m each other, which develop from the ground to the building top (**Fig. 8**).

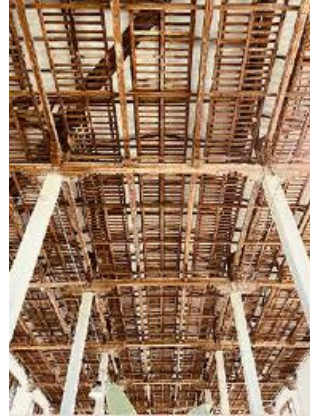
**Fig. 9.** The structure of the roof

There are not even internal horizontal floors, but only the roof structure having a double pitch configuration made of corrugated sheet metal placed so to replace the previous asbestos panels. This roof is sustained by a grid of wooden beams. (Fig. 9) The facades are characterized by a series of rectangular opening. Some of them have been closed with solid bricks after the abandonment of the factory in order to avoid the entrance of strangers (Fig. 10). All these features are highlighted in the following photographic documentation.

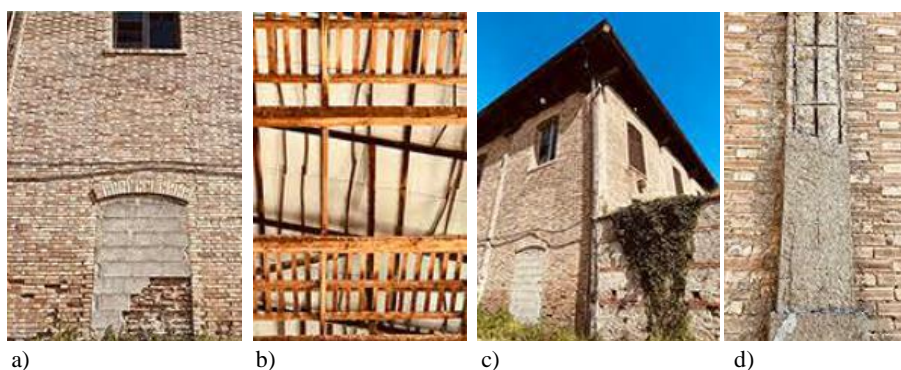
- Crushing of masonry walls;
- Poor connection among adjacent walls;
- Decay of wooden elements;
- Decay of reinforced concrete pillars.

With the regard to the first type of damage, at the base of the external masonry walls it is possible to individuate crushing phenomena. These could be related to the age of materials and the decay of the mortar. In some points of walls orthogonal to each other, there are a lack of connection between them, which give rise to the absence of the so-called “box-effect”. As a consequence, the structure could suffer local mechanisms, like overturning phenomenon [10].

Due to the humidity, numerous wooden elements of the roof grid are deteriorated. Instead, other elements show vertical lesions due to the loads increase during time.

Finally, some problems are found in reinforced concrete pillars, which exhibit in some parts the detachment of the concrete cover. As a result, the steel reinforcement bars are exposed and rusty. In **Fig. 11** the four typologies of damages above described are illustrated.

**Fig. 11.** Injuries on the case study: a) Crushing of masonry walls, b) Poor connection between adjacent walls, c) Decay of wooden beams, d) Detachment of the cover concrete from the pillars
